Building Inspection Report

XXX Road
Town, State

Saturday, November 22, 2014

112220141

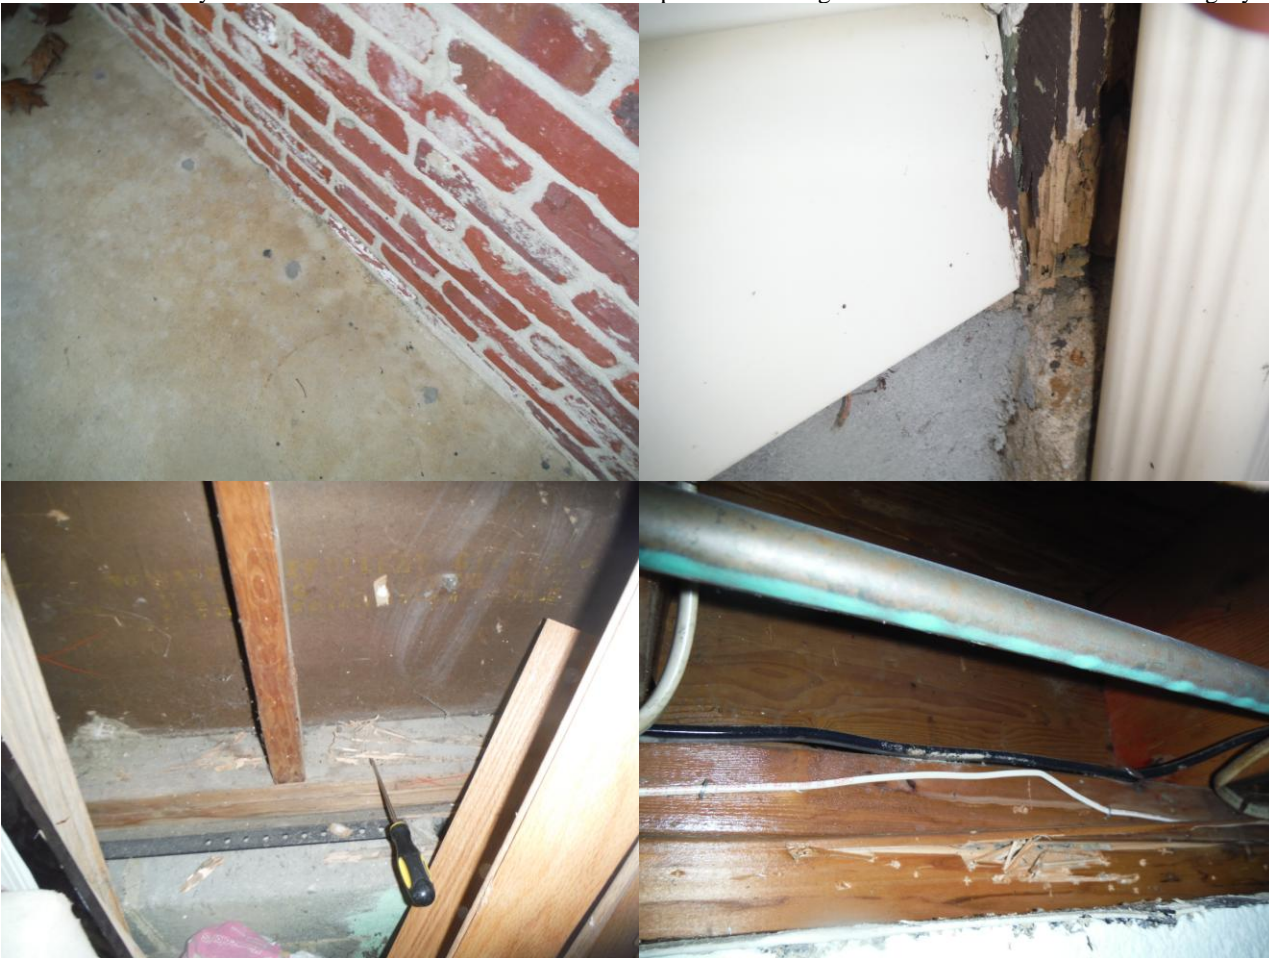
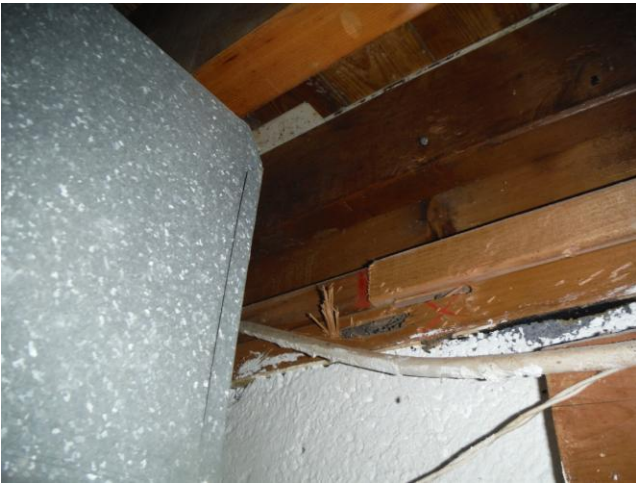
- 1) Repair-Recommend. Cost=Uncertain.

There is evidence of termite activity in the garage, basement and exterior. Additional and/or latent/hidden termite damage can be expected. There is evidence of termite treatment injection holes on the exterior block walls. A termite treatment or transfer of warranty is recommended. It is recommended to replace the damaged wood to maintain structural integrity.

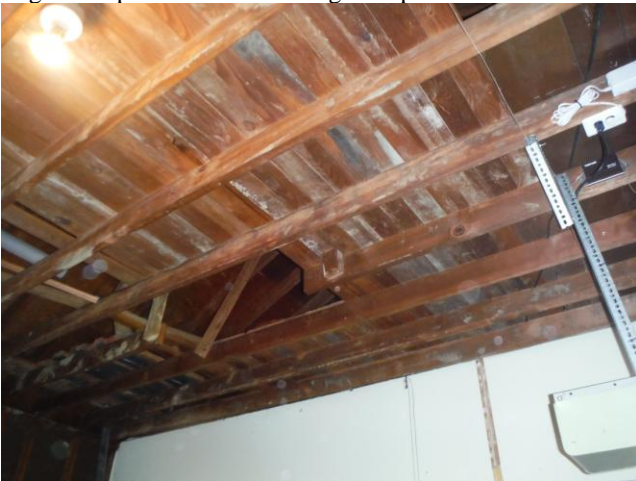
2) Repair-Recommend. Cost=Low.

The joist in the garage has been compromised/cut. It should be reinforced/replaced with a joist with a similar depth to the original to prevent localized sag/collapse.

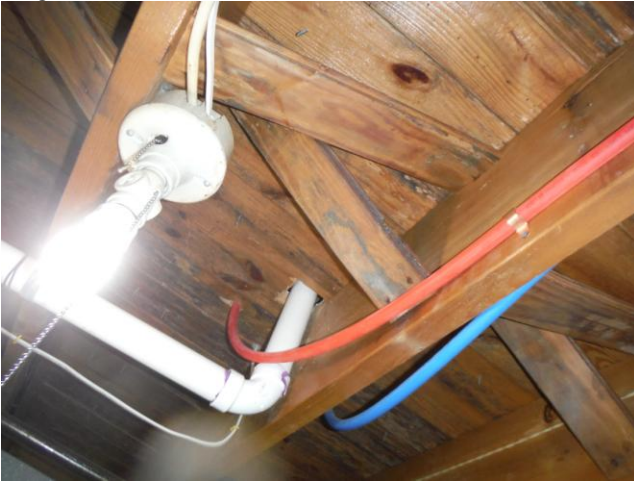
3) Monitor-Recommend.

On the main floor (kitchen area, etc.) ceramic tile and a center island with granite countertops were installed. It is uncertain if the original floor structure design accounted for this weight. If not floor sag and tile cracking, etc. may occur. The buyer may want to consider having the floor structure evaluated by a structural engineer to ensure that it is properly designed for such weight.

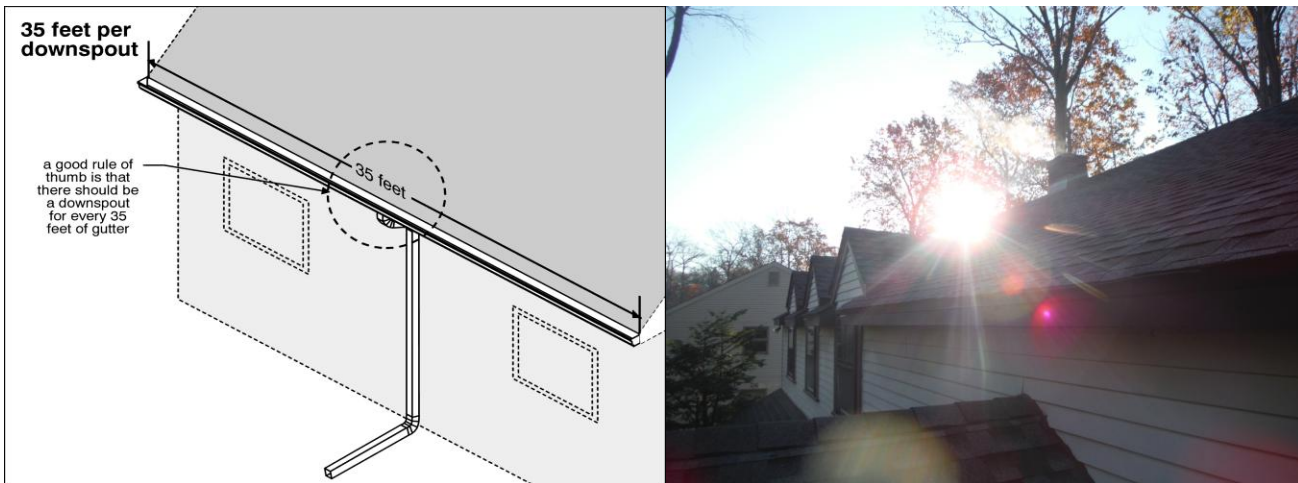
- 4) Provide-Recommend. Cost=Medium.

The front upper roof does not have a gutter. The gutter should be added to the upper roof in order to properly protect the lower/ front roof from deterioration.

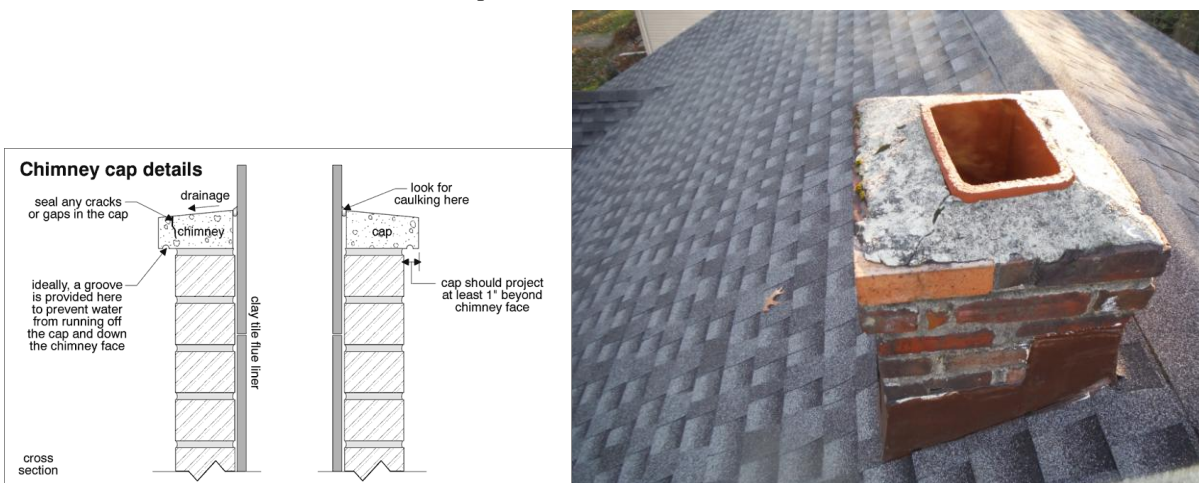
- 5) Repair-Recommend. Cost=Medium.

The center chimney crown/cap/wash is deteriorated. It should be repaired or replaced in order to properly protect the chimney structure from deterioration due to moisture penetration.

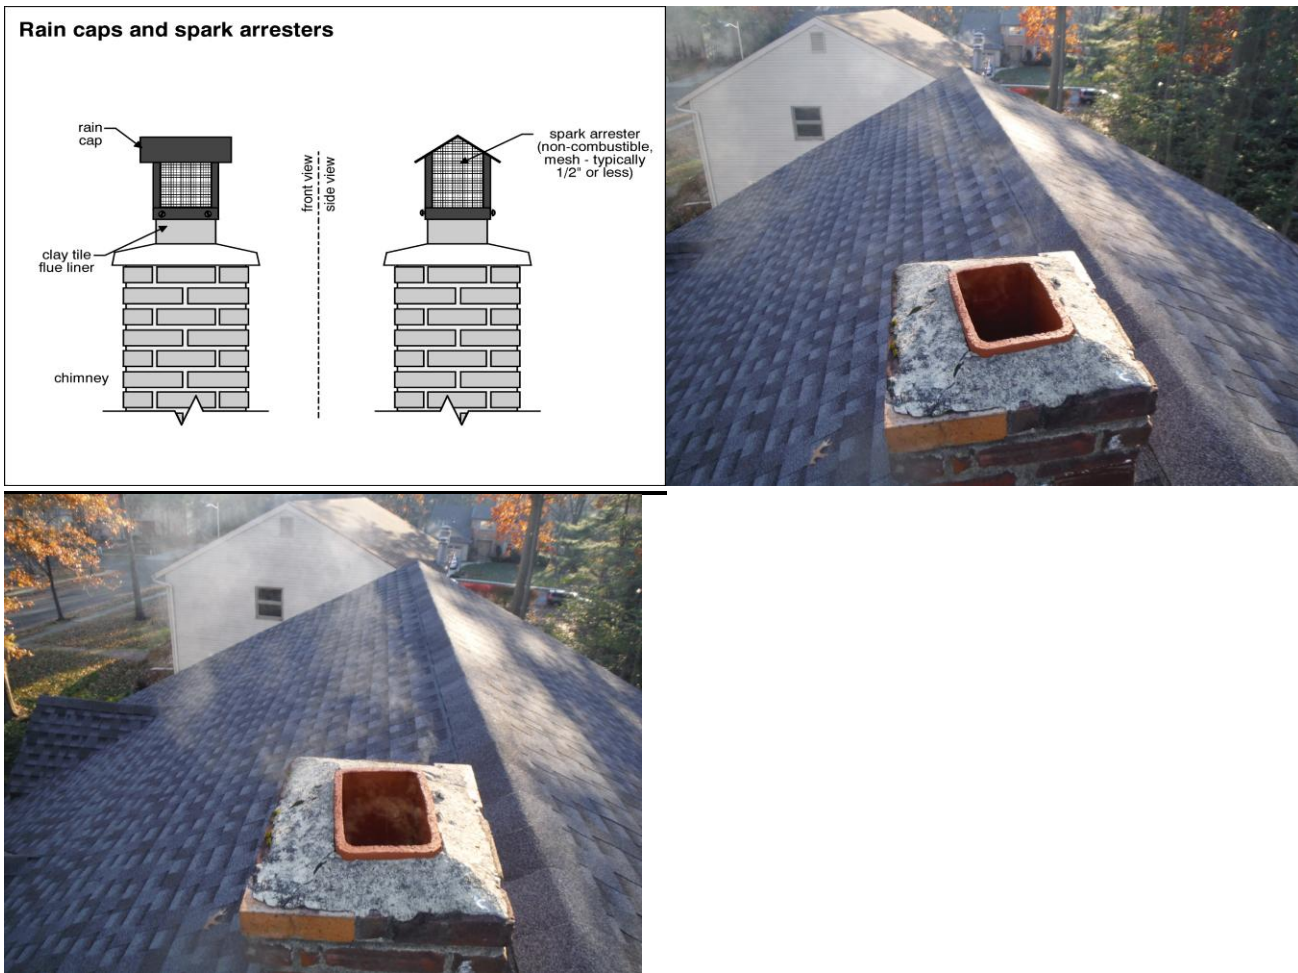
6) Provide-Recommend. Cost=Medium.

A rain cap should be added to the center chimney liner to protect the liner, chimney and firebox from moisture damage.

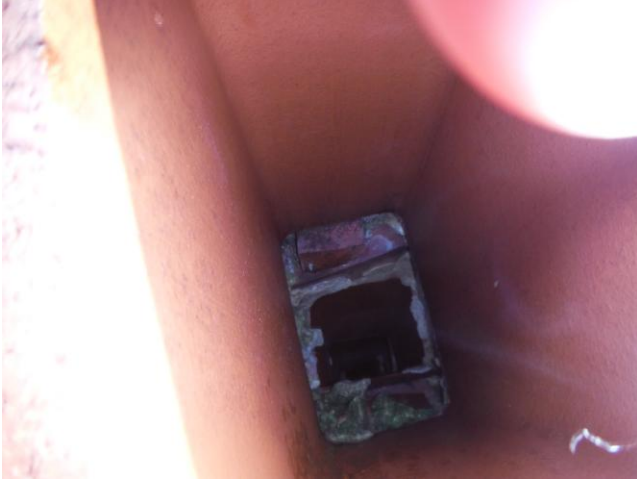
7) Further Investigation Required-Recommend.

It appears that the center chimney liner (clay) has obstructions (brick/mortar) below the top liner sections. A chimney specialist should determine if the liner is acceptable or requires repairs in order to protect the chimney structure and to prevent dangerous combustion products into living areas. A NFPA Level 2 flue inspection is recommended.

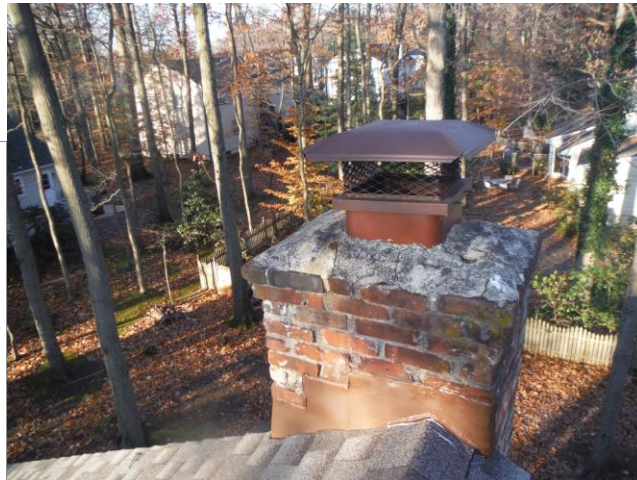
9) Repair-Recommend. Cost=Medium.

The right chimney crown/cap/wash is deteriorated. It should be repaired or replaced in order to properly protect the chimney structure from deterioration due to moisture penetration.

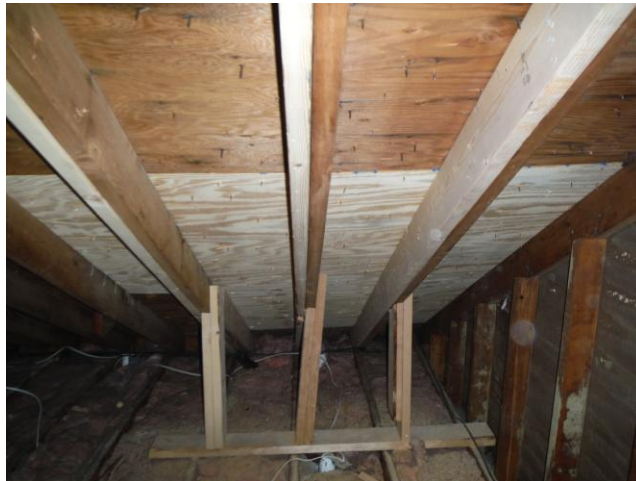
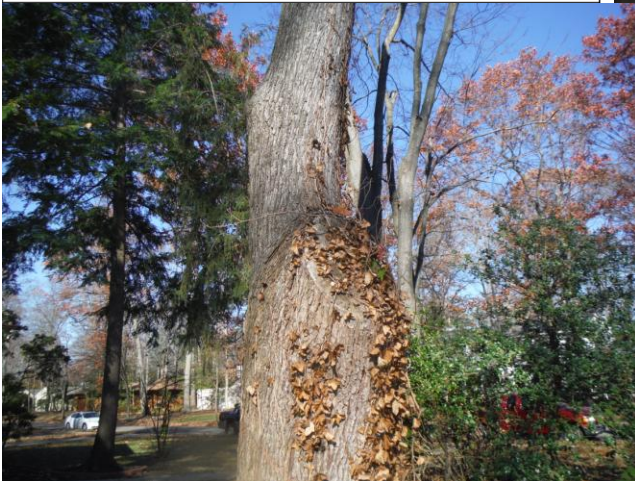
10) Monitor-Recommend.

It appears the front/left roof was damaged and reinforced – probably from tree damage. The areas should be monitored for future foot leaks.

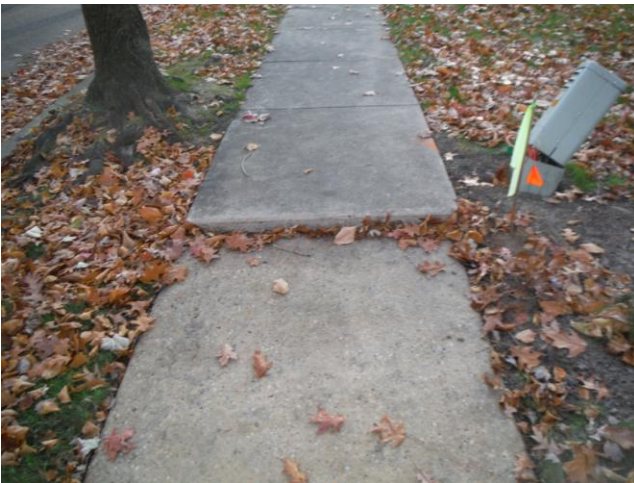
11) Repair-Recommend. Cost=Low/Medium.

The front sidewalk has a potential tripping hazard as the sidewalk has a lifted/settled section. To prevent tripping hazards the walk should be made level.

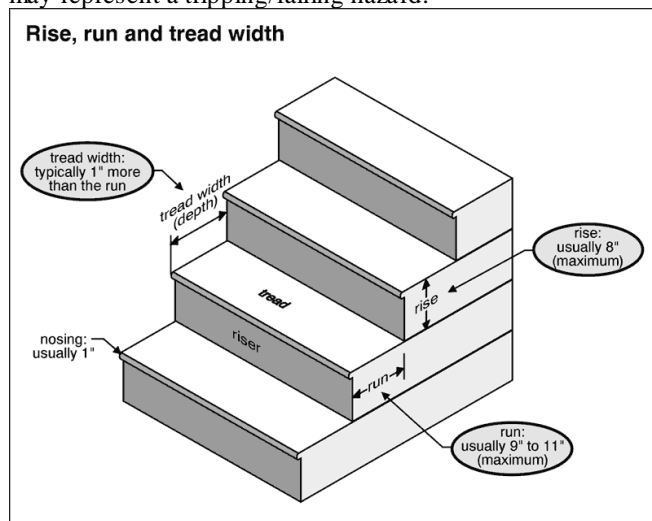
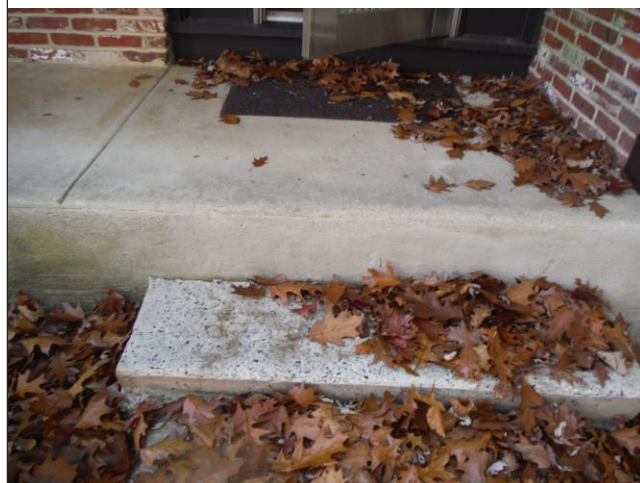
12) Improve-Recommend. Cost=Medium.

The height of the front exterior step exceeds the maximum allowable by modern building codes. It should be reduced as it may represent a tripping/falling hazard.

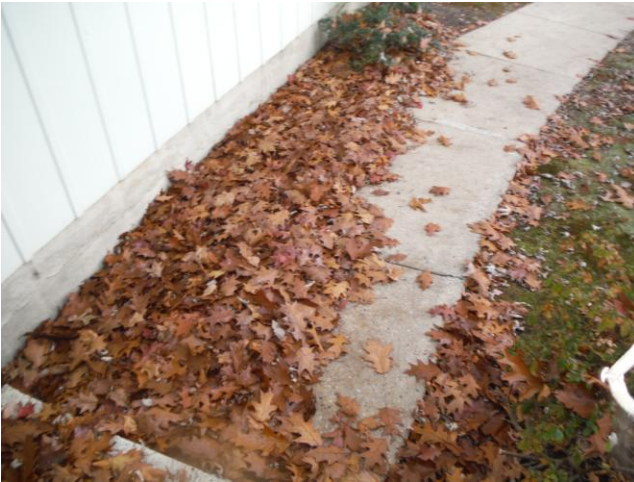
13) Repair-Recommend. Cost=Low/Medium.

The front sidewalk has a potential tripping hazard as the sidewalk has a lifted/settled section. To prevent tripping hazards the walk should be made level.

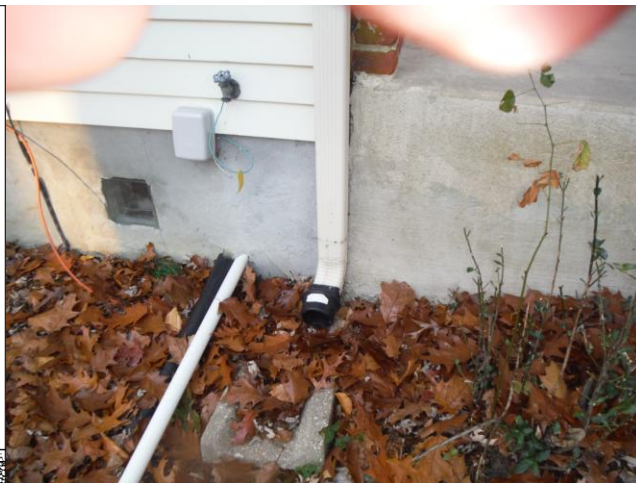
14) Improve-Recommend: Cost=Low.

ALL downspouts should be extended 4-6' away from the foundation in order to properly divert damaging roof water runoff away from the foundation.

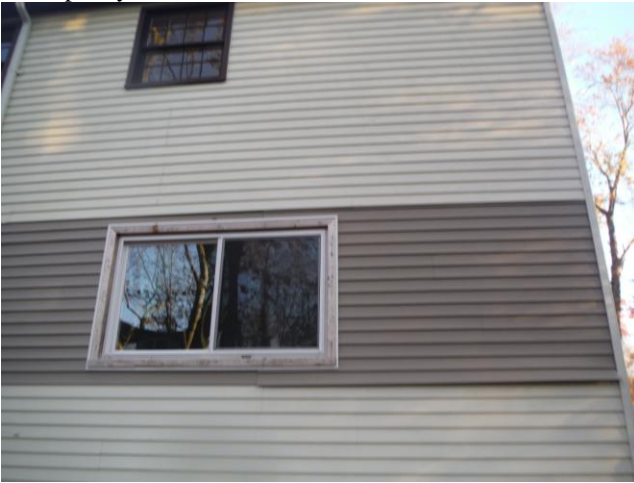
17) Further Investigation Required-Recommend.

The siding on the rear/left is of a different color than the original siding. It should be inquired from the seller as to why this discrepancy exists to ensure no structural anomalies could explain the different siding.

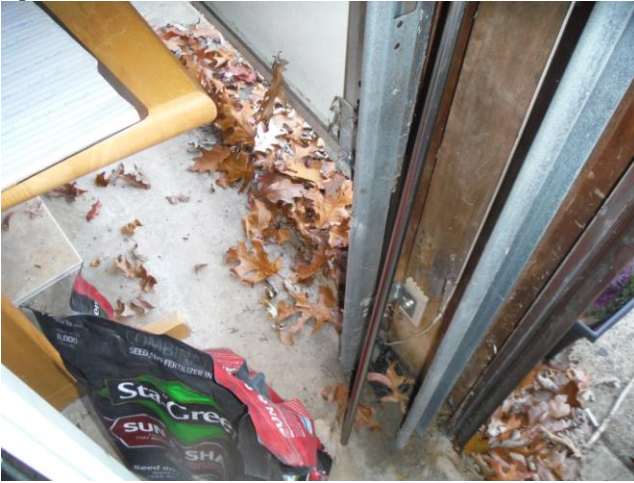
21) Provide-Recommend. Cost=Medium.

The rear garage door opener should be fitted with IR sensors along the door base opening so that the door will reverse if the IR beam is broken. Otherwise people and material can be harmed because the door will currently only reverse if the reverse sensor of the door opener is activated. Modern garage door openers would come with IR sensors as standard equipment. Openers installed since 1992 should have such sensors installed and operating as standard equipment.

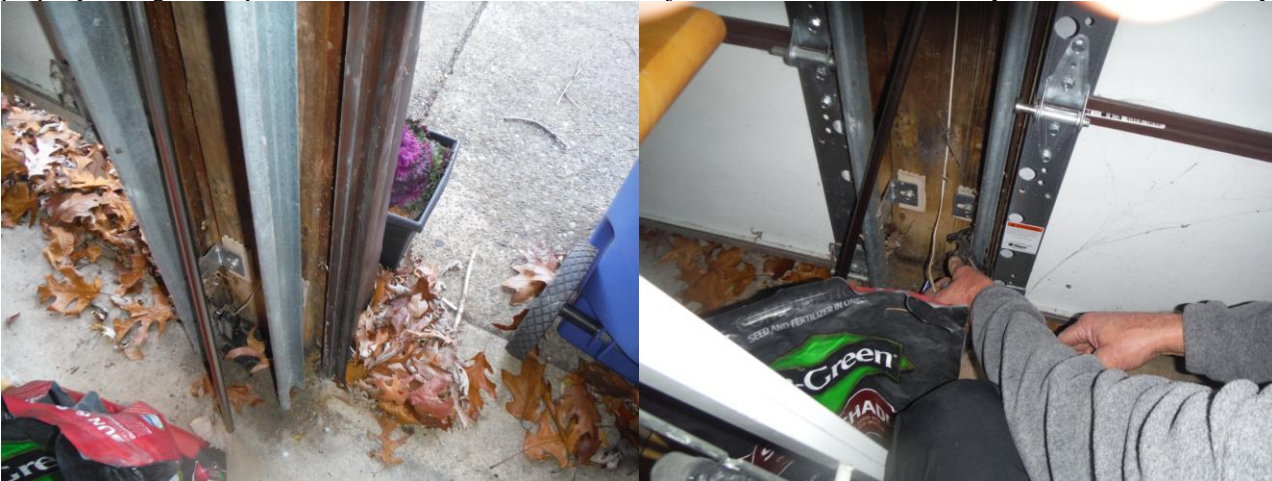
22) Repair-Recommend. Cost=Low.

The front garage door opener should be repaired/adjusted so that it operates correctly and safely. The IR sensors did not work properly during the inspection and the sensors needed to be adjusted in order for functionality to resume. This is safety risk.

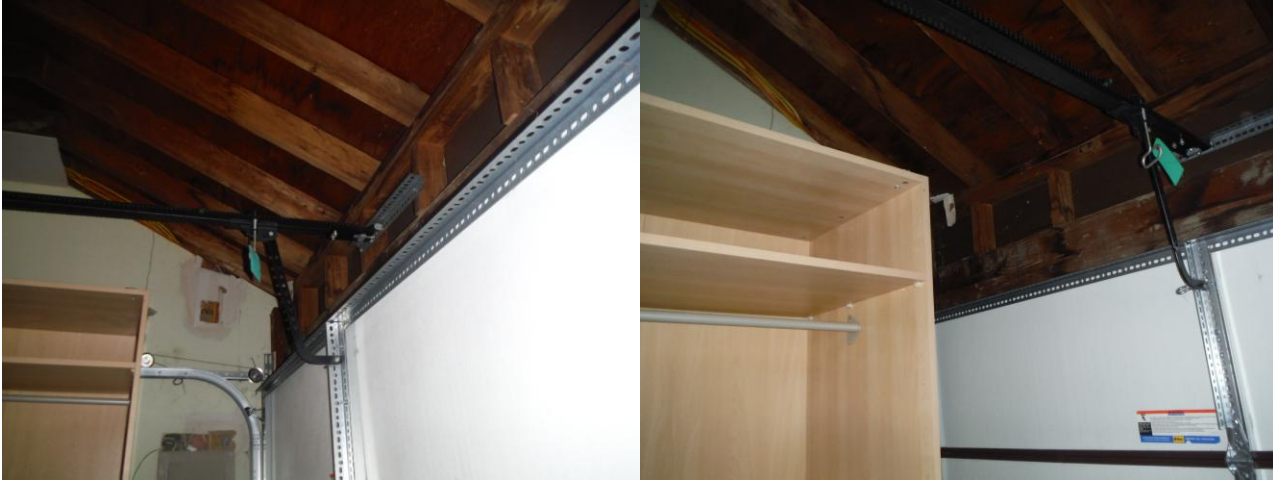
23) Repair-Recommend. Cost=Uncertain.

The right garage door could not be closed with the garage door opener. It may need to be adjusted. To ensure operability it should be repaired/maintained.

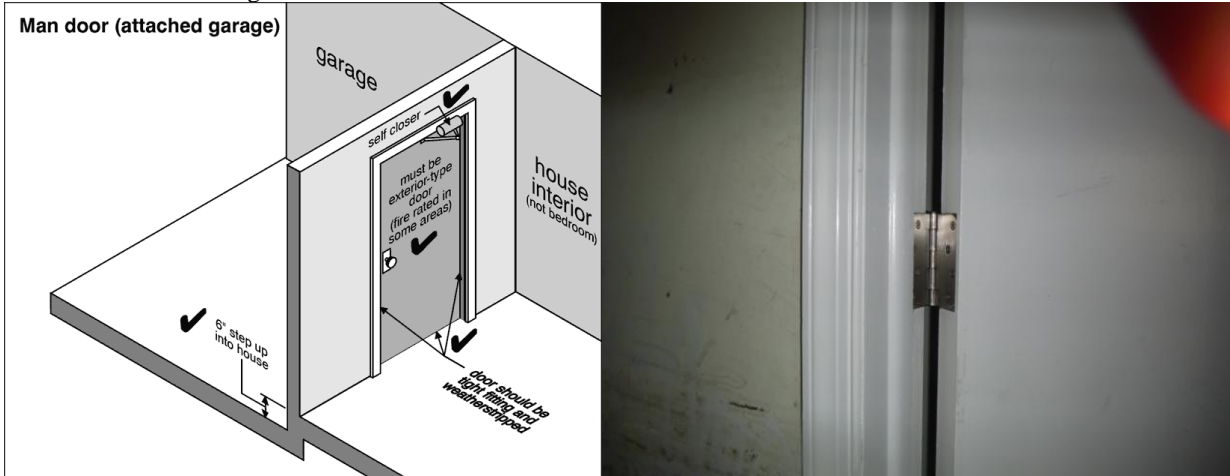
24) Provide-Recommend. Cost=Low.

A fire hinge should be installed on the garage man door so that the door closes automatically in order to keep dangerous automobile fumes and gases out of the home.

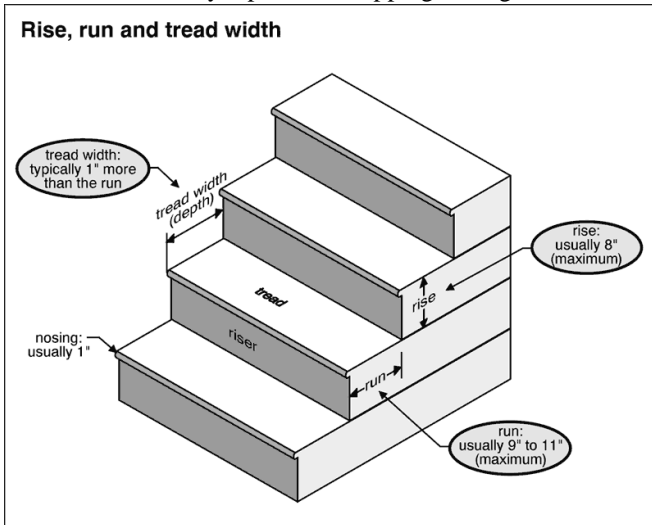
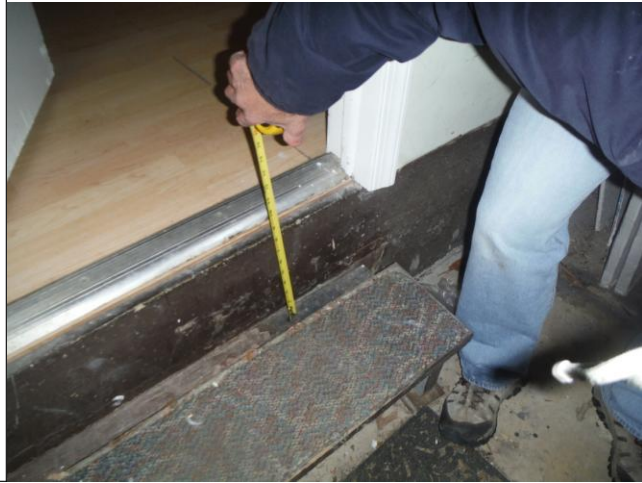
25) Repair-Recommend. Cost=Medium.

The height of the garage door riser exceeds the maximum allowable by modern building science recommendations. It should be reduced as it may represent a tripping/falling hazard.

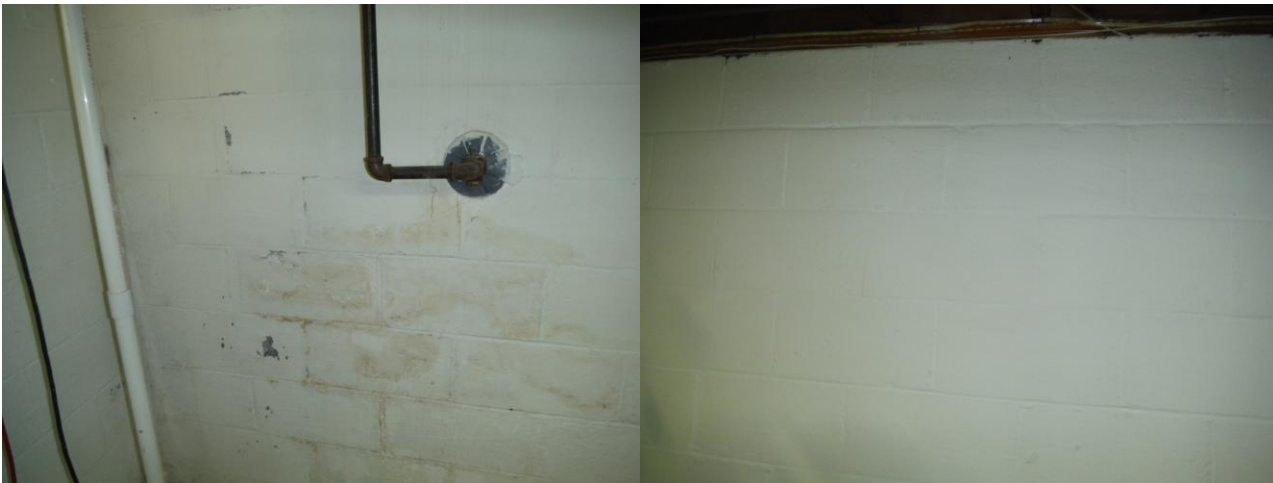
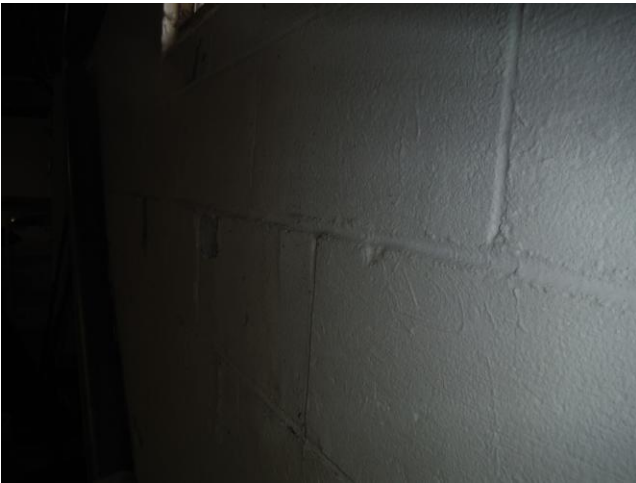
26) Monitor-Recommend.

There is evidence of minor moisture intrusion to the basement as stains are present on some walls. Peeling paint is visible on the rear wall. Drylok is present on the exposed interior walls. This paint is often used to help prevent moisture intrusion through basement walls such as these. A sump pump is installed. The operation of the sump pump and interior drain system should be monitored for efficacy by the homeowner to prevent damaging moisture into the basement. If the basement does suffer from future water penetration a water proofing contractor should be hired to rectify the issue. This can be prohibitively expensive.

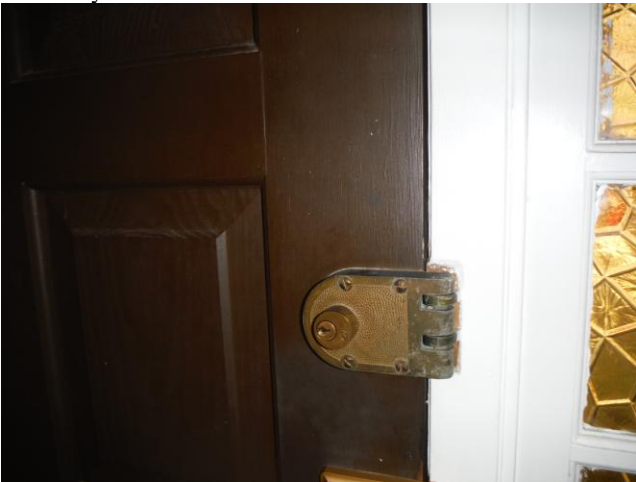
27) Replace-Recommend. Cost=Low.

The front exterior door has a keyed dead bolt lockset. Exterior doors should have turn-style locksets which can be operated quickly and do not rely upon using/finding a key in the event of an emergency (e.g. fire). The lockset should be replaced with a turn-style lockset.

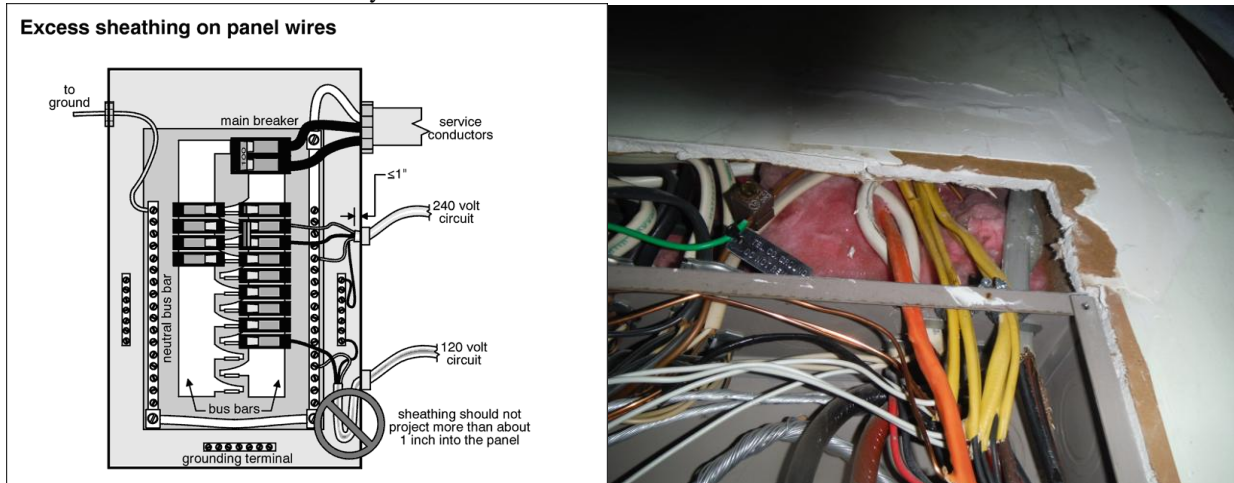
30) Repair-Recommend. Cost=Low.

In the main panel there are several distribution circuits that have excess sheathing remaining. This is considered an electrical deficiency because it can over-crowd the panel and may represent a fire pathway as the sheathing is combustible. This suggests that electrical work performed on these expansion circuits was done by a non-licensed, non-professional. These deficiencies should be corrected by a licensed electrician.

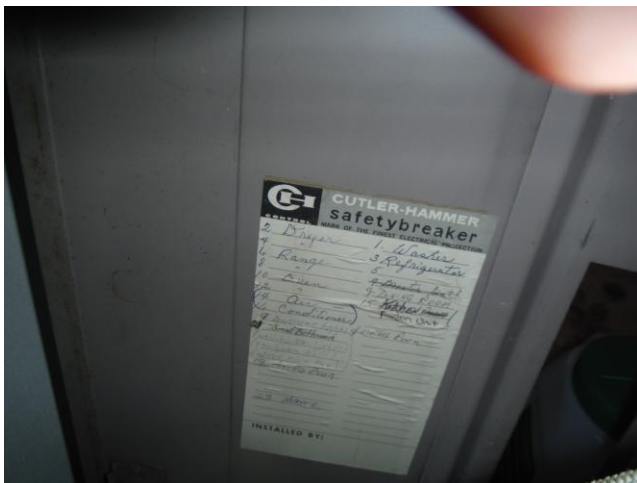
31) Provide-Recommend. Cost=Low.

The main panel in the garage is not properly marked. For convenience and servicing EVERY breaker should be identified in the panel.

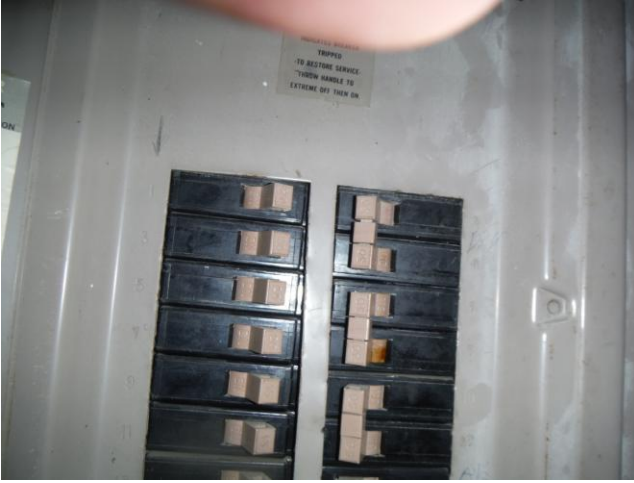
32) Further Investigation Required-Recommend.

In the main panel at least one breaker was unexpectedly making a buzzing sound during the inspection when multiple appliances were being operated. This may signify a defective breaker or an overloaded circuit which may signify an electric safety issue. An electrician should be hired to investigate the cause and solution for the noise from the breaker.

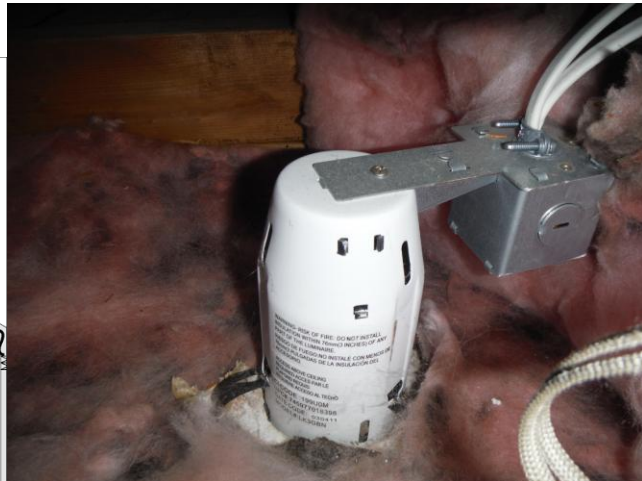
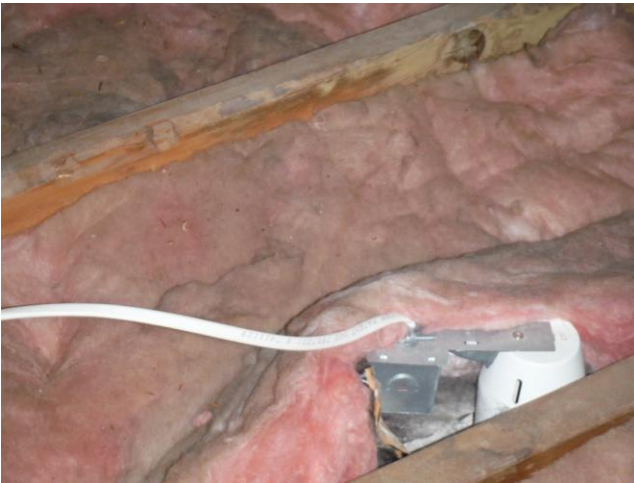
33) Repair-Priority. Cost=Low.

The pot lights in the attic are not rated for IC (insulation Contact) yet are in contact with combustible insulation. Therefore they represent a fire safety hazard. It should be ensured that the insulation is moved/separated away from the pot lights by 3"+.

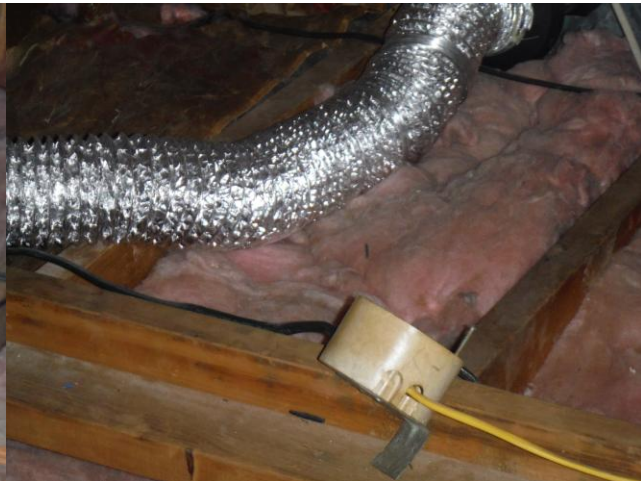
34) Repair-Recommend. Cost=Low/Medium.

There are several junction boxes in the attic that represent fire/safety issues. Several are loose/unfastened. An electrician should be hire to ensure that all junction boxes are properly secured and covered in the attic.

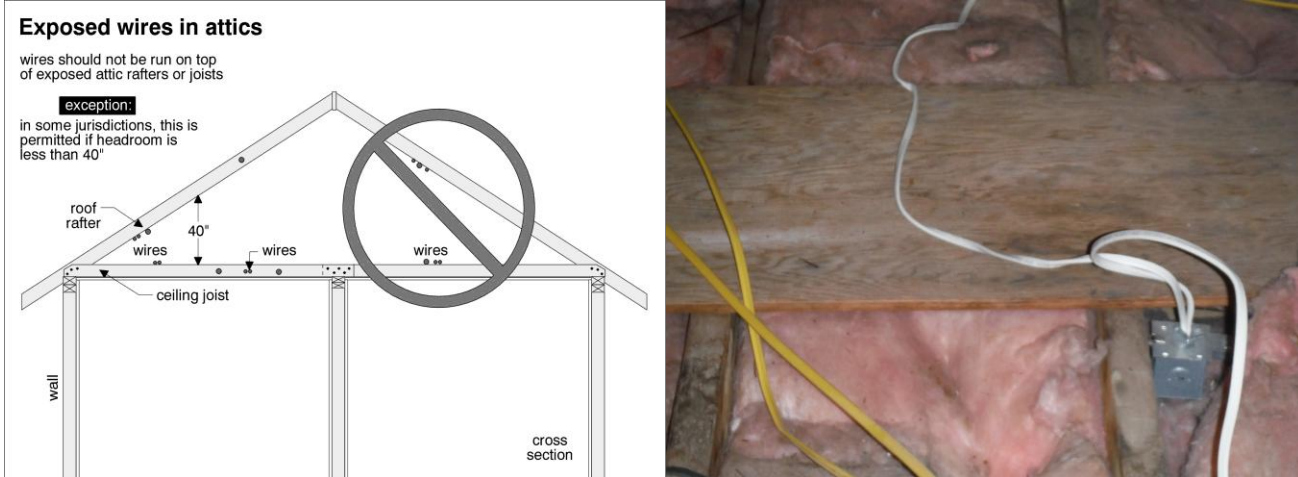
35) Monitor-Recommend.

There are multiple instances of wires installed in the attic that represent electrical/fire safety issues since they are laying on top of exposed joists/boards. Foot traffic and/or storage activities can damage/compromise these wires which can cause fires.

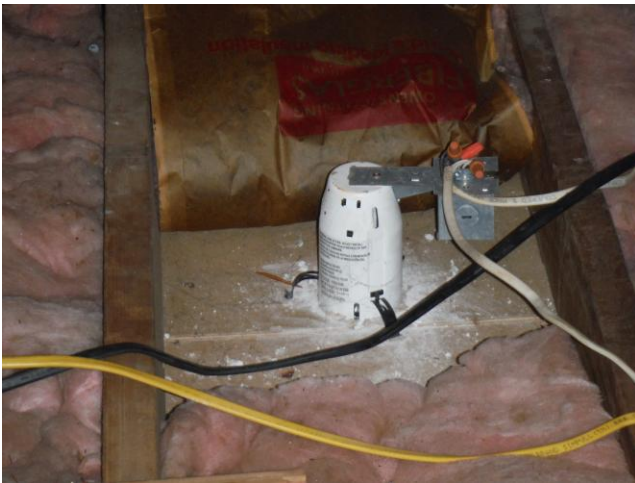
36) Repair-Recommend. Cost=Medium.

There are multiple instances of wires/connections installed in the attic that represent electrical/fire safety issues since they are improperly installed. There are several pot lights that have inappropriate wire connections. These deficiencies include exposed wires, lack of protective Romex connectors at pop-outs, etc. An electrician should be hired to rectify such deficiencies in the attic.

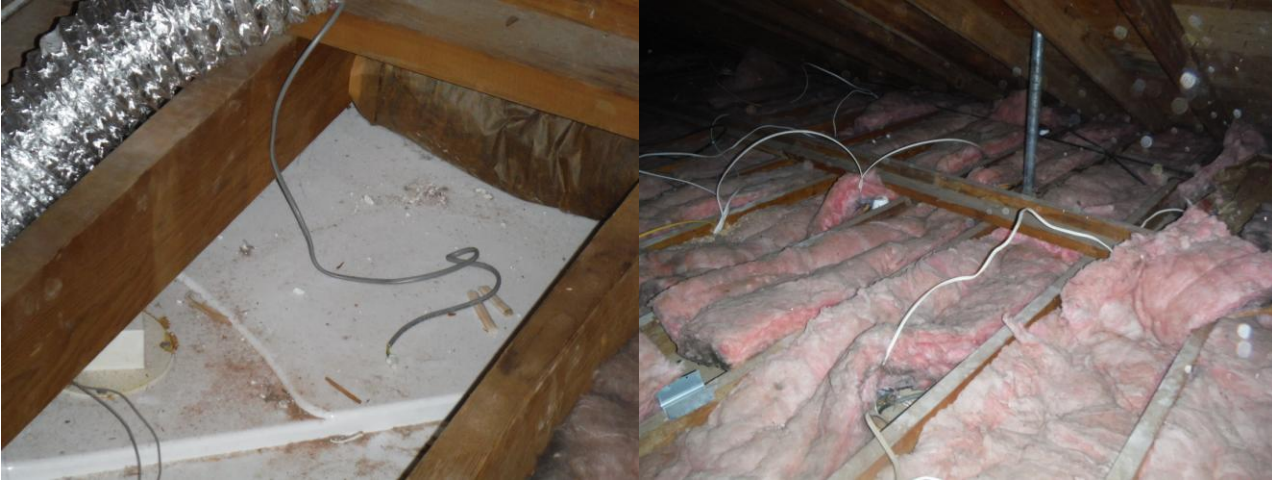
37) Repair-Recommend. Cost=Low/Medium.

There are multiple loose/unfastened wires in the attic that need to be properly fastened and protected as they represent an electrical/fire hazard in its current state. All wires should be fastened with a minimum distance of 4.5'. An electrician should be hired to repair all such deficiencies in the attic.

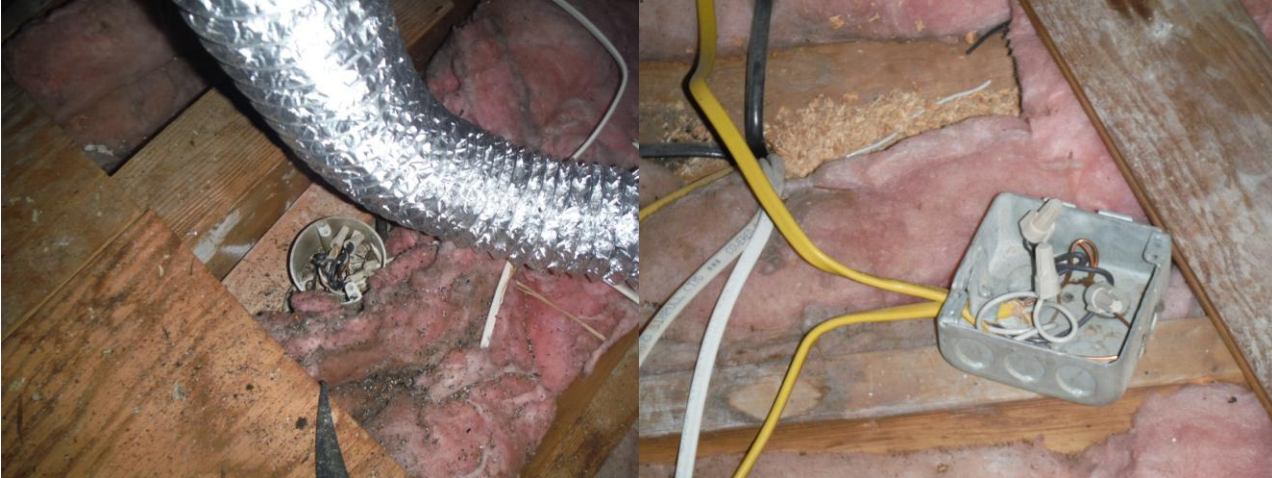
38) Repair-Recommend. Cost=Low.

The junction boxes in the attic need to have protective plates installed to protect against fires/shock/electrocution.

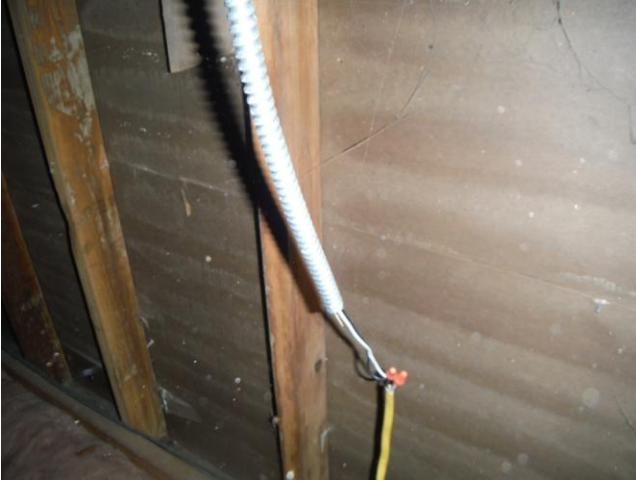
39) Repair-Recommend. Cost=Medium.

There are multiple exposed splices and improperly installed/terminated wires in the attic (e.g. power gable vent) that represent electrical/fire safety issues. An electrician should be hired to properly correct the electrical deficiencies in the attic.

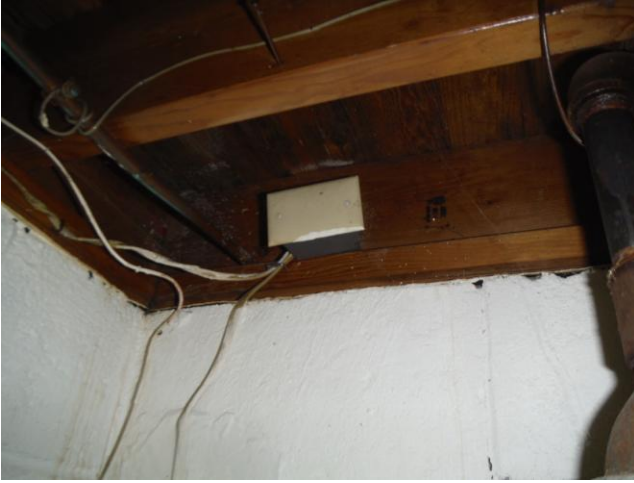
41) Repair-Recommend. Cost=Medium.

There are several outlet/junction boxes in the basement (e.g. front/left) that represent fire/safety issues. Several are loose/unfastened. An electrician should be hire to ensure that all junction boxes, fixtures and splices are properly secured and covered in the basement.

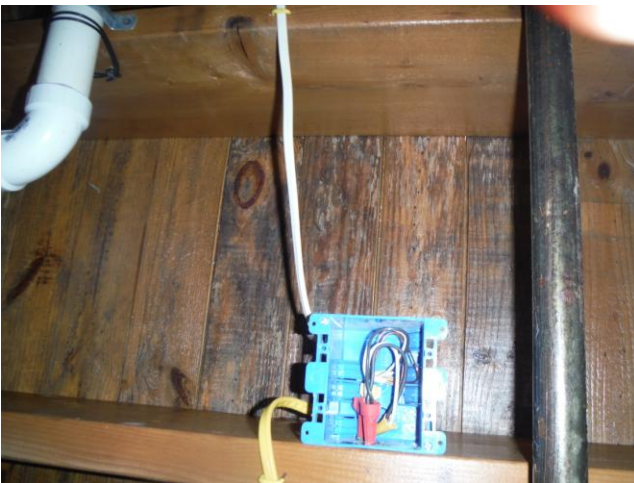
42) Repair-Recommend. Cost=Low.

The junction boxes in the basement need to have protective plates installed to protect against fires/shock/electrocution.

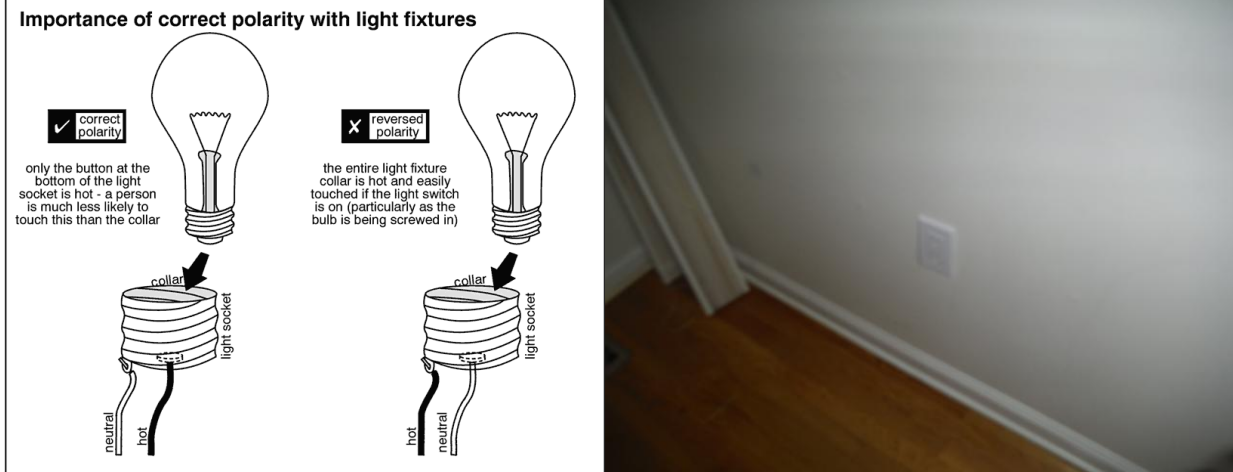
47) Repair-Recommend. Cost=Low.

The outlet on the front/right bedroom front wall has reversed polarity. It should be re-wired for electrical safety.

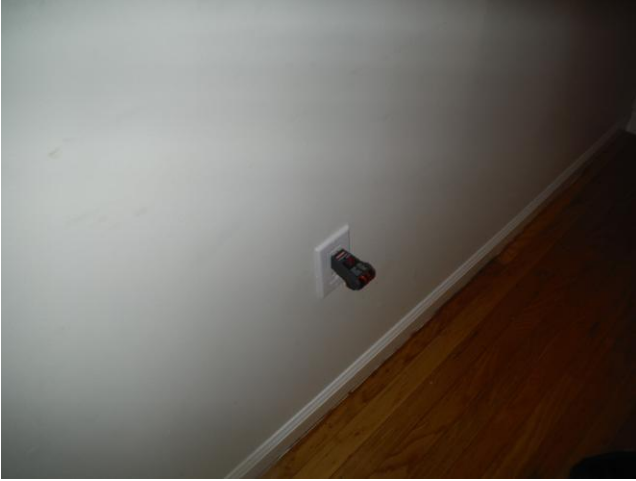
51) Repair-Recommend. Cost=Low.

The outlet on the dining room left wall has reversed polarity. It should be re-wired for electrical safety.

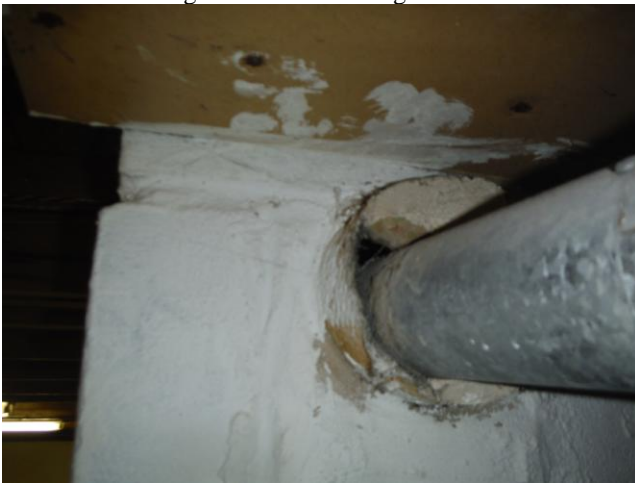
53) Repair-Recommend. Cost=Low.

The water heater vent connector joint at the chimney is improper. It should be sealed with refractory mortar to prevent the allowance of dangerous combustion gases into the home which can be a health safety hazard.

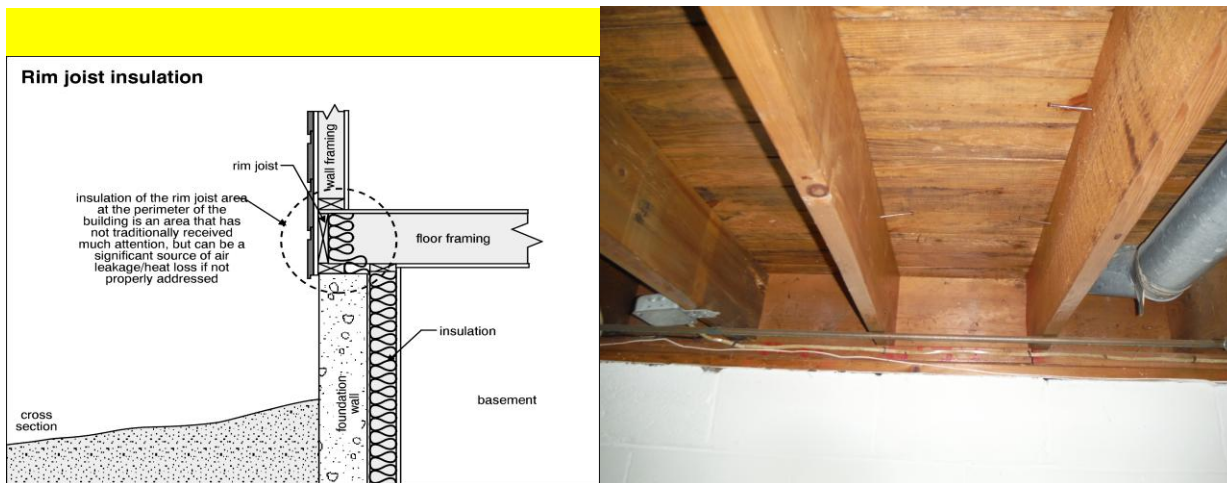
54) Provide-Recommend. Cost=Medium.

It is recommended to add insulation to the basement rim joists where missing to increase heating/cooling efficiencies, etc.

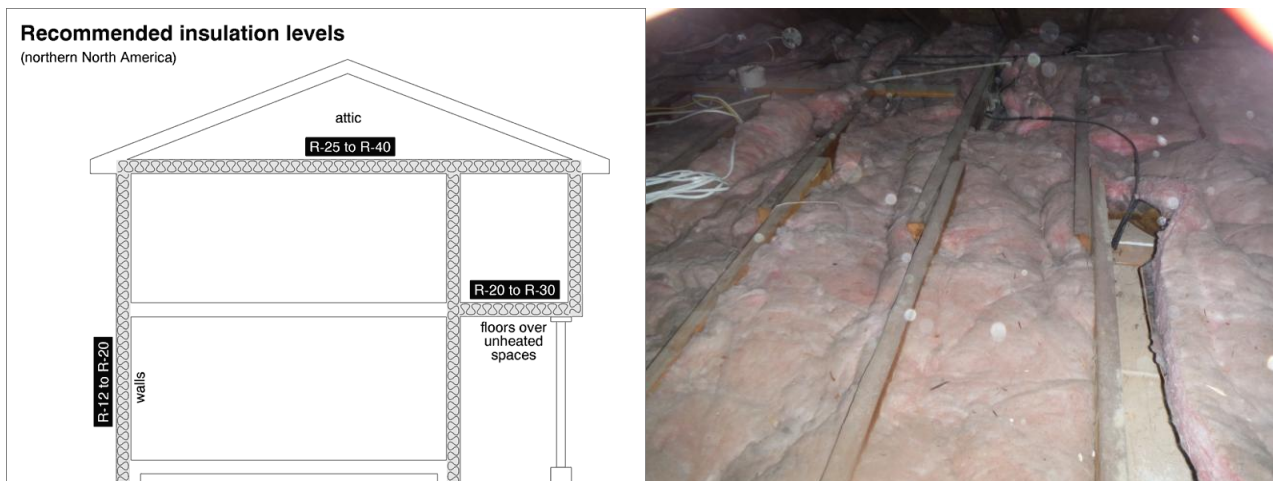
55) Improve-Recommend. Cost=High.

The main attic is poorly insulated. There is insufficient insulation depth on the floor in this area. Insulation that provides R-30+ capacity should be provided in order to prevent conditioned air loss and the formation of ice dams which can cause roof and interior damage. Also, poor insulation levels in the attic can cause mold issues and wood rot in the attic area.

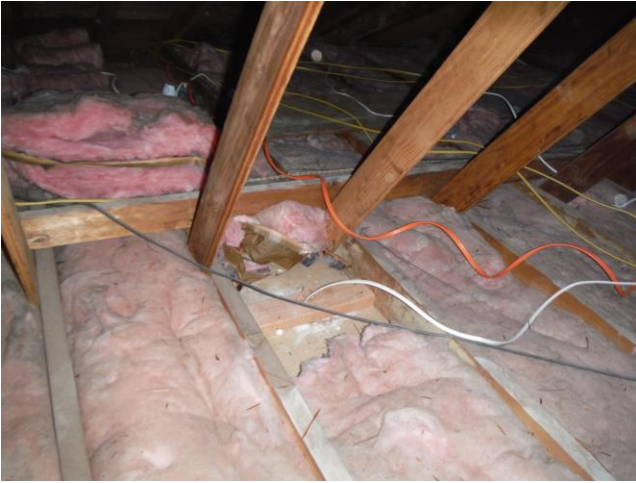
56) Repair-Recommend. Cost=Low.

The insulation is not continuous in the attic. Several areas of missing/moved. Insulation that provides R-30+ capacity should be provided in order to prevent conditioned air loss and the formation of ice dams which can cause roof and interior damage. Also, poor insulation levels in the attic can cause mold issues and wood rot in the attic area.

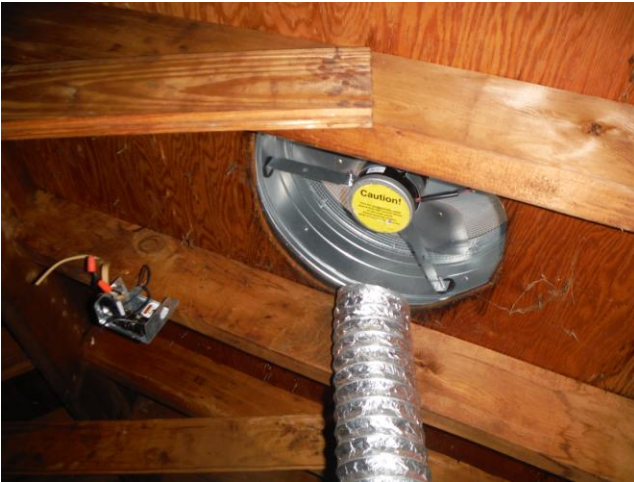
58) Improve-Recommend. Cost=Medium.

The bathroom fan discharges to the attic power vent area.. The discharge should be properly extended to the exterior to keep damaging moisture out of the attic.
