Building Inspection Report

XXX Road
Town, State

Saturday, November 22, 2014

112220141

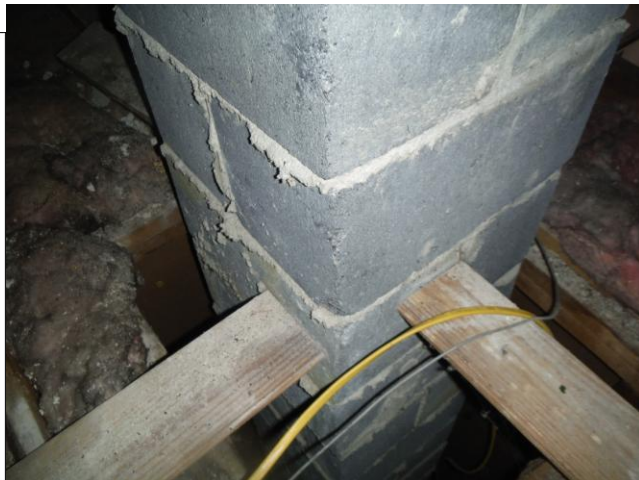
60) Monitor-Recommend.

In the attic a 2" gap (with metal fire shield/stop) should exist around the masonry chimney so that the combustible wood does not catch fire/burn/deteriorate in the event of a chimney fire.

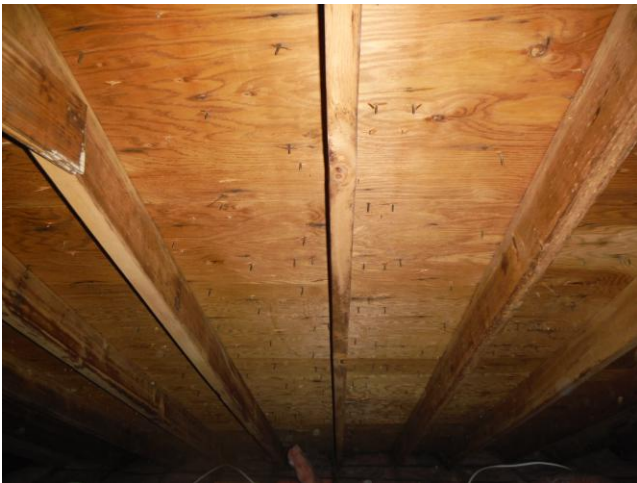
62) Monitor-Recommend.

The rust stains on the roof sheathing (underside, around nails) suggests the attic is insufficiently ventilated and insulated. This can lead to a weakened roofing structure and mildew/mold. The attic should be periodically inspected to measure their efficacy. An anti-microbial treatment may become necessary.

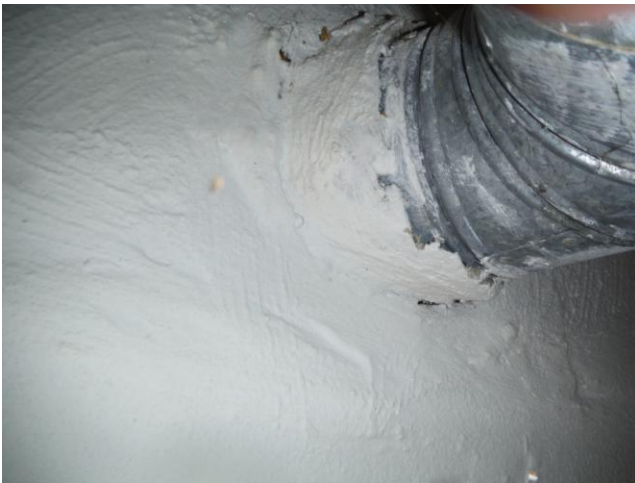
64) Further Investigation Required-Recommend. Cost = Medium/High.

It appears that the supply ducts in the basement may be covered with asbestos insulation where they penetrate the walls and are under the slab areas. This would not be uncommon and consistent with the age of the home. An off-site laboratory test would be required to confirm if the insulating materials asbestos based. However it is not known to be an issue as long as the asbestos material is not damaged, etc.

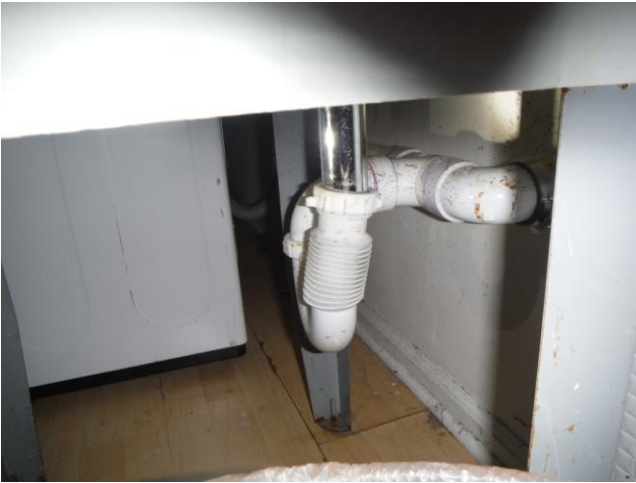
75) Replace-Recommend. Cost=Low.

The trap below the laundry sink has a section of flexible piping is used which can impede drainage flows.
