Building Inspection Report

Any Street

Saturday, November 29, 2014

South Jersey Home Inspection, LLC

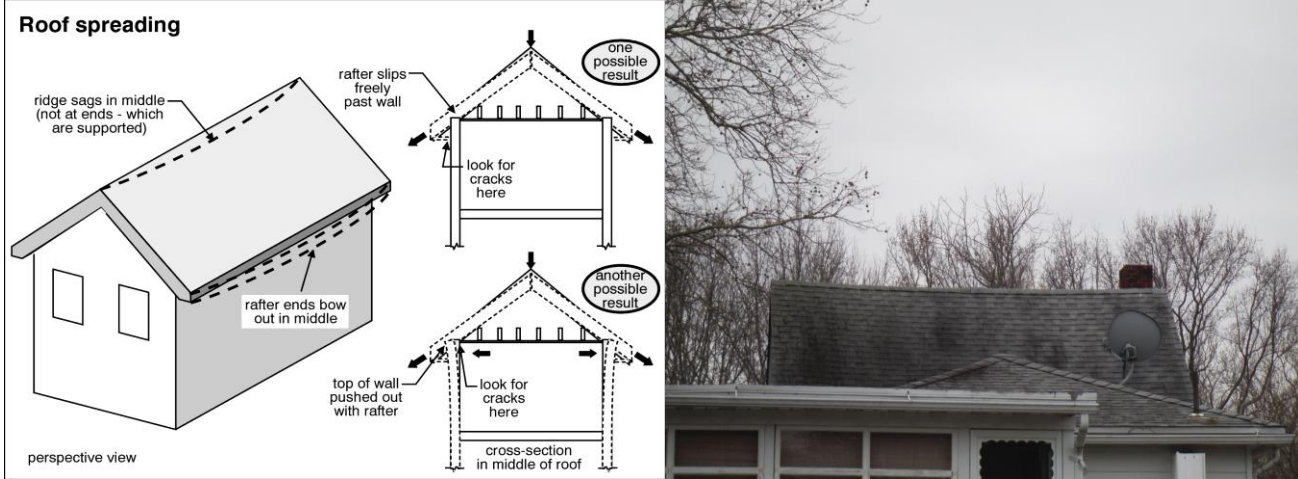
2) Monitor-Recommend.

There is evidence of roof spreading whereby the ridge is dipping in the middle. It may be indicative of rafters slipping past the top of the exterior walls. If the dip does increase/worsen then a roofing structural engineer should be consulted to rectify.

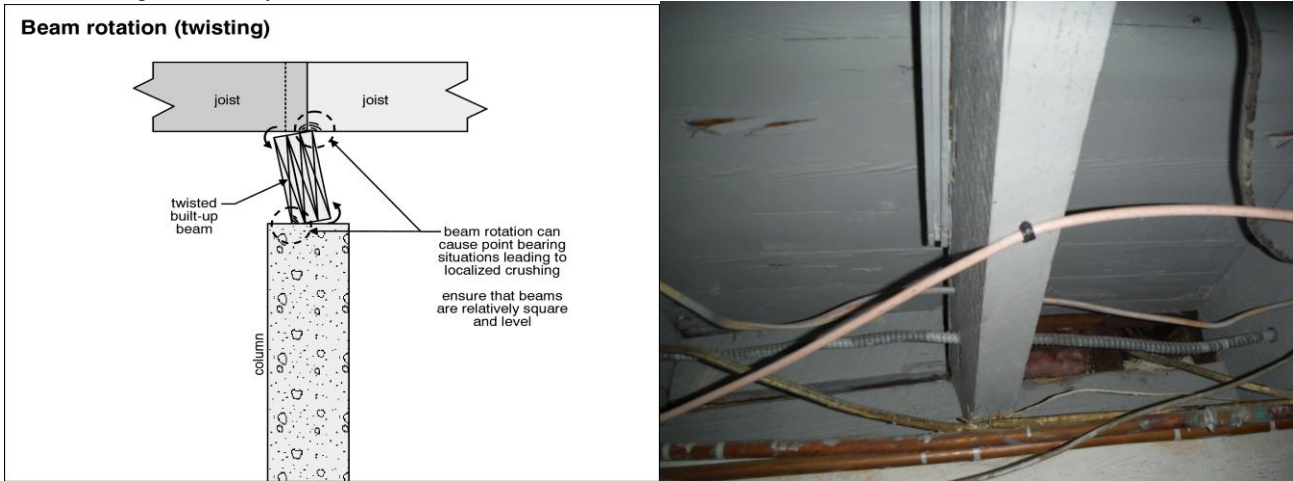
4) Monitor-Recommend.

Several joists in the basement are suffering from twisting. This may explain the unevenness of some floors above. Although the twisting is not likely to worsen if it does it can lead to lost joist end bearing which could result in localized floor collapse. The joists and their end bearing should be monitored for further movement and addressed as necessary by a licensed structural engineer if they do so.

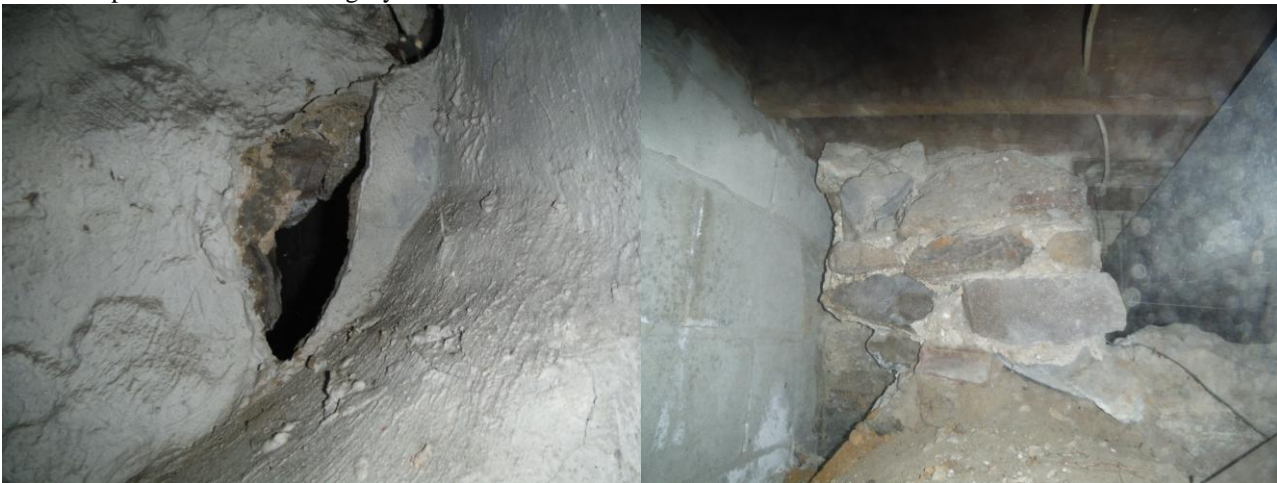
5) Repair-Recommend. Cost=Medium.

An opening was made in the front/left of the basement for the installation of ducts work. The opening is apparently not sound as the wall is not continuously supported as there are openings visible above the ground. A foundation specialist should be hired to repair the structural integrity of the wall.

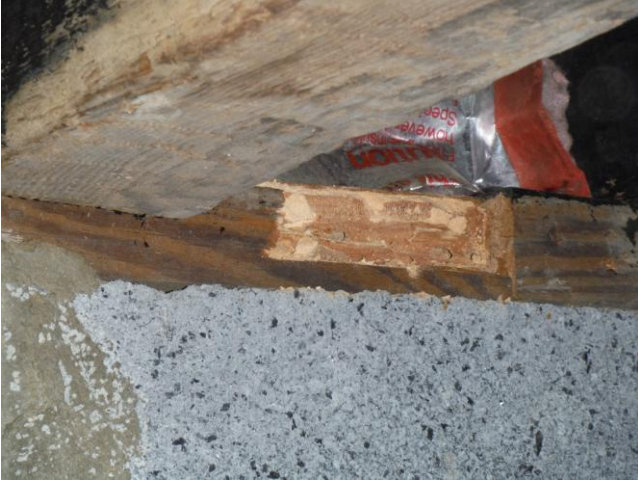
6) Repair-Recommend. Cost=Medium/Unknown.

There is evidence of termite activity and damage in the right/rear crawl space. The damaged wood should be replaced or reinforced to prevent localized wall/floor collapse/sag due to lost structural capacity. Additional and/or latent/hidden termite damage can be expected. A treatment is recommended.

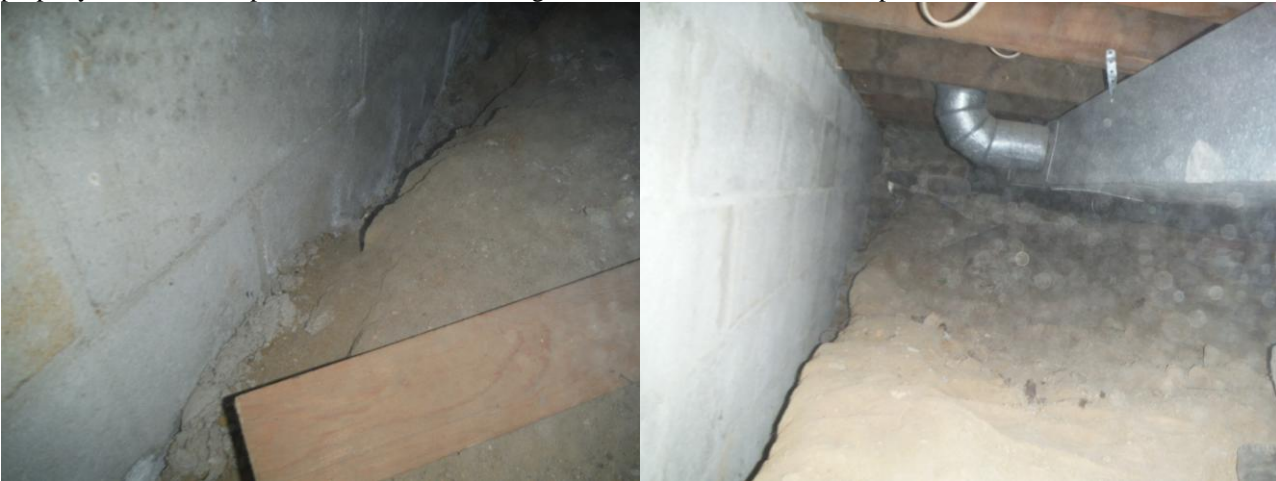
7) Further Investigation Required-Recommend.

The left block foundation walls were apparently rebuilt as the interior perimeter of the wall appears to have been dug out/lowered. The construction permits should be obtained from the local construction office in order to ensure the walls were properly modified or replaced in order to ensure against localized foundation collapse/deterioration.

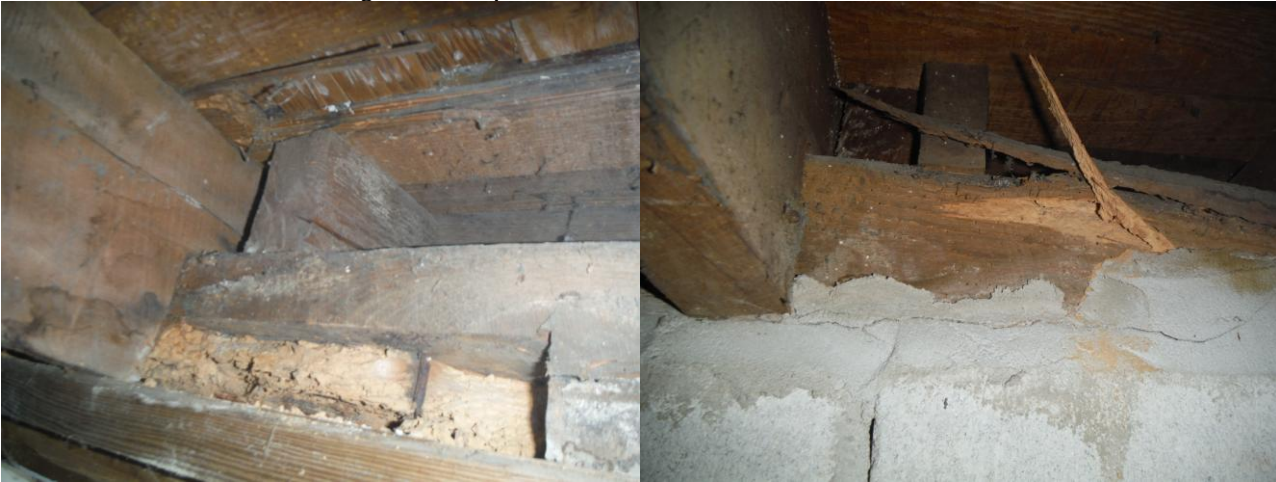
8) Repair-Recommend. Cost=Medium/Unknown.

There is evidence of significant termite activity and damage in the main crawl space (e.g. along left wall). The damaged wood should be replaced or reinforced to prevent localized wall/floor collapse/sag due to lost structural capacity. Additional and/or latent/hidden termite damage can be expected. A treatment is recommended.

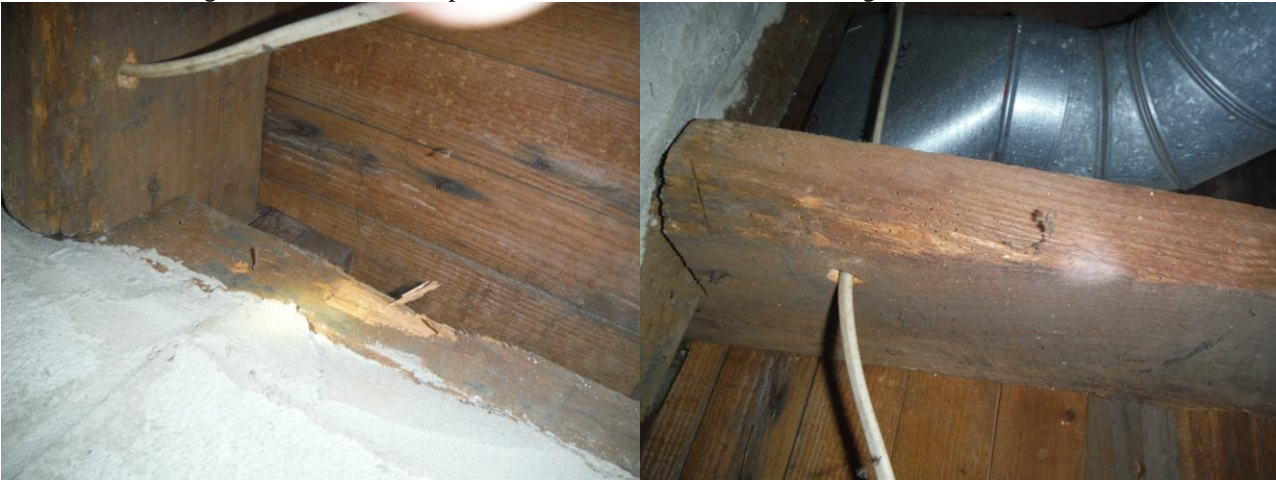
9) Provide-Recommend. Cost=Medium.

There is evidence of wood boring beetle damage in the crawl space (main, along left wall). There can be expected additional hidden/latent damage as well. The crawl spaces should be treated for wood boring beetles.

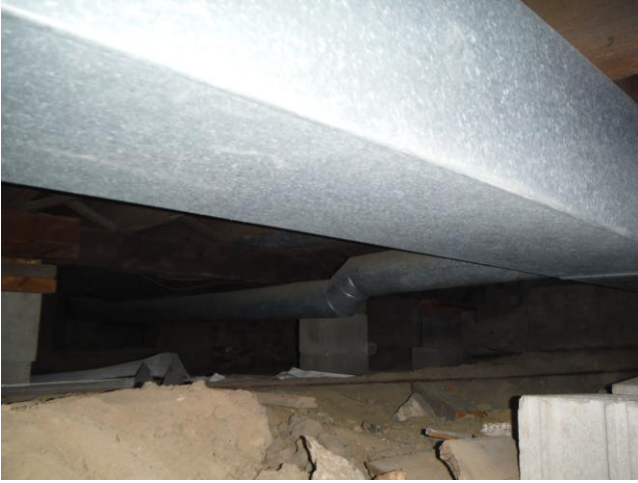
10) Further Investigation Required-Recommend.

The right/front crawl spaces and a large portion of the center crawl space could not be inspected due to height limitations. It is recommended that the area be inspected prior to closing to verify the structural integrity in this area. These areas have good probability for further termite and wood boring beetle damage.

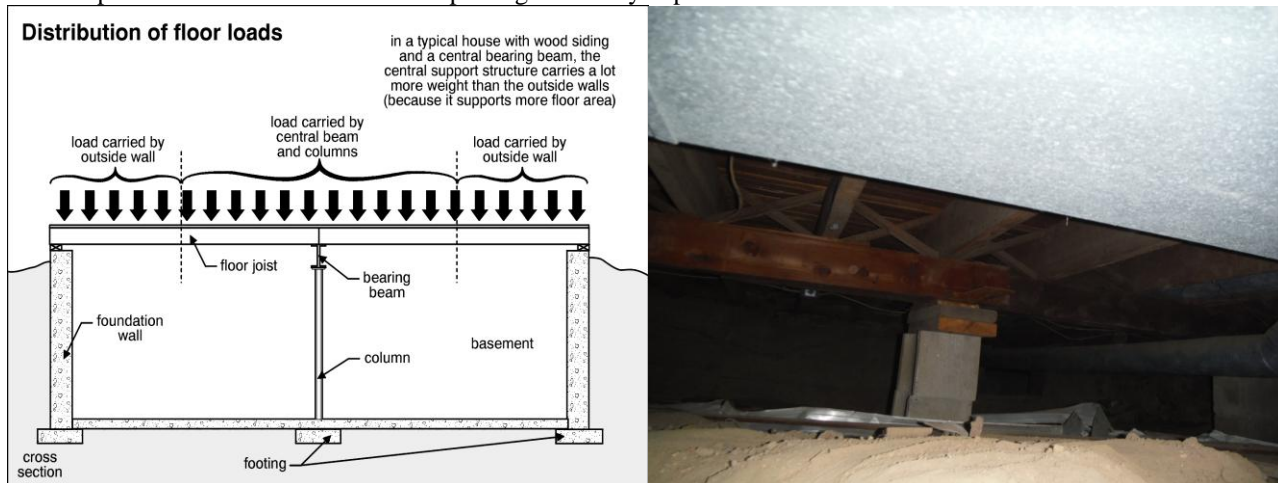
11) Further Investigation Required-Recommend.

The bearing beam in the main crawl space may have been moved/modified as it appears the piers, etc are not original construction. The construction permits should be acquired that confirm this was a design modification that is acceptable in order to prevent localized floor/wall collapse/sag. This may explain some of the floor unevenness above.

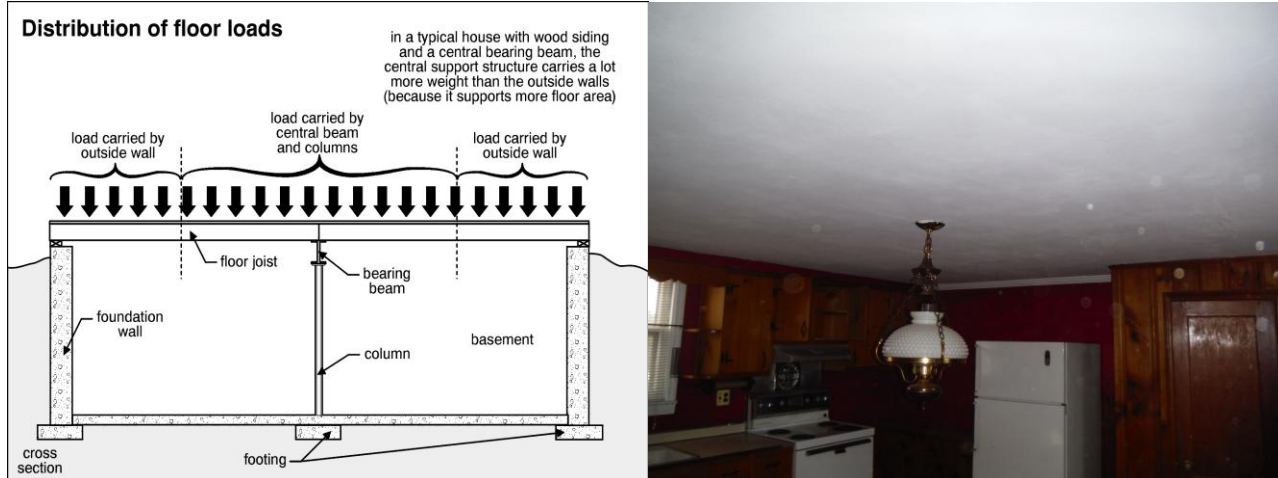
12) Monitor-Recommend.

A bearing beam may have been removed/modified in the top kitchen area. A beam would have been expected running front to back in this area. Although the ceiling does appear level the homeowner should be aware that beam may have been removed and ceiling/roof irregularities may present themselves. The homeowner should consider consulting a structural engineer to ensure a beam was not removed that is necessary for structural integrity in this area.

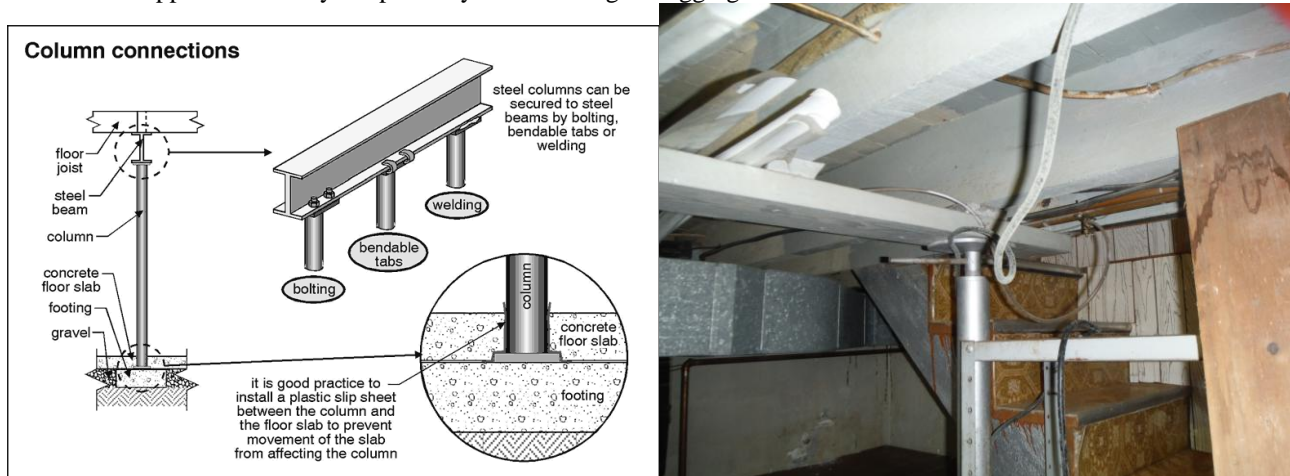
13) Monitor-Recommend.

In the basement temporary support columns have been added. These supports cannot be expected to last indefinitely as they have wood-soil contact and are not properly fastened at their bases or top plates. It is uncertain as to what anomaly will occur when these supports fail. They are probably used to mitigate sagging floors.

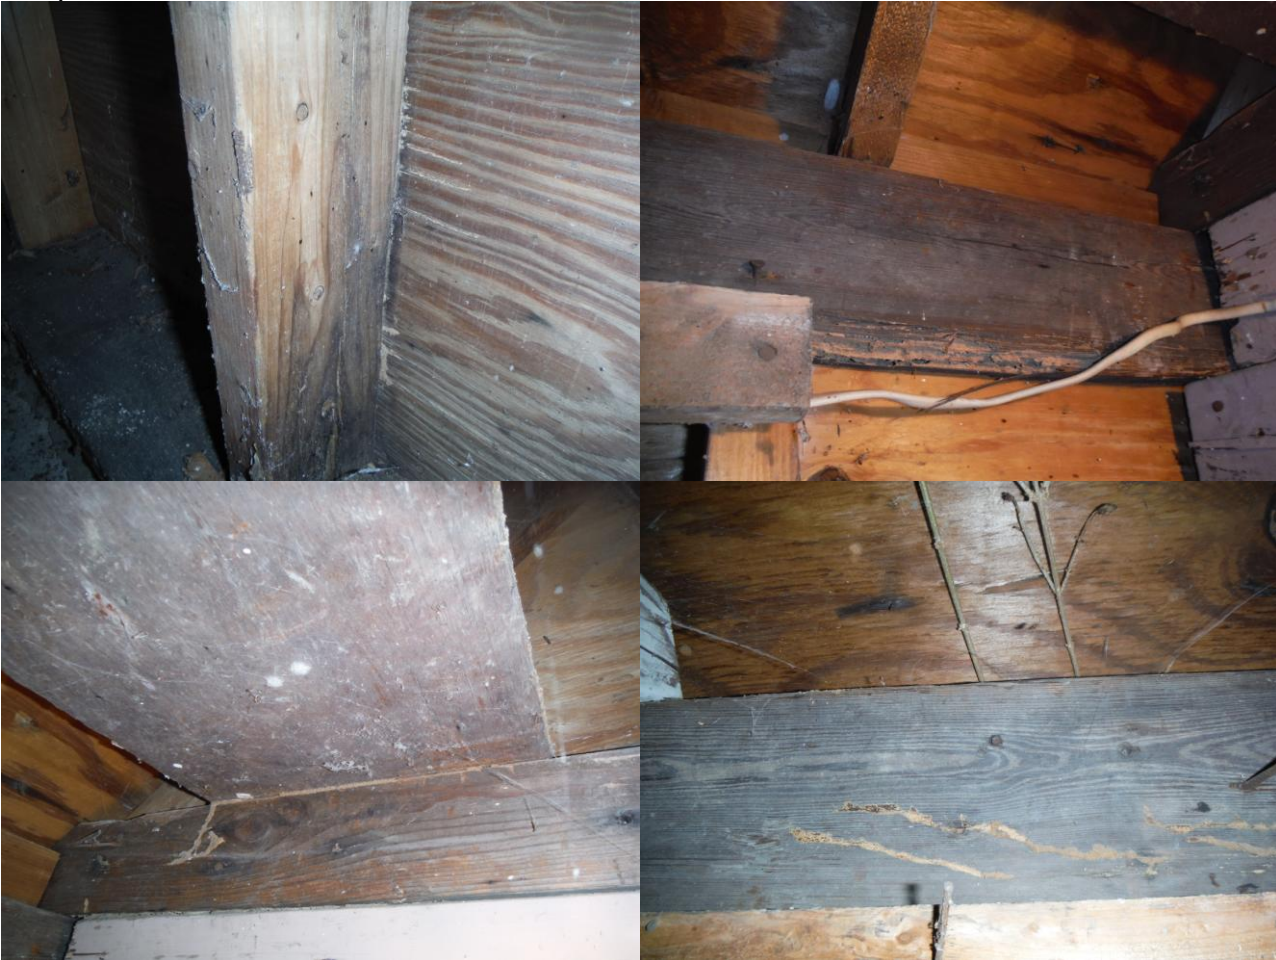
14) Repair-Recommend. Cost=Medium/Unknown.

There is evidence of significant termite activity and damage in the shed. The damaged wood should be replaced or reinforced to prevent localized wall/floor collapse/sag due to lost structural capacity. Additional and/or latent/hidden termite damage can be expected. A treatment is recommended.

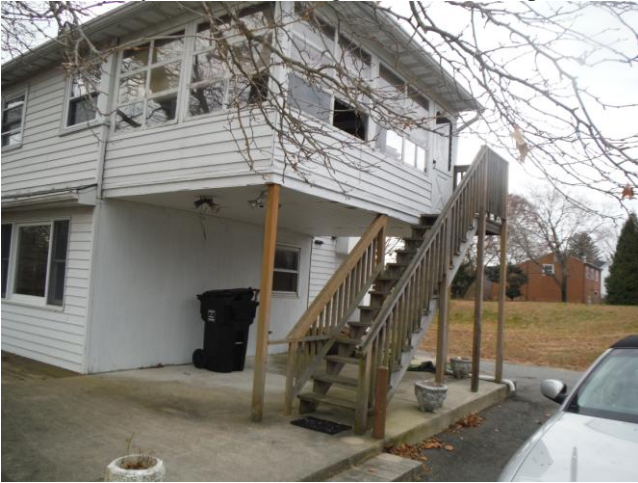
15) Provide-Recommend.

The top/rear (porch) appears to be an addition to the original structure. A copy of the completed permits should be obtained from the local construction office prior to settlement to ensure the addition was engineered and built properly to ensure its structural integrity. There are several anomalies present with this structure that may indicate this was an addition that may not be structurally sound. Obtaining the construction permits should ensure it is structurally sound and safe.

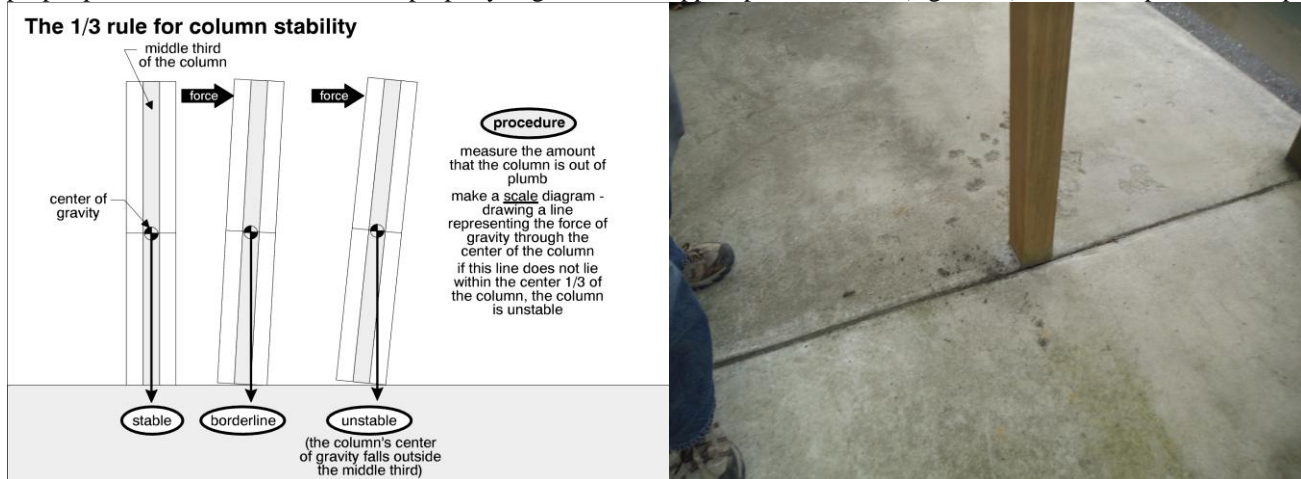
16) Further Investigation Required-Recommend.

The columns that support the rear porch appear to be undersized. It should be verified that this porch was installed by the proper permits and the columns were properly engineered to support possible loads (e.g. snow) in order to prevent collapse.

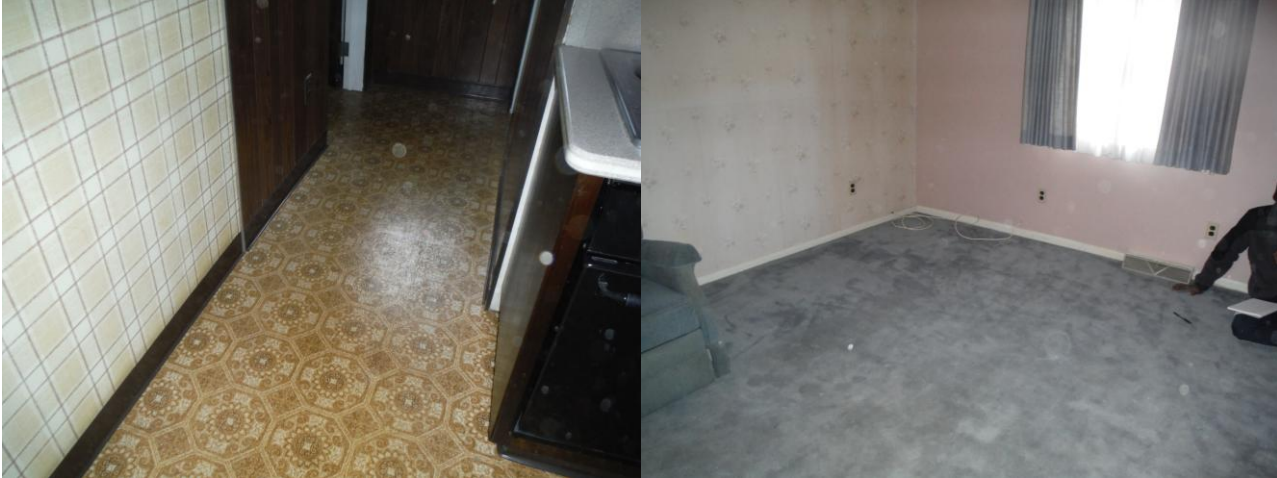
17) Monitor-Recommend.

At least one addition was added to the house. There is evidence of uneven floors that may be related to settlement or unanticipated loads. The homeowner should be aware that the differential settlement may continue which can cause additional cracks to appear as well as utility pipe damage and improperly opening doors/windows, etc. as well as uneven floors.

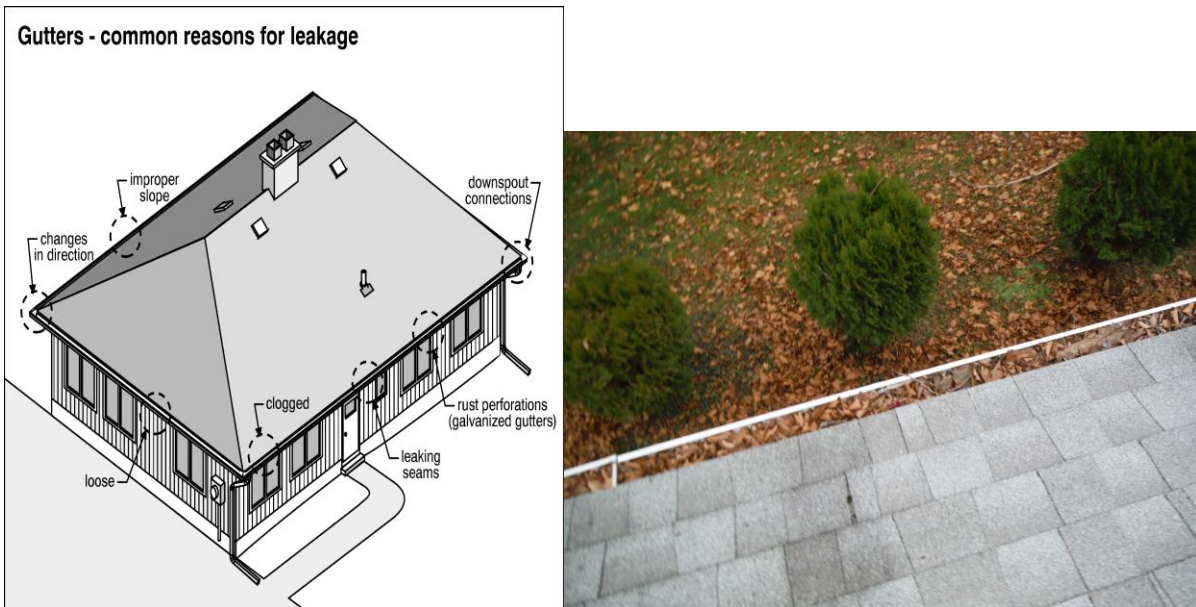
18) Repair-Recommend. Cost=Low.

The gutters should be cleaned of debris, etc. in order to allow proper roof water runoff away from the foundation to prevent damaging moisture penetration to the interior.

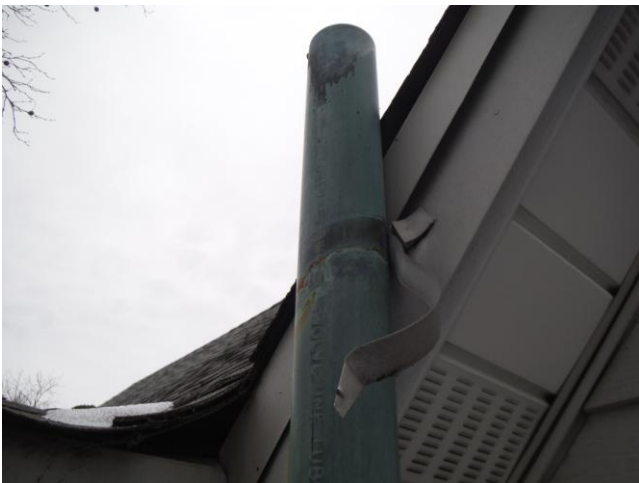
19) Repair-Recommend. Cost=Low.

The right plumbing stack is loose as its fastening bracket has come detached. To prevent damage to it the fastener should be re-installed.

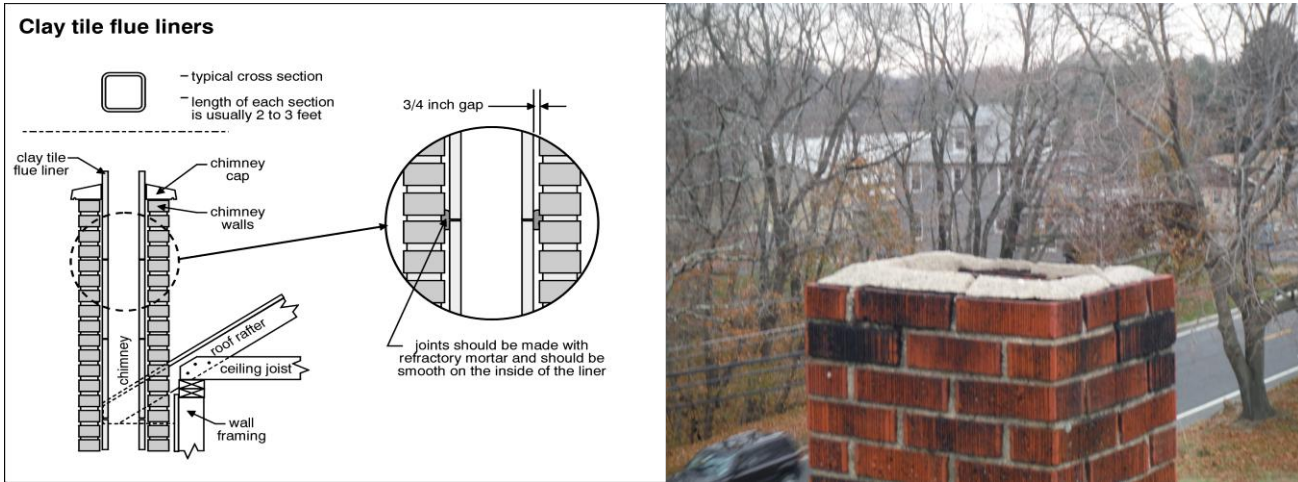
There does not appear to be a chimney liner installed. One needs to be installed to prevent chimney deterioration which will lead to expensive chimney repairs/replacement and may yield health safety issues from combustion by-products leaking into the home.

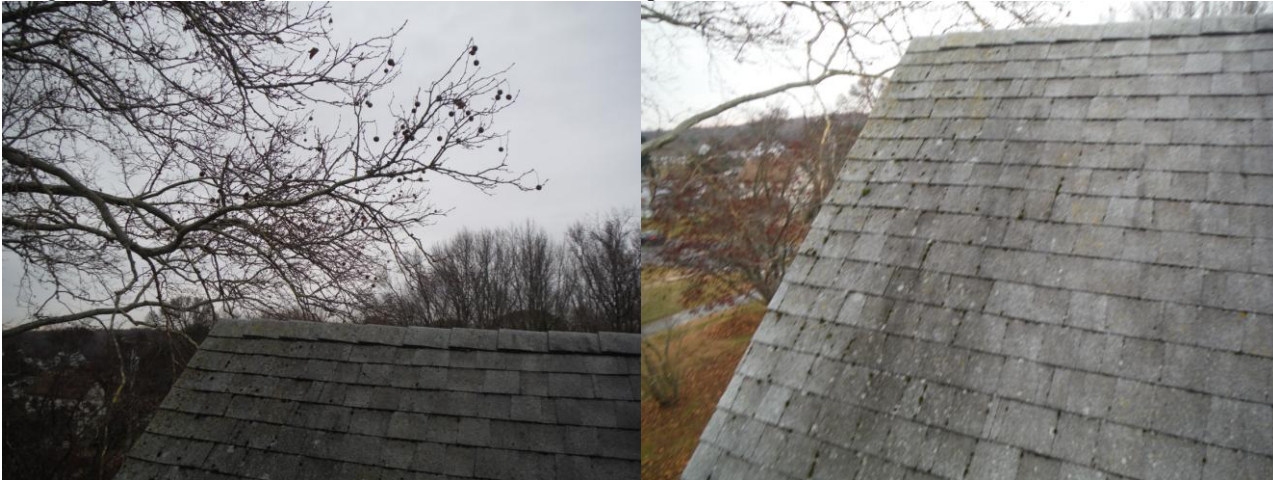
21) Monitor-Recommend.

There is evidence of deterioration on the asphalt shingles. This indicates the roof may be aging. The current age is unknown. The age is more difficult to determine with dimensional shingles such as these. The homeowner should be aware that the roof will eventually need to be replaced. The remaining lifespan is uncertain. The homeowner may be able to yield some short-term additional life if maintenance repairs are made as needed. No current interior leaks were noted during the inspection. Budgeting should be in-place for roof maintenance and/or replacement.

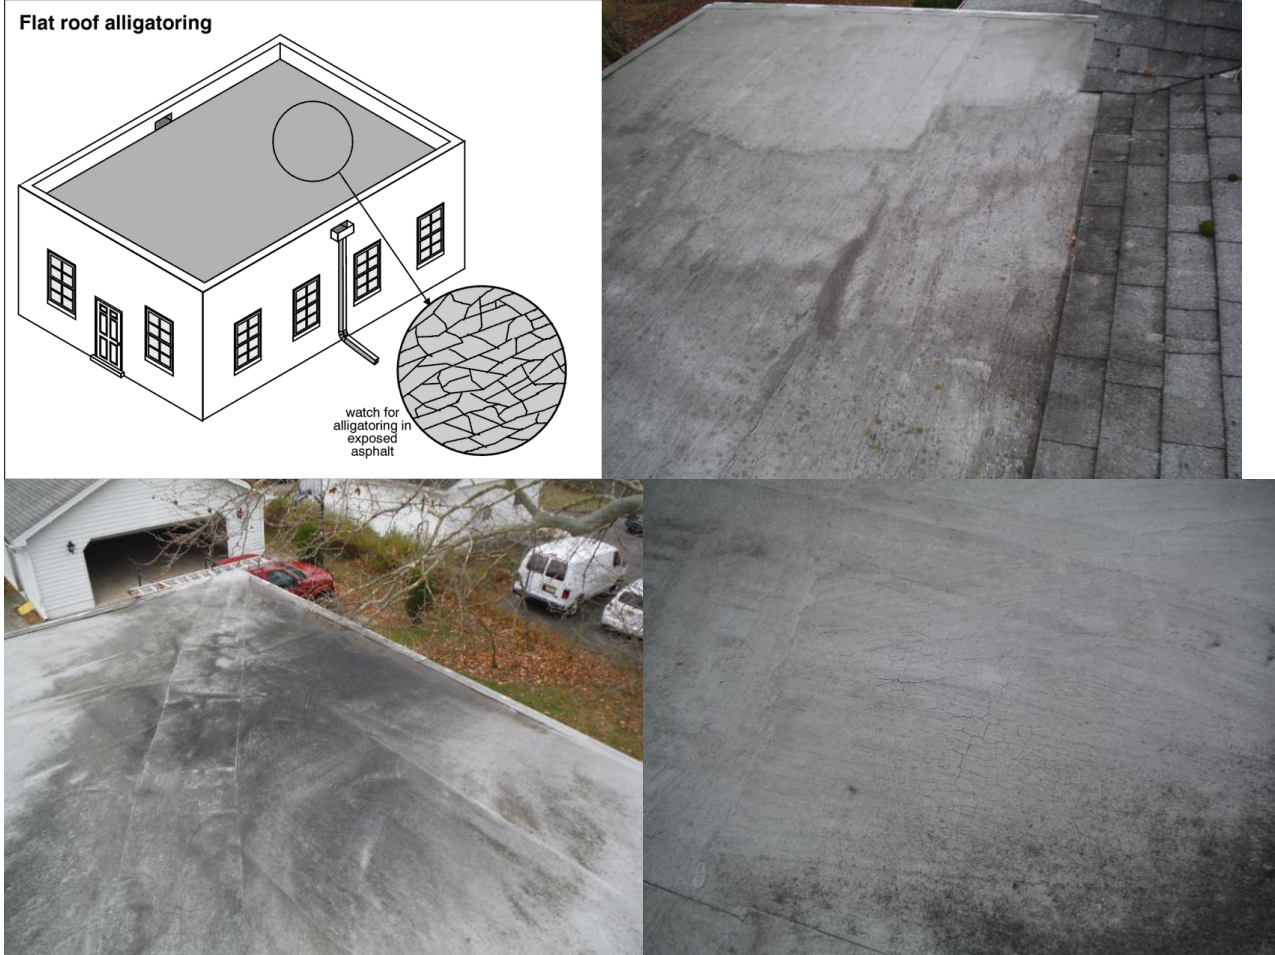
22) Monitor-Recommend.

The upper (rear) porch flat roof covering should be closely monitored. It does not need to be repaired/replaced at this time but the home buyer should be aware that roofs with coverings such as this do not last indefinitely and do require periodic maintenance (painting, etc.) and inspections to proactively prevent leaks, etc. There is evidence “alligating”. Budgeting should be in-place for maintenance repairs and replacement costs. No active roof leaks were found during the inspection.

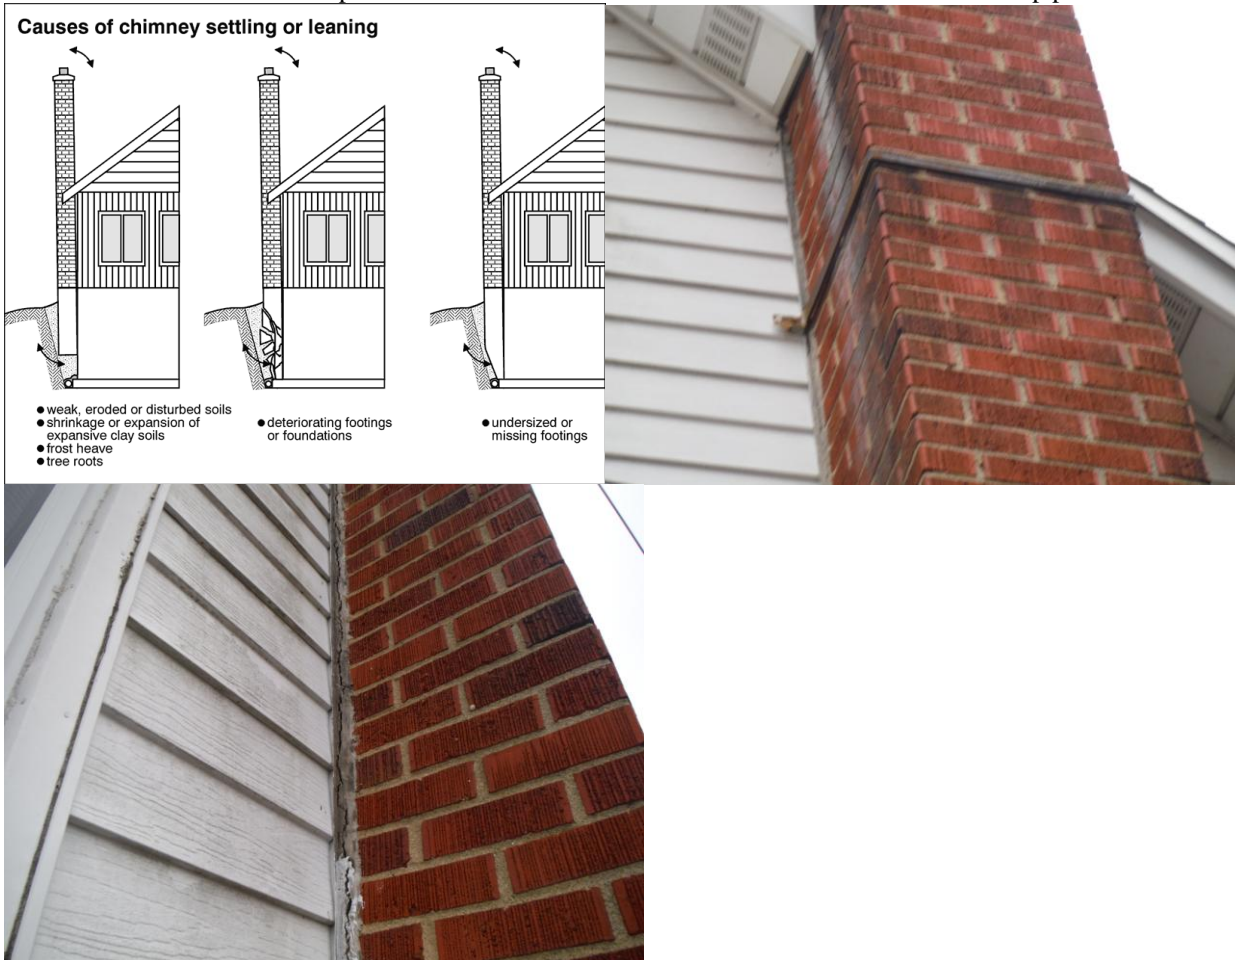
23) Repair-Recommend. Cost=Low.

The left chimney has a slight lean away from the exterior wall as cracking is evident along the intersection. Straps have been installed in the past in order to help impede the rate of lean. It is uncertain as to the exact cause of the lean or if the lean rate will continue. However the straps have become loose/unfastened and should be reattached to help prevent further movement.

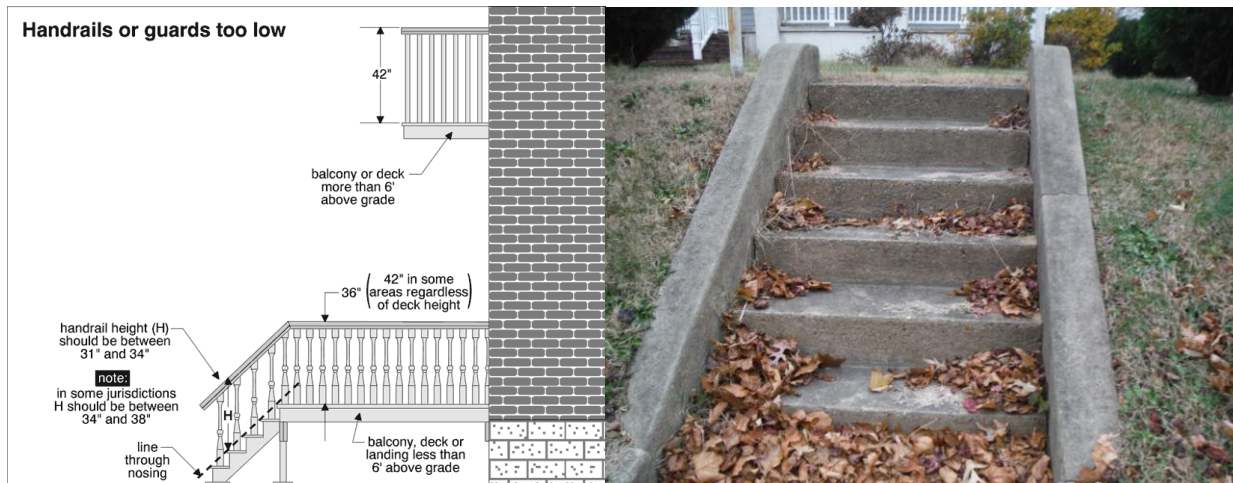
25) Provide-Recommend. Cost=Medium.

Handrails should be added to the front steps. Modern building science recommendations require that a 4" ball should not be allowed to fall off/through the guard rail. All areas above a 30" elevation should have proper guard rails installed for safety.

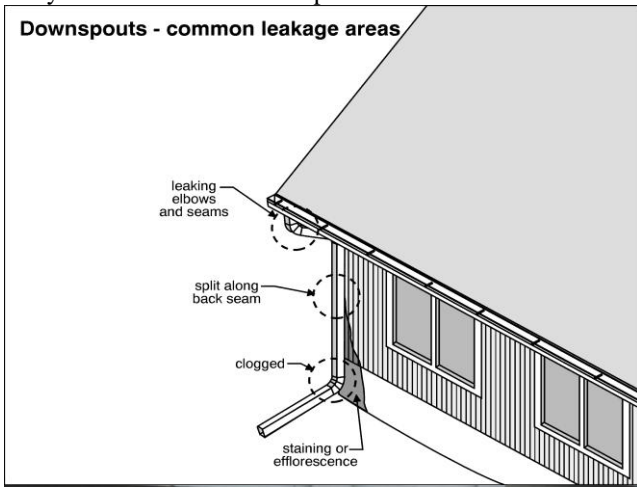
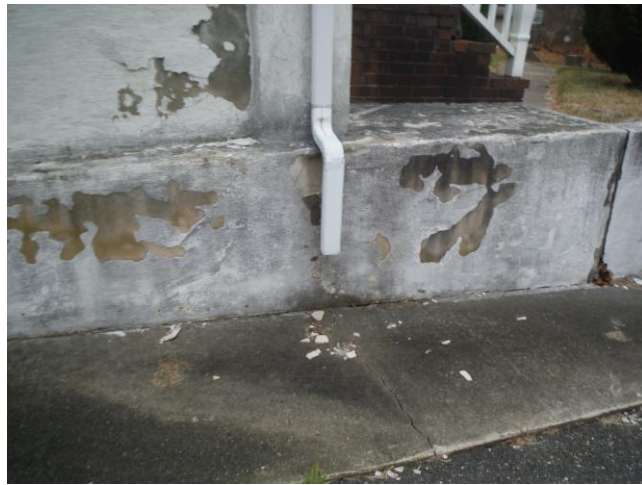
27) Repair-Recommend. Cost=Low.

Several downspouts and/or elbows are missing/disconnected. They should be replaced and installed so as to divert water away from the foundation to prevent foundation deterioration.

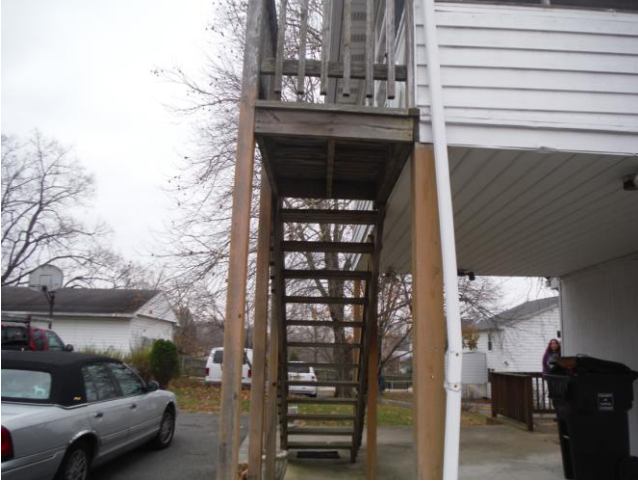
28) Improve-Recommend. Cost=Medium.

Tread backers (vertical infill between the treads) should be added to those treads that are at/above 30" from the ground elevation to the rear exterior stairs. A 4" ball should not be allowed to pass off/through the stairs at a height of 30" or above. This is a child safety issue.

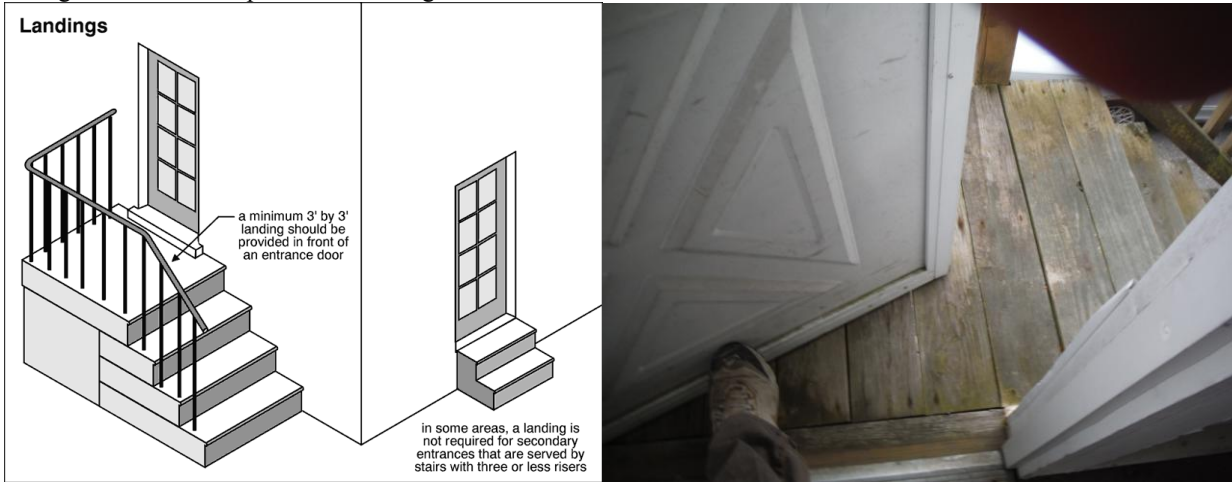
30) Replace-Recommend. Cost=High

The rear exterior steps/landing may not be constructed according to modern building science recommendations. The steps should have a 3' X 3' landing for safety due to its height (greater than 30"). It may be a safety hazard in its current configuration as the depth of the landing is less than 3'.

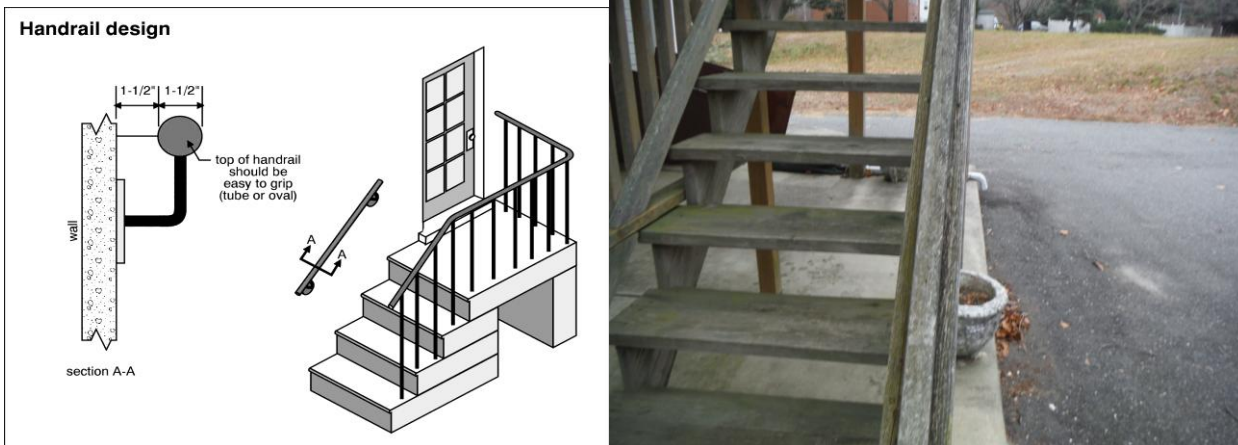
31) Provide-Recommend. Cost=Low/Medium.

There rear stairs should have a proper (rounded profile) hand rail installed for safety (protection from falling).

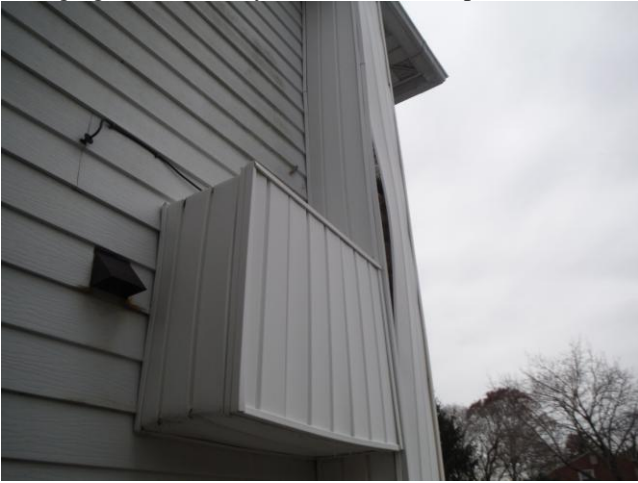
32) Repair-Recommend. Cost=Low.

The rear/left wall siding on the exterior is loose/has open gaps. It should be properly repaired to prevent the allowance of damaging moisture entry to the wall envelope.

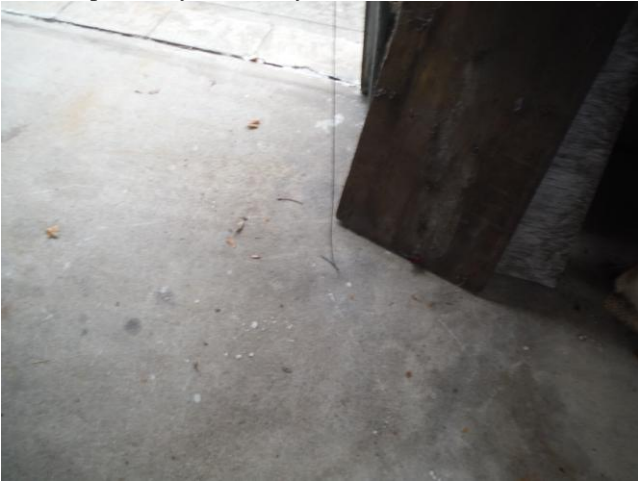
34) Repair-Recommend. Cost=Low.

The garage door lock mechanism is broken. The lock mechanism may need parts or may need to be replaced/repaired to ensure operability and safety.

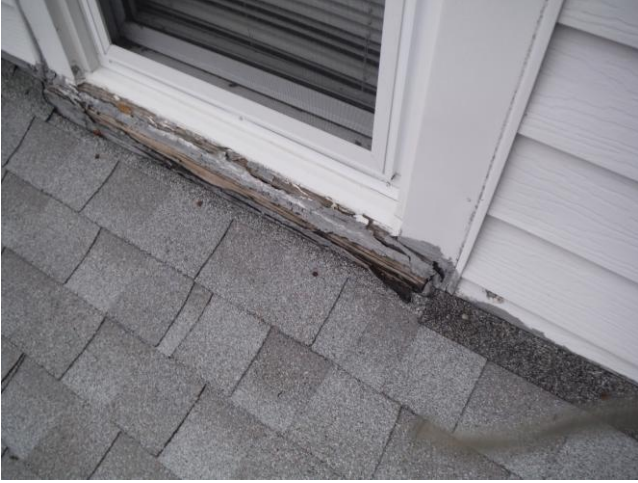
36) Repair-Recommend. Cost=Uncertain

The wood trim on the window/door exteriors are suffering from water damage. The homeowner should consider replacing all such deteriorated wood trim with maintenance free materials. Otherwise periodic maintenance/repairs of such trim can be expected. Water entry and wall damage/mold are a concern with such instances as this.

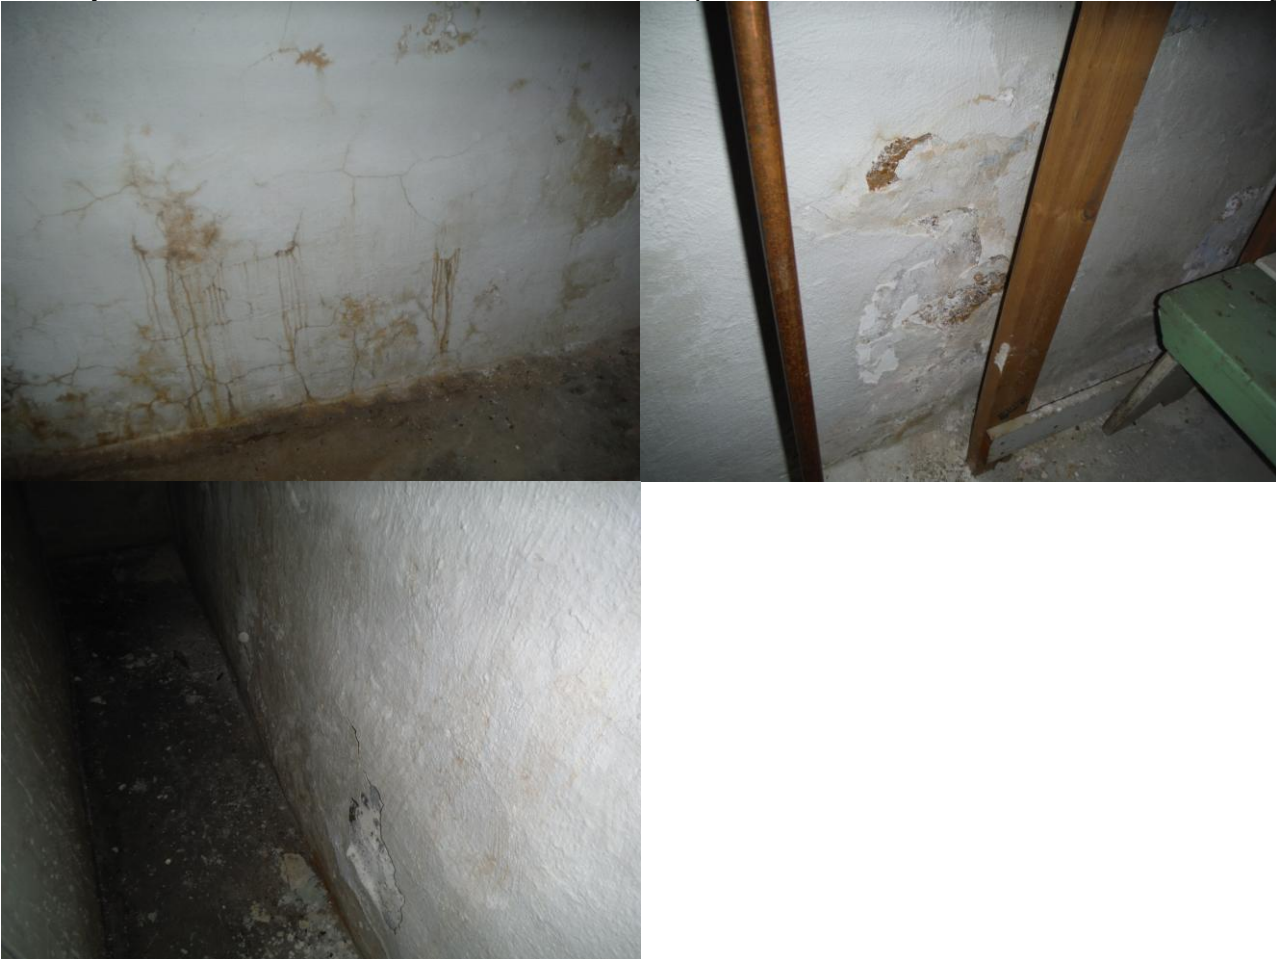
38) Monitor-Recommend.

There is staining, rust, efflorescence, peeling paint, etc. on the basement interior walls. This is due to moisture penetration. There may be mildew/mold present which may present a health hazard to some individuals. An interior drain system may be necessary if the moisture intrusion continues/worsens. Moisture penetration to the basement can cause extensive damage.

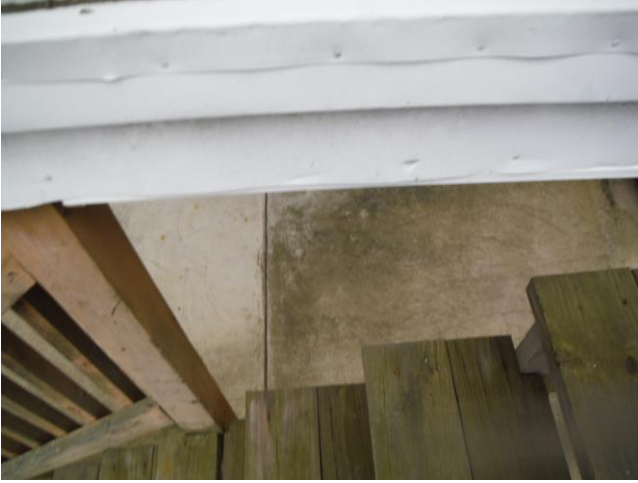
39) Provide-Recommend. Cost=Low.

Infill should be provided to rear porch stairs (top) for safety (to prevent falls, etc.). It is required because the stairs exceed 30" in height.

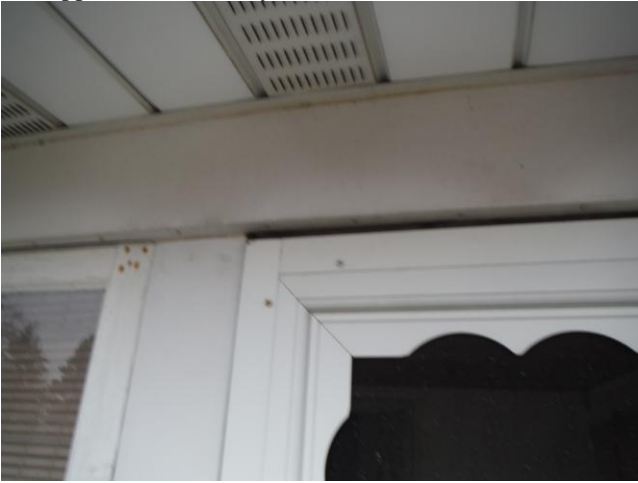
41) Provide-Recommend. Cost=Low/Medium

Each exterior door should have an adjacent/overhead exterior light to for convenience and safety. Consider adding one to the rear upper door for safety and convenience.

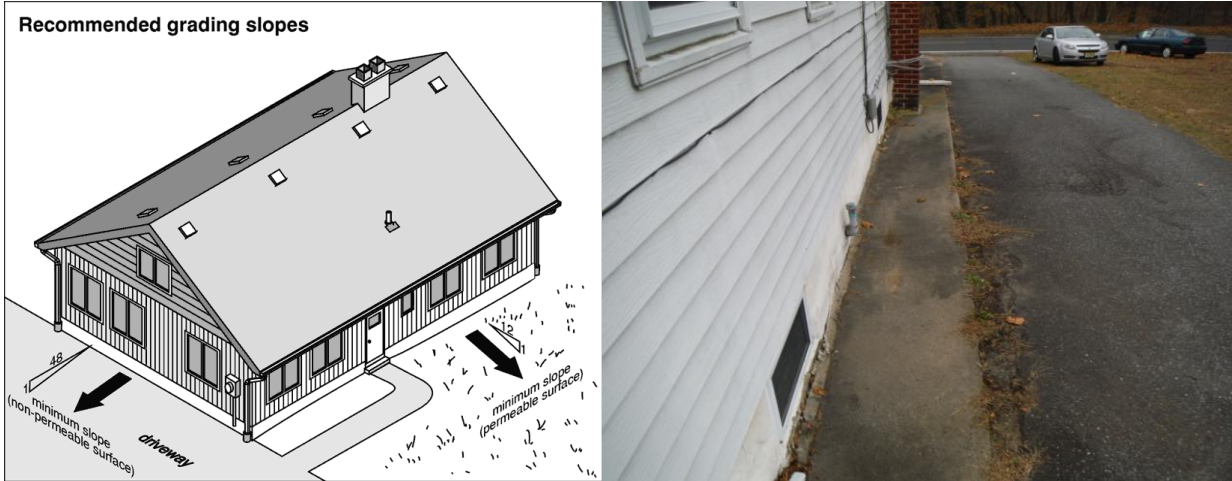
45) Improve-Recommend. Cost=Medium/High.

The left impervious grade should be improved so that it slopes down/away from the foundation to prevent water infiltration to the basement/crawl space which can cause mold issues, wood rot and structural issues. It should drop 1" over the first 4 feet from the foundation. There is evidence of settlement of the slabs which can be expected to worsen over time. There is also evidence of water penetration to the basement/crawl space (water stains, etc.) which can lead to foundation damage and mold issues. As a minimum the intersections between the non-permeable surfaces and the walls should be sealed to prevent water entry.
