Building Inspection Report

Any Street

Saturday, November 29, 2014

South Jersey Home Inspection, LLC

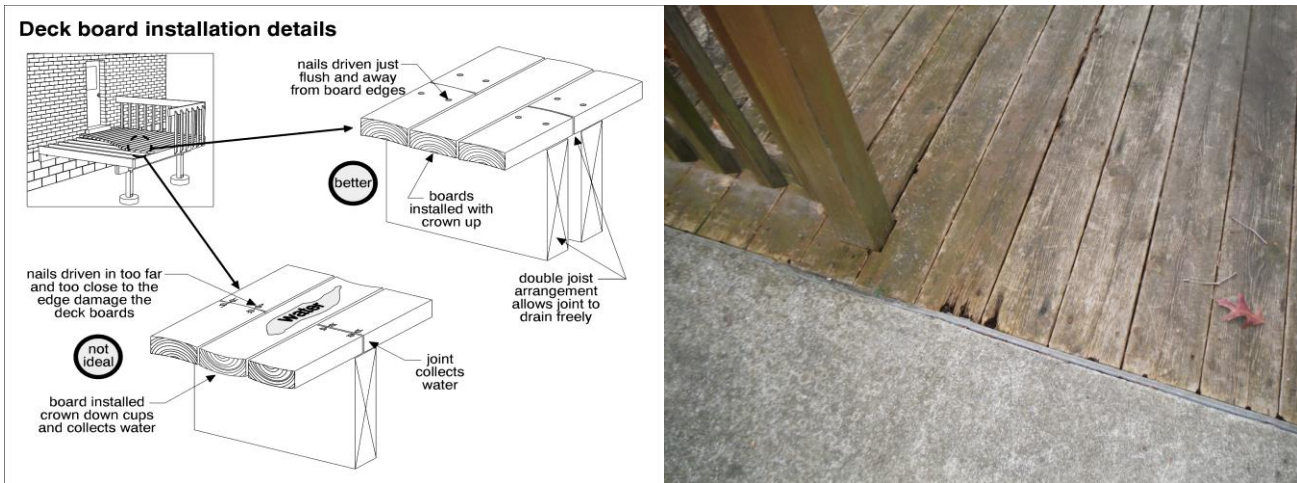
46) Replace-Recommend. Cost=Medium.

The right deck boards are deteriorating due to age and weathering. The homeowner should budget for deck replacement in the near future.

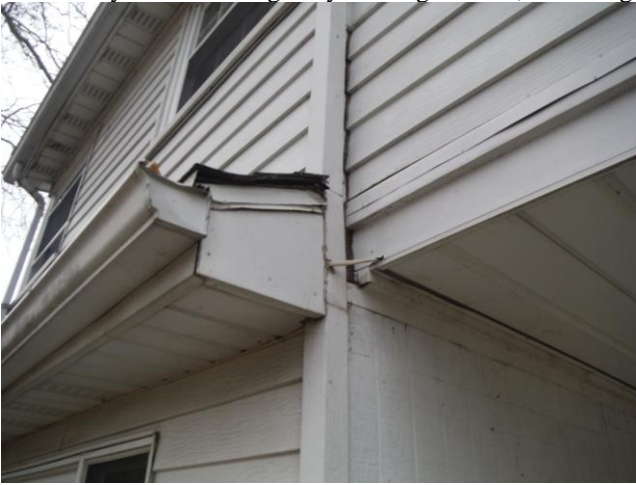
49) Provide-Recommend. Cost=Low.

The exposed NM (non-metallic) wires on the right/rear exterior wall should be protected by a conduit for electrical/fire safety so that they are not damaged by UV degradation, sheathing punctures, etc.

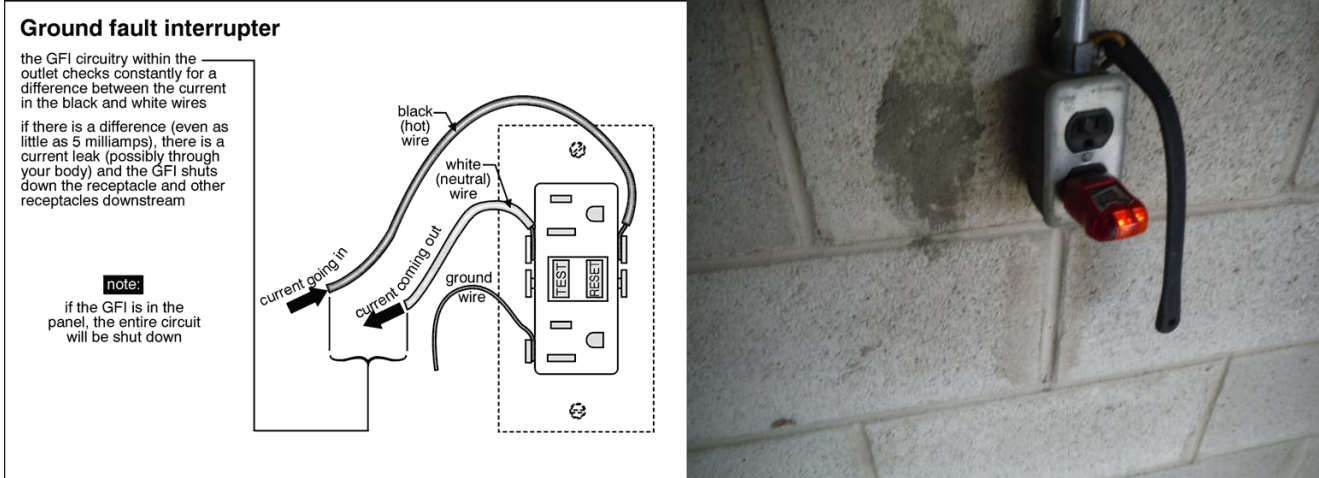
51) Replace-Recommend. Cost=Low.

The outlets in the garage should be replaced with GFCI outlets for electrical safety. All exterior, unfinished basement, crawl space outlets and outlets within 6' of a sink should be GFCI outlets or should be protected by upstream GFCI outlets to protect against electrocution/shocks.

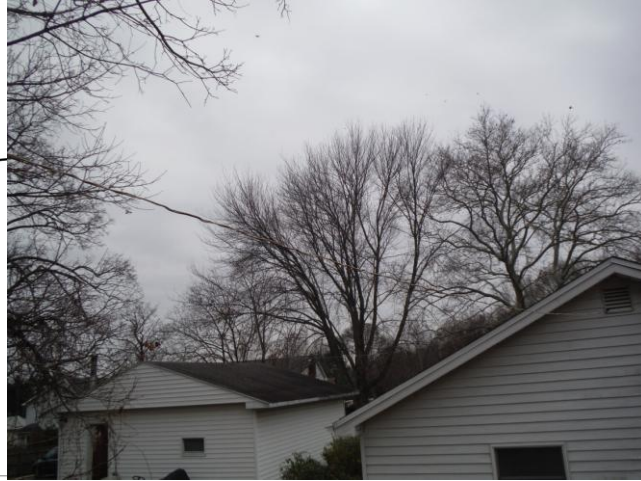
53) Repair-Recommend. Cost=Medium.

The wire from the garage to the shed does not have the required clearance above ground. A mast should be installed in order to elevate the wires to the proper height above the ground for electrical and fire safety.

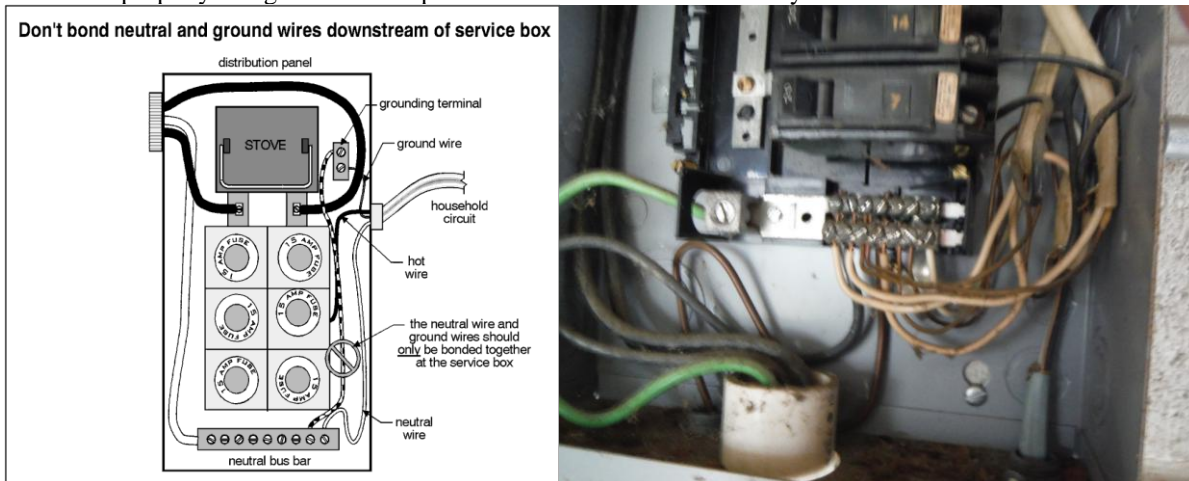
58) Repair-Recommend. Cost=Low/Medium.

In the subpanel that is located on the garage the ground and neutral wires are bonded. The ground and neutral wires should be separated in a downstream subpanel as they should only be bonded in the main panel. Otherwise the ground wires will become improperly energized which represents an electrical and fire safety issue.

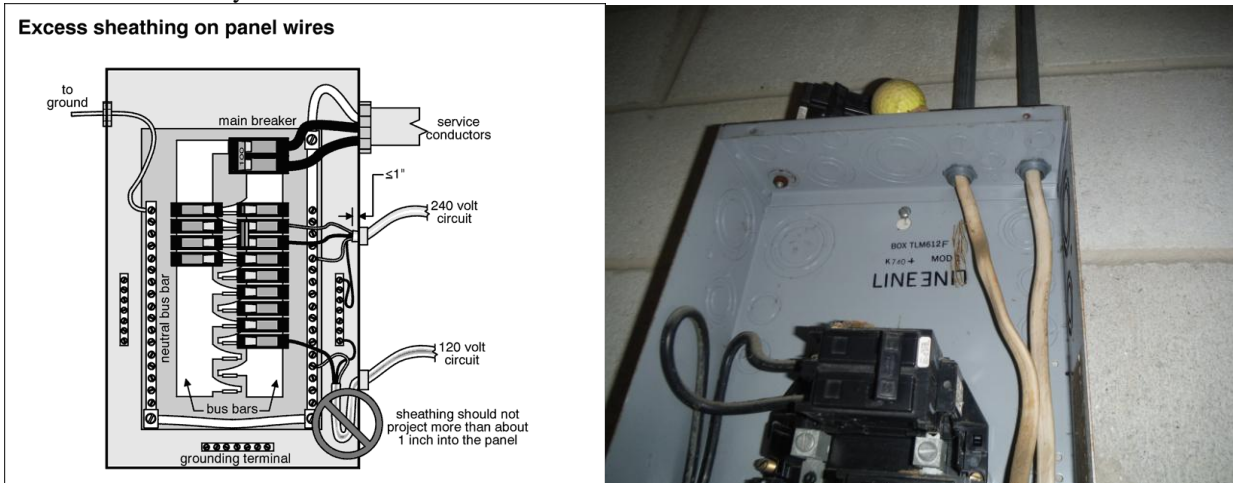
59) Repair-Recommend. Cost=Low.

In the garage sub panel there are several distribution circuits that have excess sheathing remaining. This is considered an electrical deficiency because it can over-crowd the panel and may represent a fire pathway as the sheathing is combustible. This suggests that electrical work performed on the house was done by a non-licensed, non-professional. These deficiencies should be corrected by a licensed electrician.

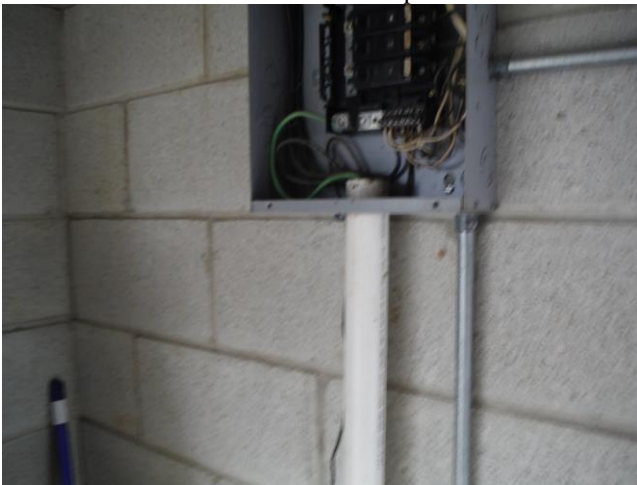
60) Further Investigation Required-Recommend.

The conduit below the sub panel in the garage is questionable. It is composed of PVC which may not be suitable for such an application. It is recommended a licensed electrician ensure this is a safe and functional installation to prevent electrical/fire safety issues. In general, the wiring must not take up more than 40% of the cross-sectional area of the raceway. Space is needed to allow the air to cool and to prevent excessive heat build-up.

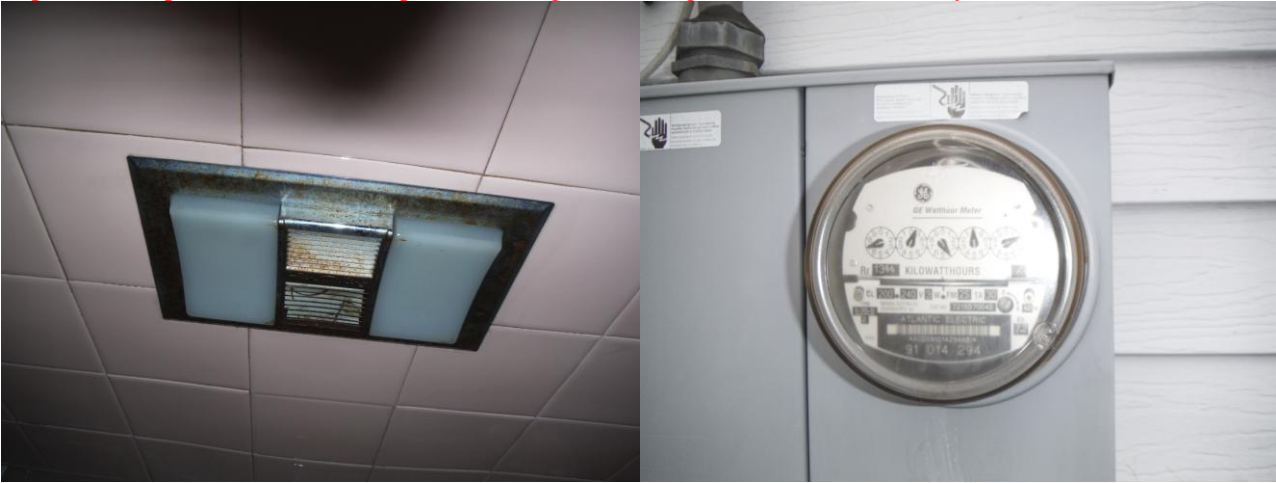
61) Further Investigation Required-Priority.

The electricity to the top unit was off at the meter panel. The electric service downstream of the meter panel should be inspected once power is restored and prior to closing to ensure against electrical fire/safety issues.

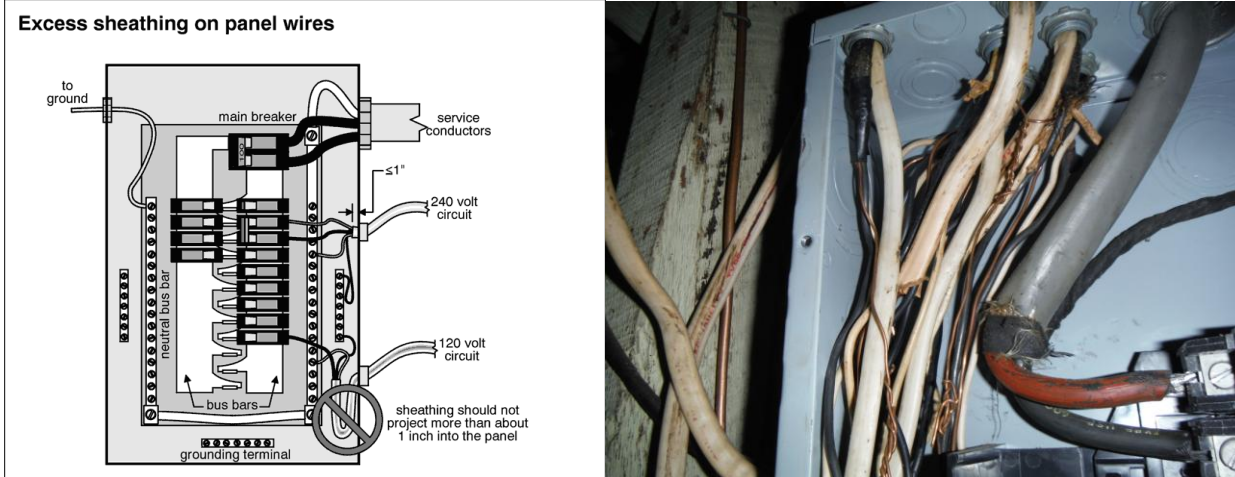
63) Repair-Recommend. Cost=Low.

In the basement left wall panel there are several distribution circuits that have excess sheathing remaining. This is considered an electrical deficiency because it can over-crowd the panel and may represent a fire pathway as the sheathing is combustible. This suggests that electrical work performed on the house was done by a non-licensed, non-professional. These deficiencies should be corrected by a licensed electrician.

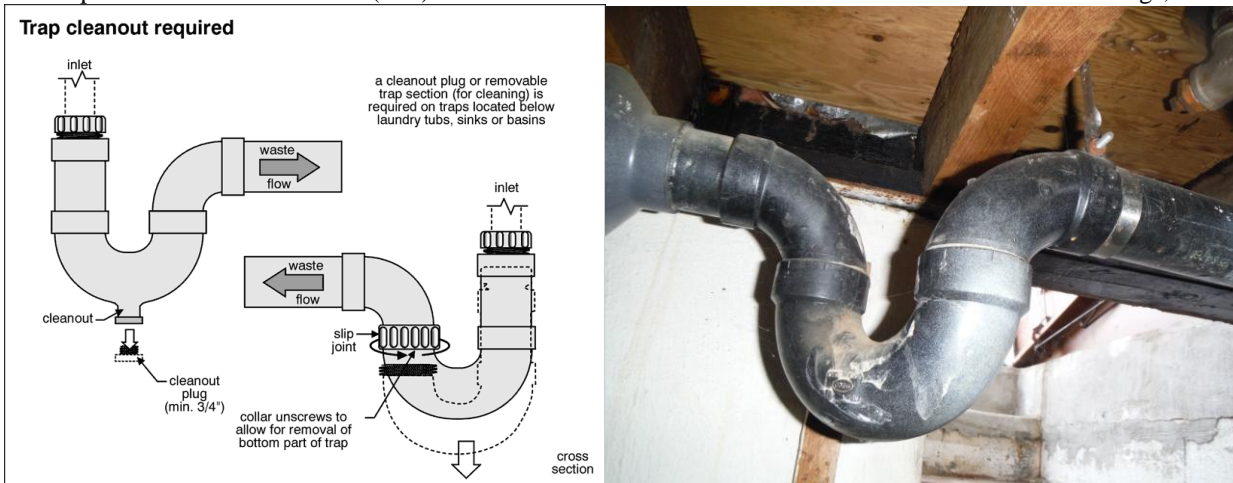
118) Provide-Recommend. Cost=Low.

The trap installed in the basement (rear) should have a clean-out installed so that it can be serviced if it clogs, etc.
