Building Inspection Report

XXX Road
Town, State

Saturday, November 22, 2014

112220141

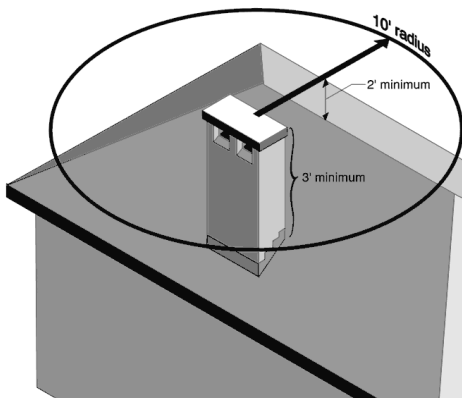
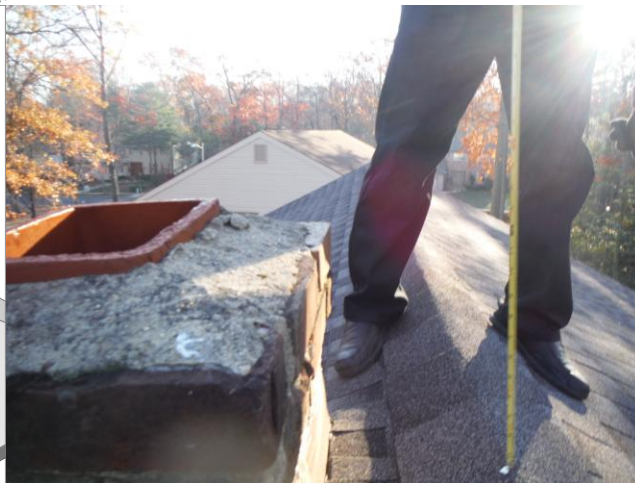
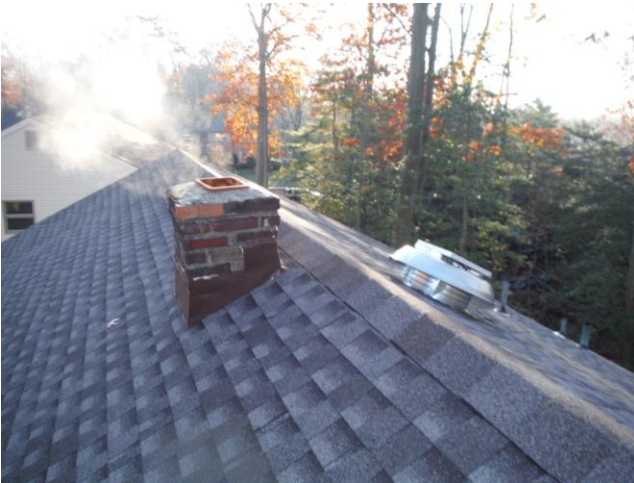
The center chimney should extend 2'+ higher than the roof within a 10' radius from it in order to prevent back drafting and poor draft performance. It does not. Consider having the liner extended to the proper height in order to increase draft performance and to prevent dangerous back-drafting.

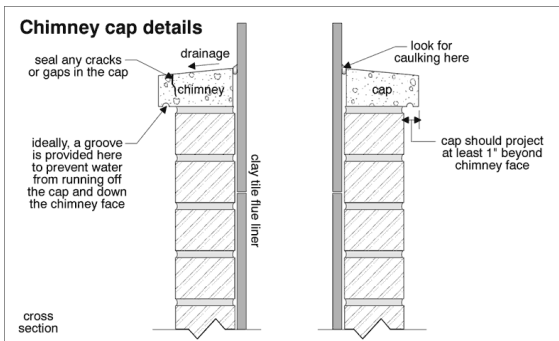
The right chimney crown/cap/wash is deteriorated. It should be repaired or replaced in order to properly protect the chimney structure from deterioration due to moisture penetration.

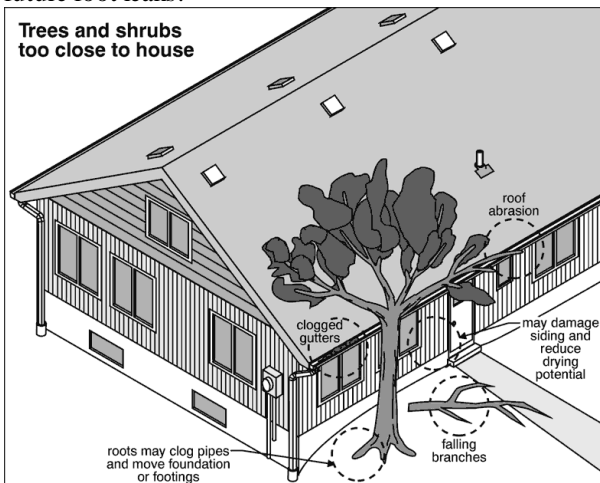
It appears the front/left roof was damaged and reinforced – probably from tree damage. The areas should be monitored for future foot leaks.

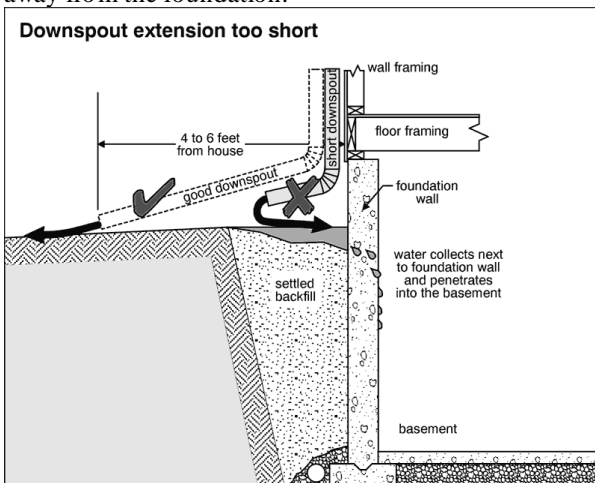
ALL downspouts should be extended 4-6' away from the foundation in order to properly divert damaging roof water runoff away from the foundation.

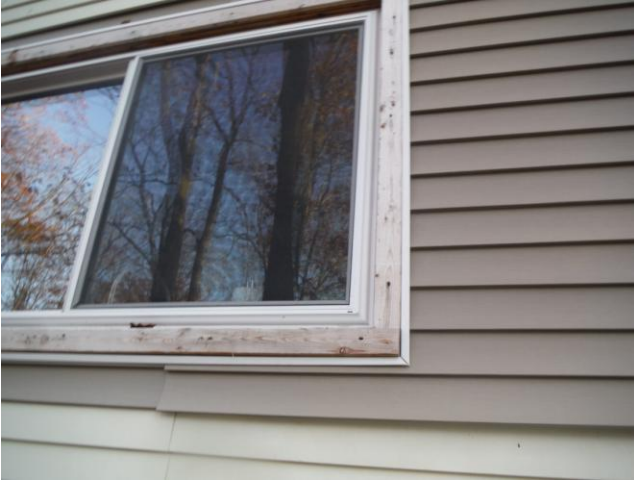
The rear/left window flashing/trim/weather-stripping is incomplete. Wood is exposed.. It should be properly repaired to prevent continued damage from moisture, etc.

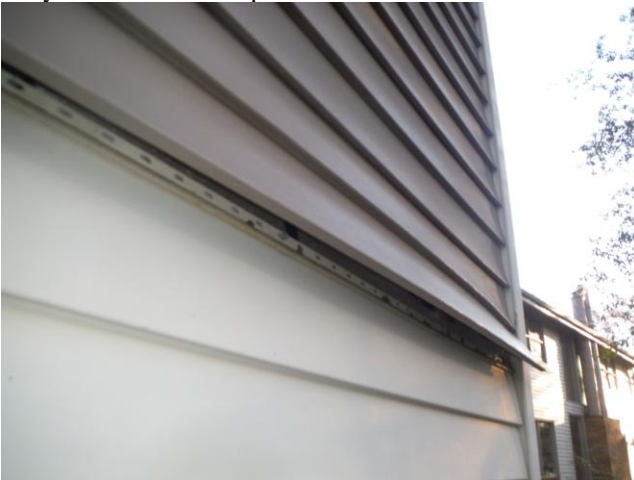
The rear/left siding on the exterior is loose. It should be properly repaired to prevent the allowance of damaging moisture entry to the wall envelope.

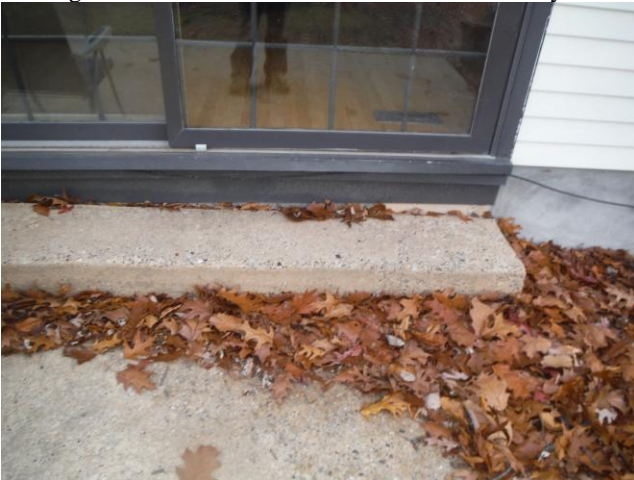
The rear exterior steps are not level which are tripping hazards. This was probably caused by ground settlement. The source of the ground settlement should be rectified and they should be made level.

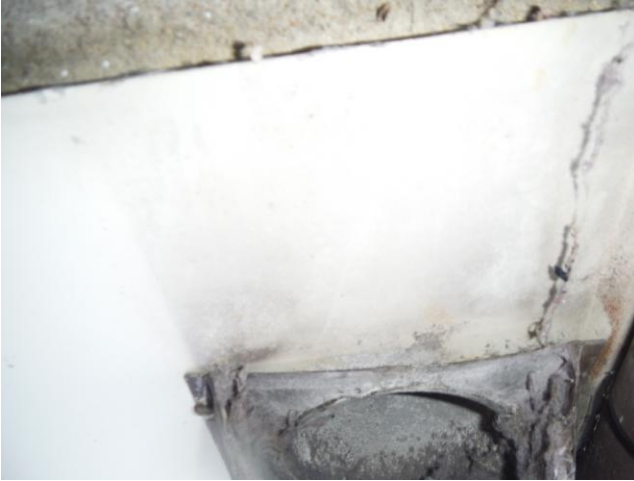
The weather hood for the dryer discharge should be repaired/replaced as at the flap is stuck open. The lint should be removed as it is a fire hazard. Left open the duct can become subject to insect/bird nesting.

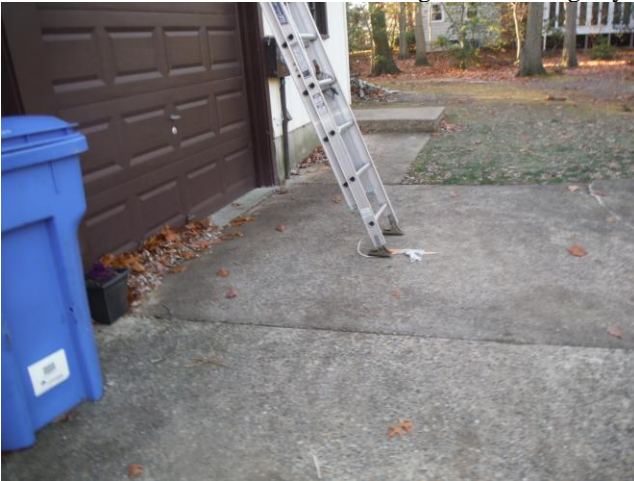
The impervious (driveway) grade slopes toward the home. It should slope down/away from the foundation to prevent water infiltration to the garage which can cause mold issues, wood rot and structural issues. It should drop 1" over the first 4 feet from the foundation. An external underground drainage system may be required if moisture is proven to enter the garage.

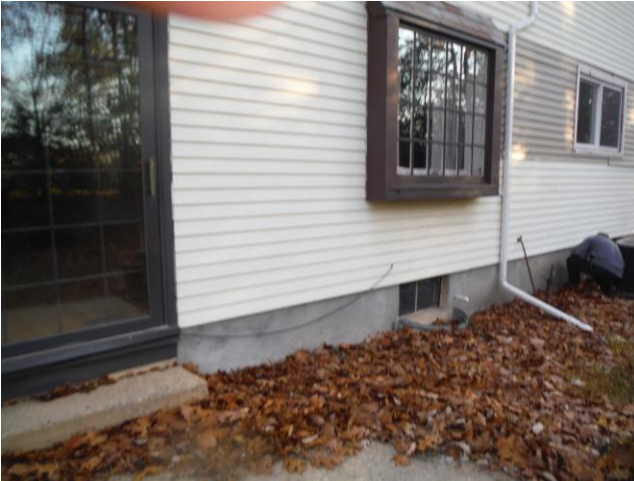
An outlet should be added to the rear exterior for convenience. Modern building science recommends exterior outlets on the front and rear exterior of the house. Otherwise extension cords are used which are fire/safety issues.

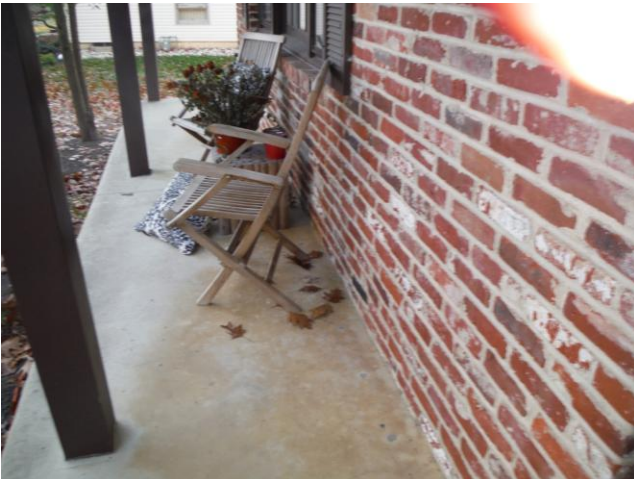
An outlet should be added to the front exterior for convenience. Modern building science recommends exterior outlets on the front and rear exterior of the house. Otherwise extension cords are used which are fire/safety issues.

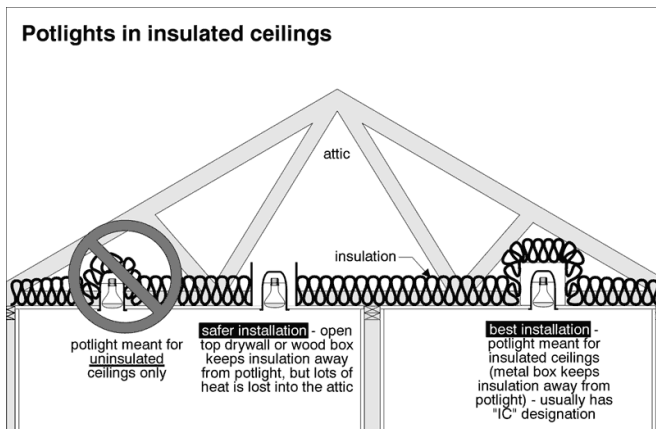
The pot lights in the attic are not rated for IC (insulation Contact) yet are in contact with combustible insulation. Therefore they represent a fire safety hazard. It should be ensured that the insulation is moved/separated away from the pot lights by 3"+.

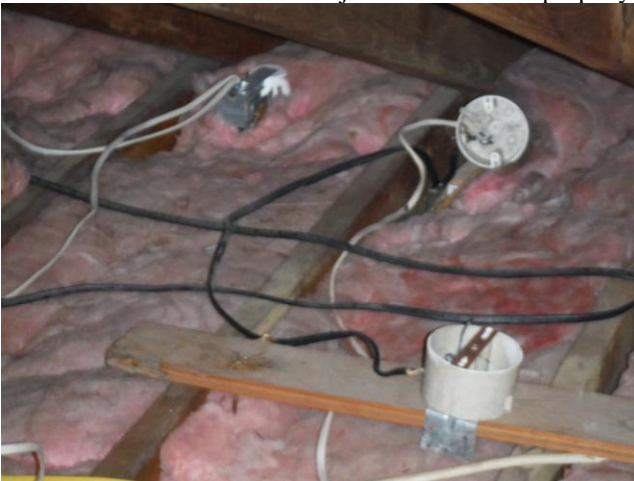
There are several junction boxes in the attic that represent fire/safety issues. Several are loose/unfastened. An electrician should be hire to ensure that all junction boxes are properly secured and covered in the attic.

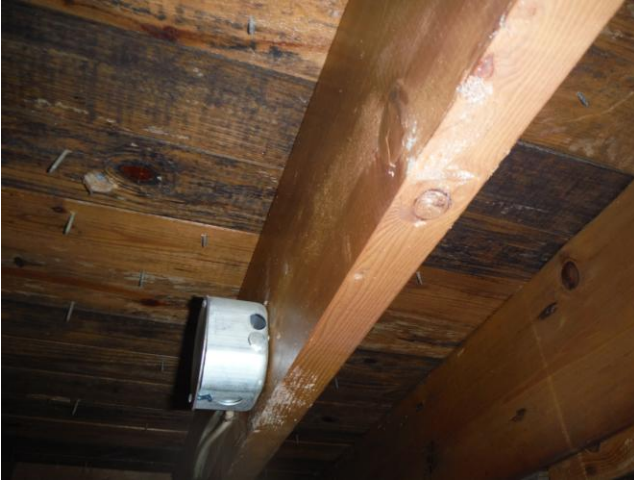
The junction box on the basement front/left has an open pop/knock-out that should be covered/sealed for electrical and fire safety.

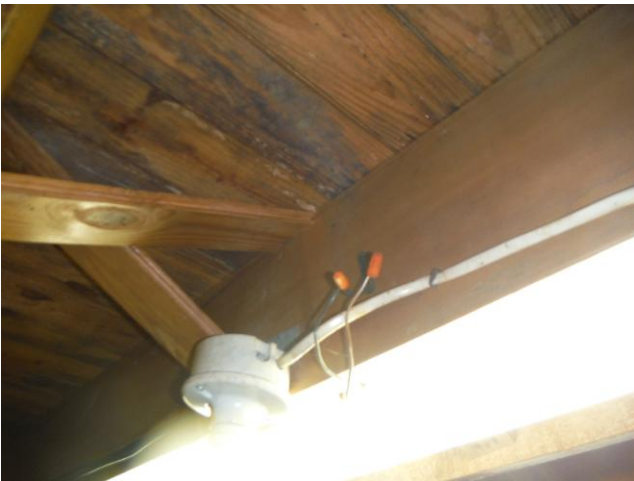
There are multiple improperly terminated/connected wires (e.g. front/left ceiling) in the basement. All wire splices that are unsheathed or terminated need to be contained in a junction box for electrical and fire safety. An electrician should be hired to correct all such wiring deficiencies in the basement.

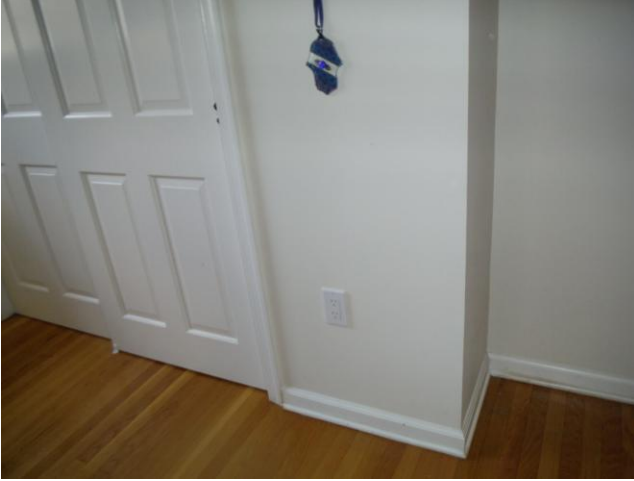
The front/left rear wall outlet has an open ground and should be properly wired/repaired for electrical/fire safety.

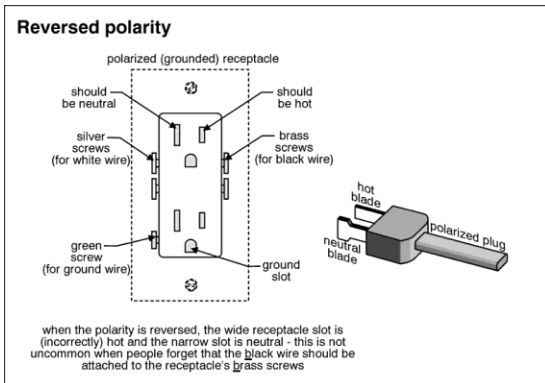
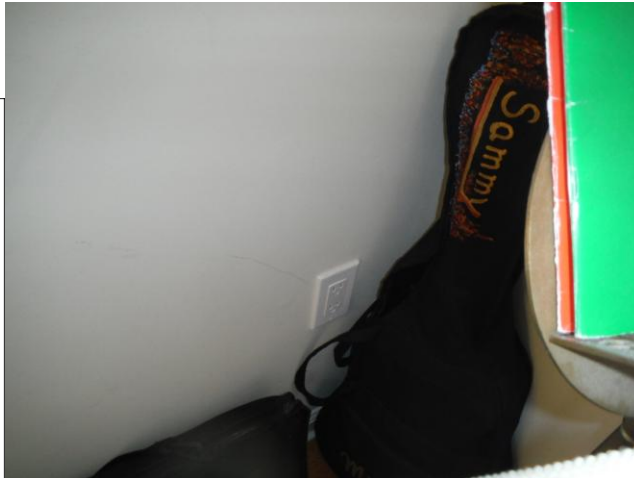
The outlet on the front/left bedroom left wall has reversed polarity. It should be re-wired for electrical safety.

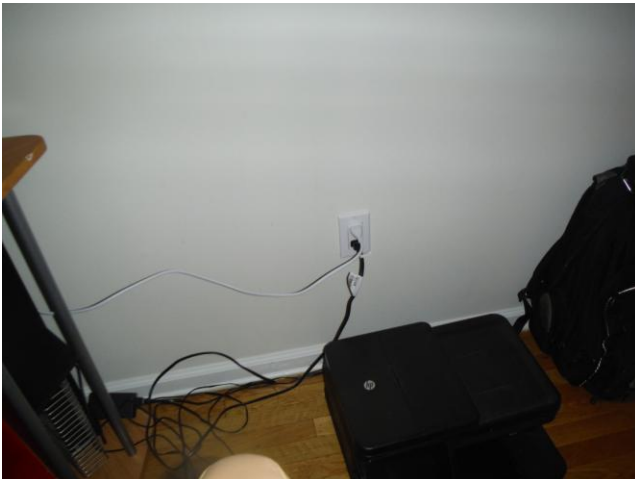
The outlet on the front/right bedroom left wall has reversed polarity. It should be re-wired for electrical safety.

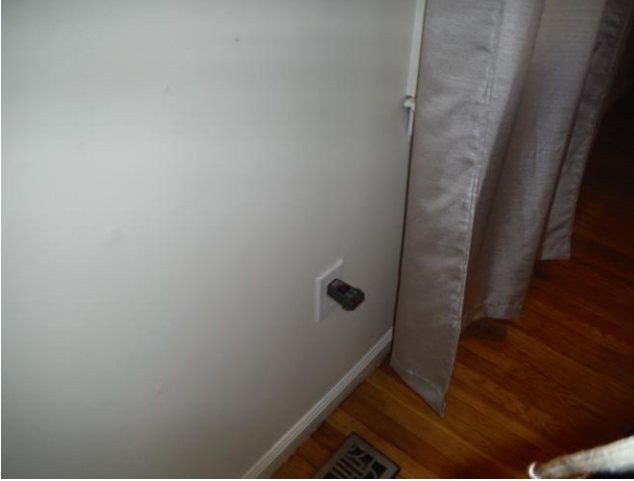
The outlet in the dining room front wall (right) is not energized/functioning.

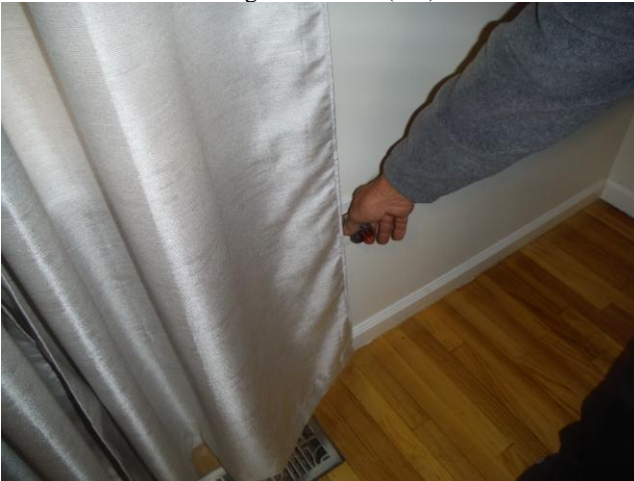
The outlet on the dining room front (left) wall has reversed polarity. It should be re-wired for electrical safety.

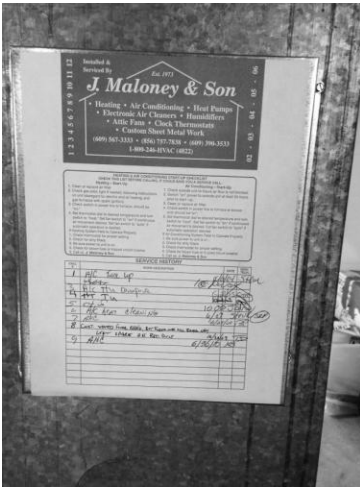
There are no service records present that indicate the furnace has been serviced/calibrated since 2010. To ensure operability and efficiency the furnace should be serviced by a HVAC technician. While servicing testing should be performed to ensure that the heat exchanger is fully intact in order to prevent health issues and loss of efficiency, etc. The manufacturer of this furnace model recommends it should be serviced annually.

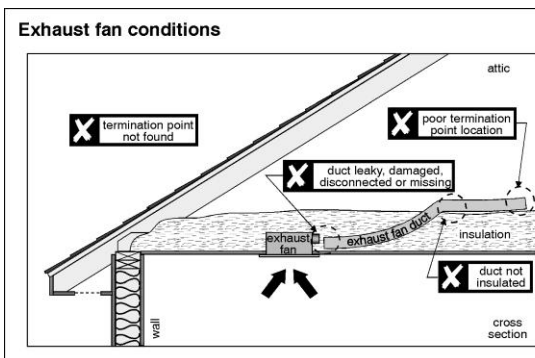
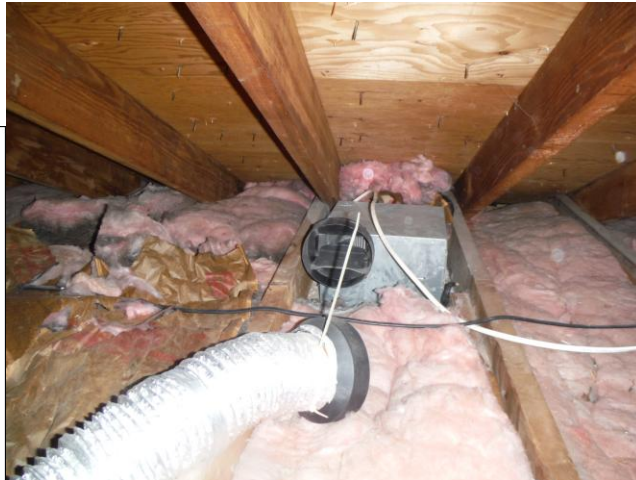
The bathroom ventilation fans discharge to the attic as it has become disconnected near the fan itself. This causes excess moisture to be added to the attic space which can cause mold and wood rot issues.

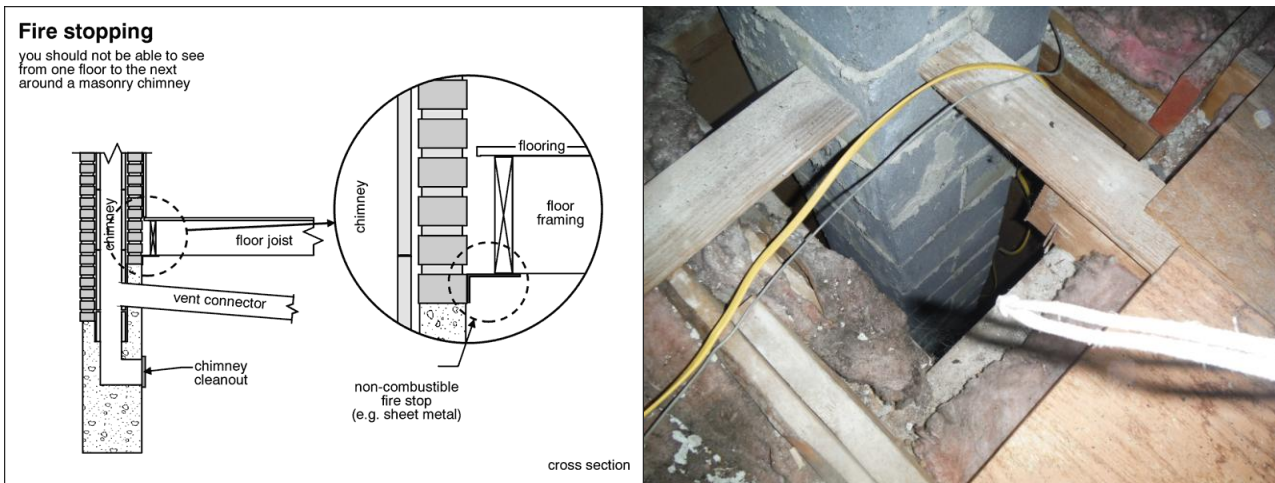
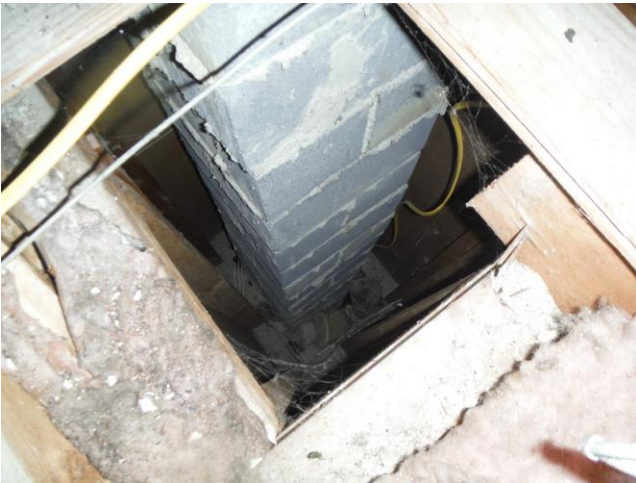
In the attic a fire stop should be installed around the masonry chimney so that a fire cannot spread between the home and the attic.

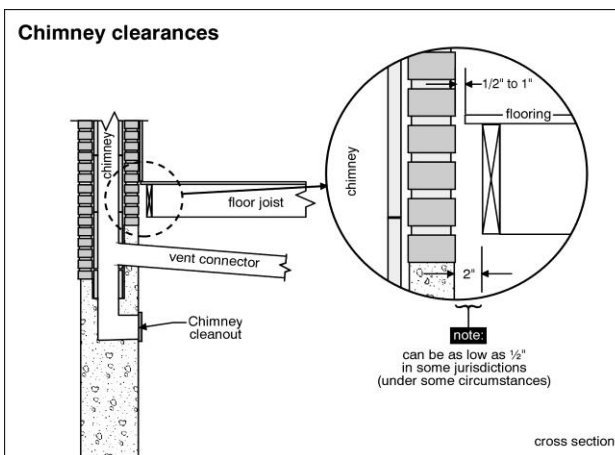
In the attic a 2" gap (with metal fire shield/stop) should exist around the masonry chimney so that the combustible wood does not catch fire/burn/deteriorate in the event of a chimney fire.

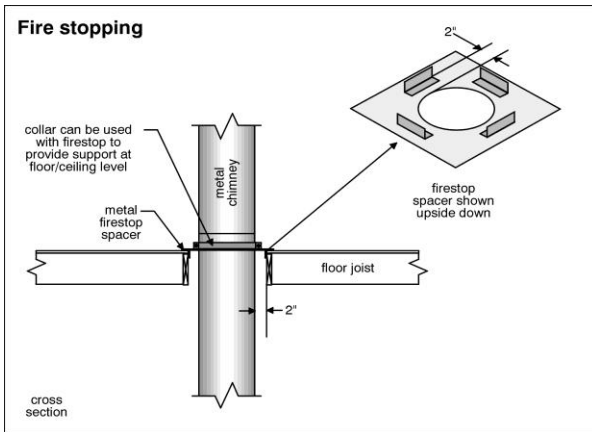
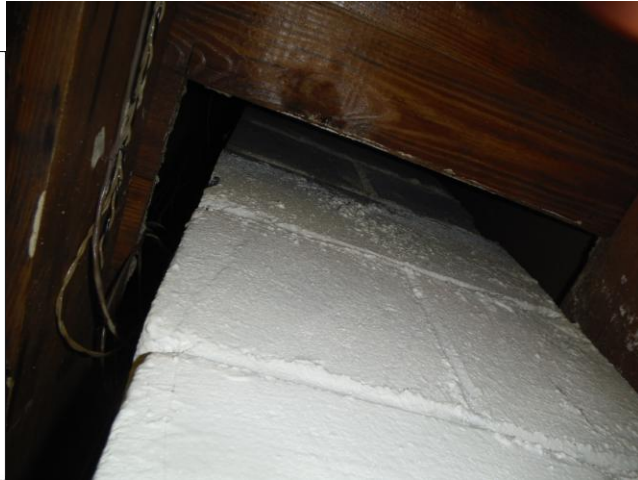
There are several openings in the basement ceiling that should be properly sealed to prevent the ability of fires to spread from the basement to the floor above.

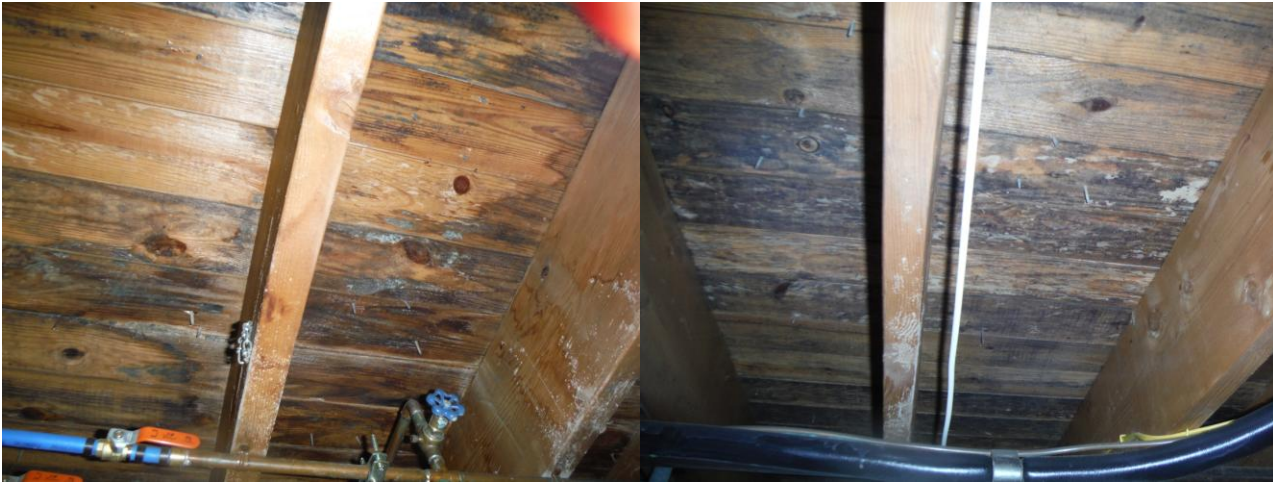
Mildew/mold is visible on some areas of the basement ceiling. This may be a health risk to certain residents. The mildew/mold can be expected to return unless the ventilation/insulation is properly installed and sufficient. The homeowner may want to consider sealing the mildew or having it professionally cleaned/removed.

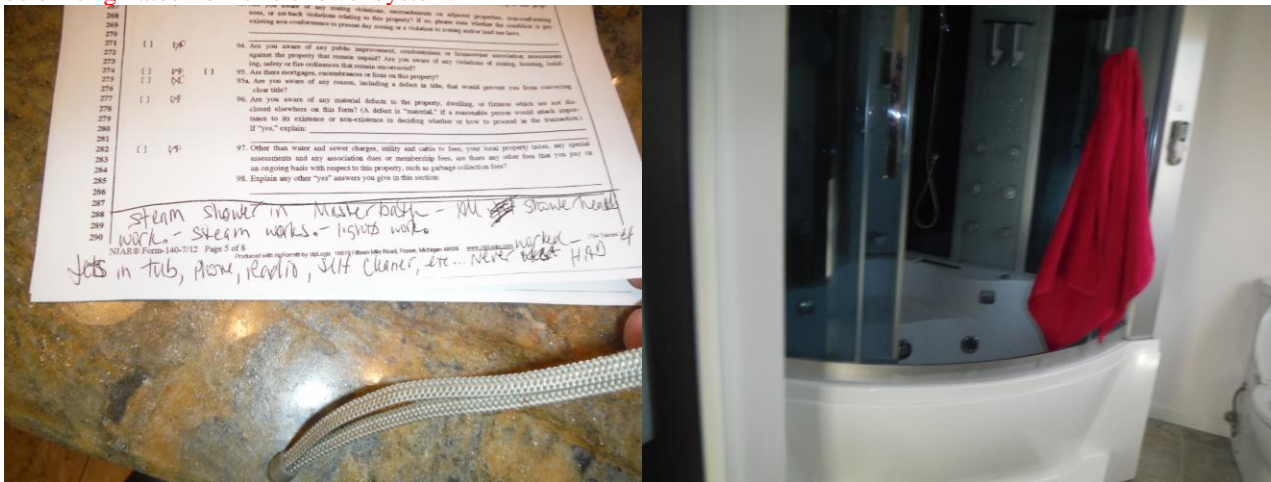
The master bathroom has a combined steam/shower system with multiple electronic accessories. The Seller's Disclosure indicated some of these functions do not operate. The inspector was unable many of these functions during the inspection. The buyer should consider having a specialized inspection performed by someone who is familiar with electronic steam/shower system to determine what is operable and what requires repairs, etc. It also appears the leak to the ceiling below originates from this shower system.

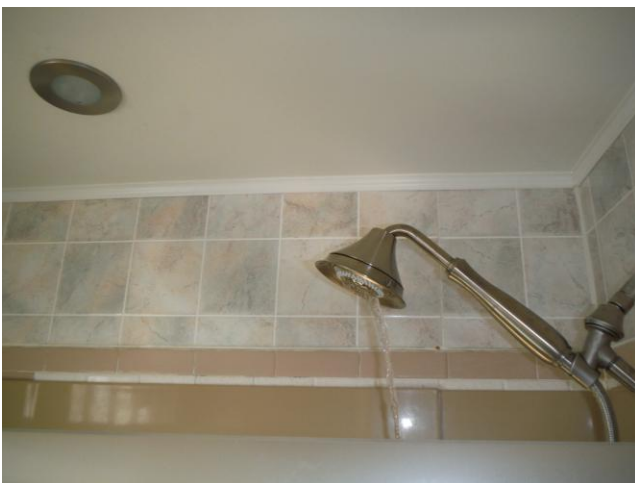
The water pressure in the supply plumbing on several fixtures was low on the top floor during the inspection when multiple fixtures were operated. The homeowner should consider upgrading the diameter of the water pipes in the basement. Otherwise operability and comfort may be compromised regarding water usage within the home.

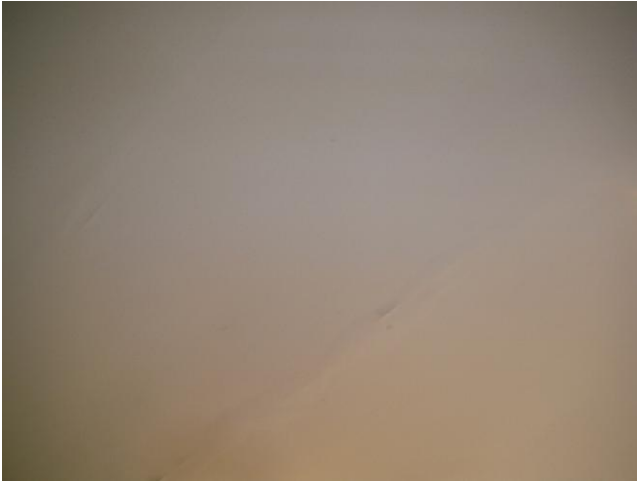
When the water was run to the top bathroom a leak formed below this bathroom which was visible on the ceiling below. There were stains on the ceiling prior to the water being run to the bathroom. A licensed plumber should be hired to locate and repair the leak before the bathroom is used. Mildew/mold may be hidden on the non-visible wall surfaces, etc.

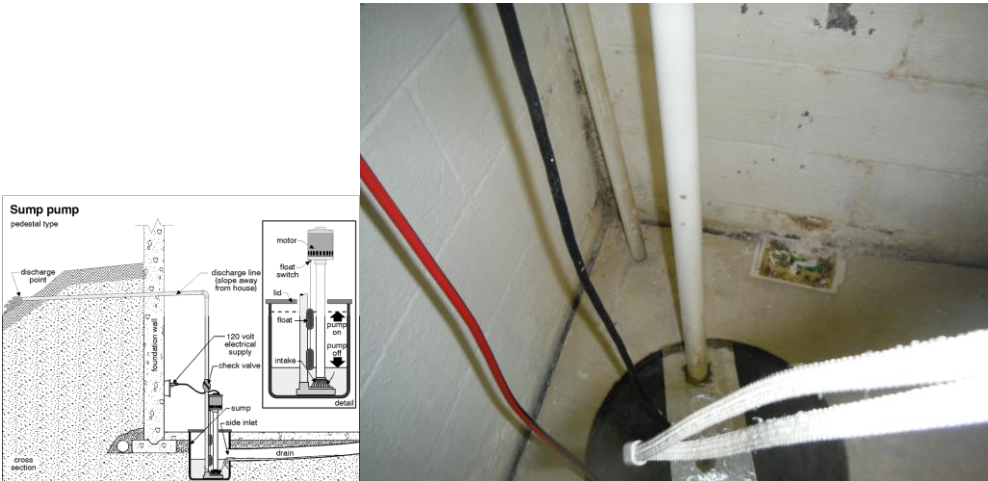
The sump pump installed in the basement needs to have a check valve installed in the discharge line to prevent damaging and hazardous backflow.

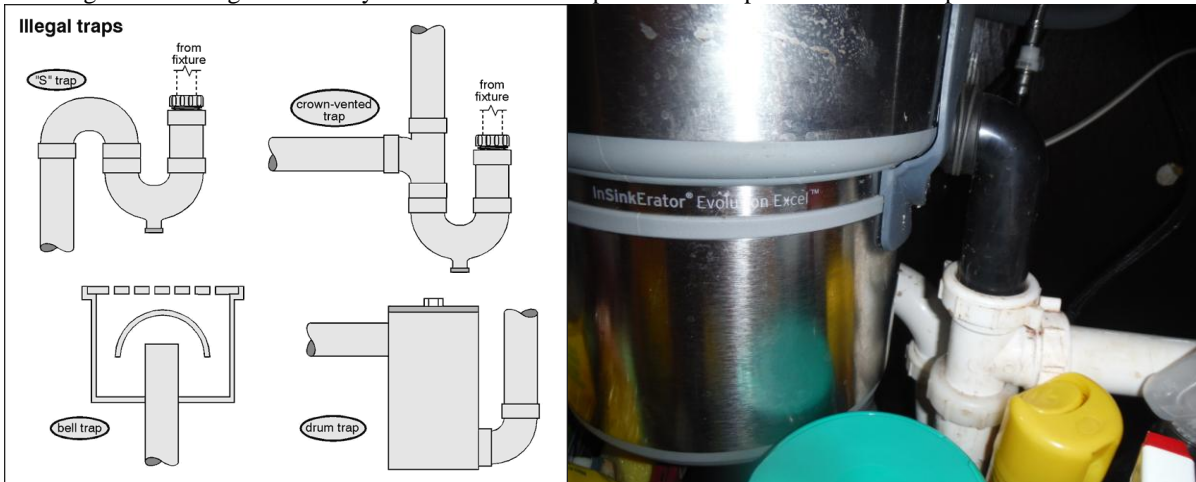
The kitchen sink drain trap should be replaced in order to allow proper drainage and to prevent dangerous sewer gases from entering the home. The S-trap which serves the sink can suffer from self-siphoning which leave the trap dry which permits the dangerous sewer gases to enter the home. The S-trap should be replaced with a P-trap.

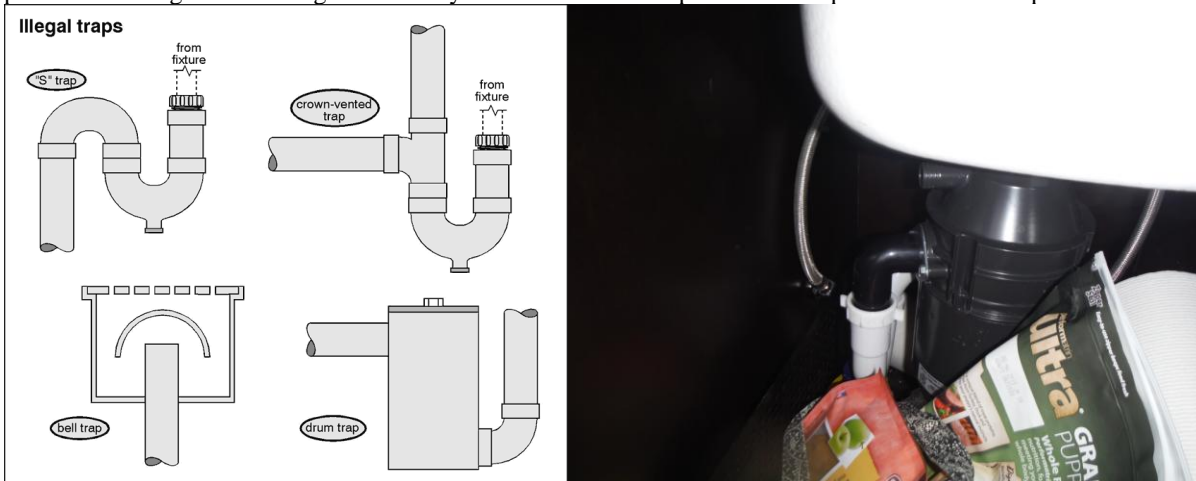
72) Replace-Recommend. Cost=Low.

The kitchen island sink drain trap should be replaced in order to allow proper drainage and to prevent dangerous sewer gases from entering the home. The S-trap which serves the sink can suffer from self-siphoning which leave the trap dry which permits the dangerous sewer gases to enter the home. The S-trap should be replaced with a P-trap.

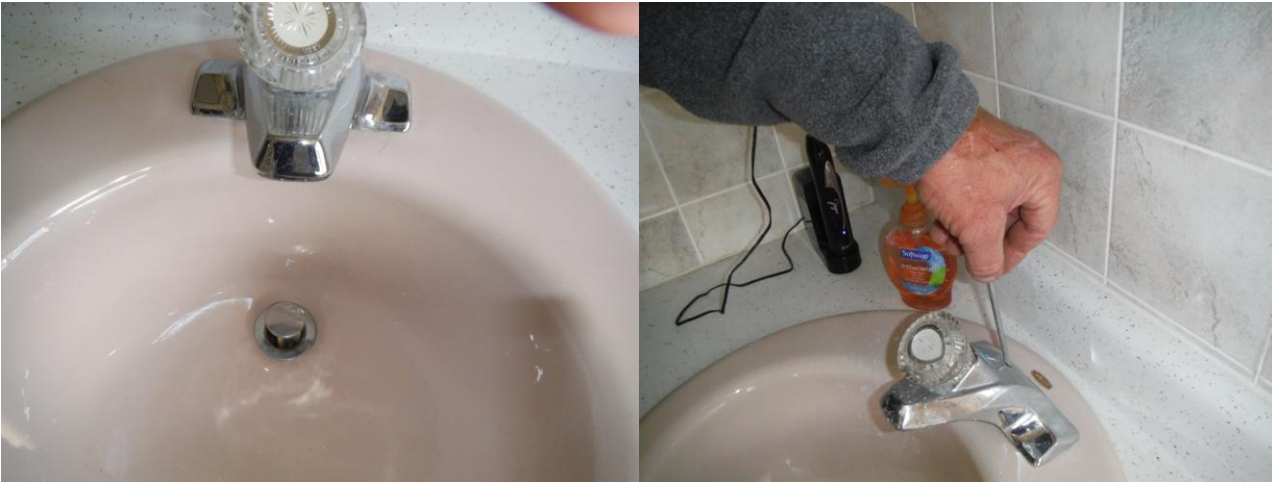
73) Repair-Discretionary. Cost=Low.

The hall bathroom sink stoppers are not functioning/missing. They should be repaired/replaced if the homeowners wish to use them.

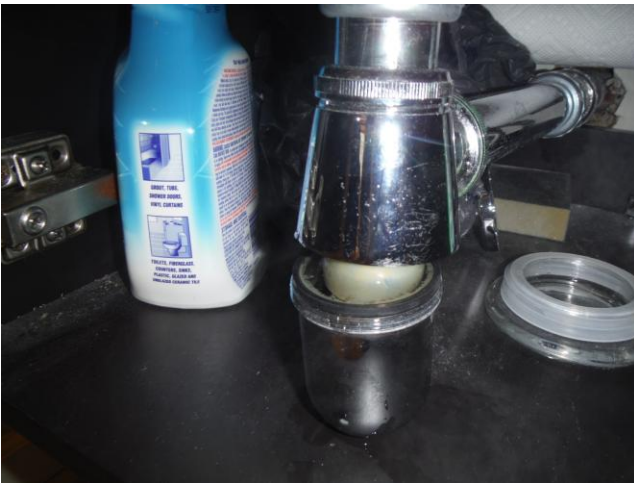
74) Further Investigation Required-Recommend.

The trap below the powder room bathroom sink is an unusual type. The homeowner should consider consulting with a licensed plumber to ensure that it is a functional and approved model/type. Otherwise this may circumvent the proper function of the trap and allow dangerous sewer gases into the home.

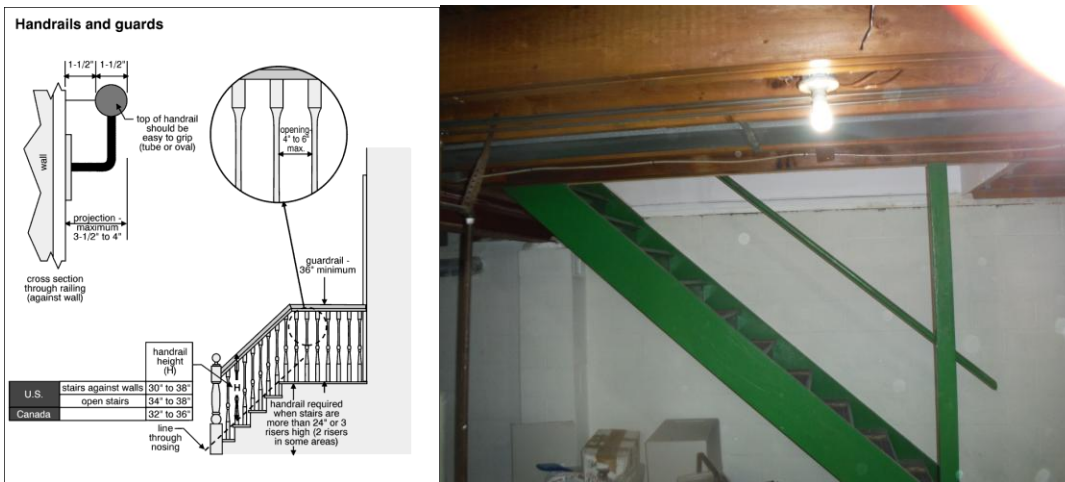
76) Replace-Recommend. Cost=Medium.

The basement stairway opening is a potential child/pet safety issue. A 4" ball should not be able to pass off/through the opening for child/pet safety. Spindles should be installed in this opening to prevent falls.

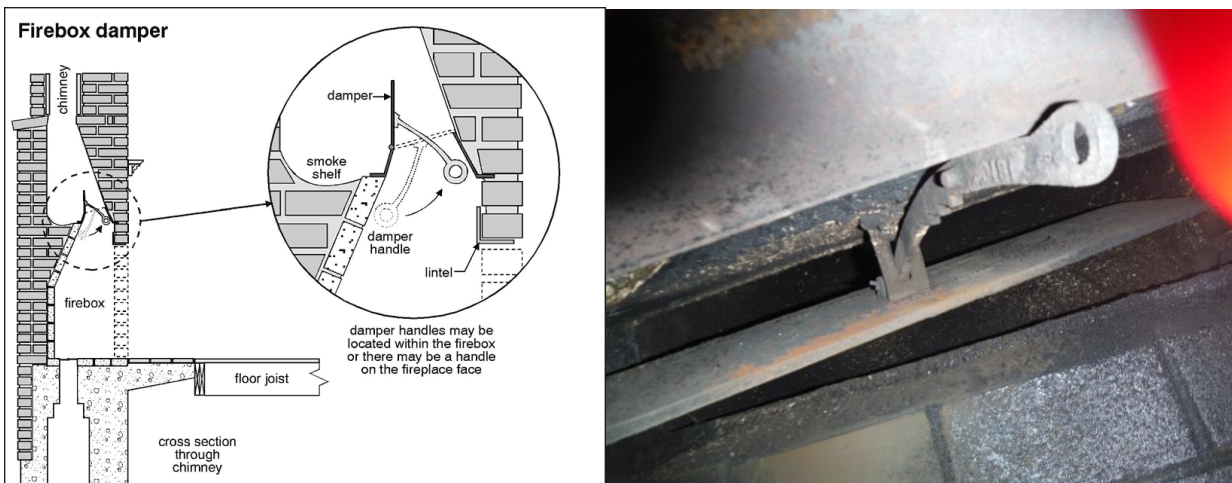
77) Repair-Recommend. Cost=Low.

The fireplace damper lever is broken. It should be repaired to keep exterior moisture and temperatures from inside the home.

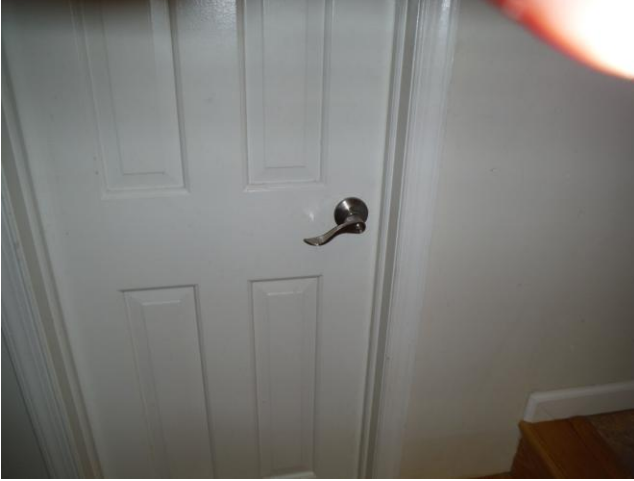
78) Repair-Recommend. Cost=Low/Medium.

The powder room bathroom door is difficult to open/close (rubs) and should be adjusted for operability.

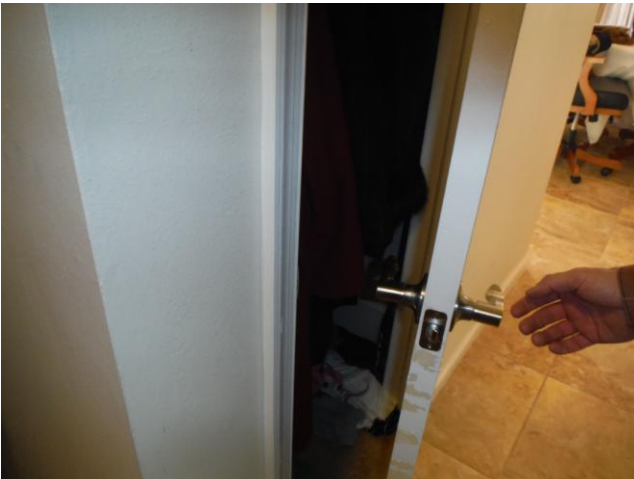
79) Repair-Recommend. Cost=Low/Medium.

The foyer closet door is difficult to open/close (rubs) and should be adjusted for operability.

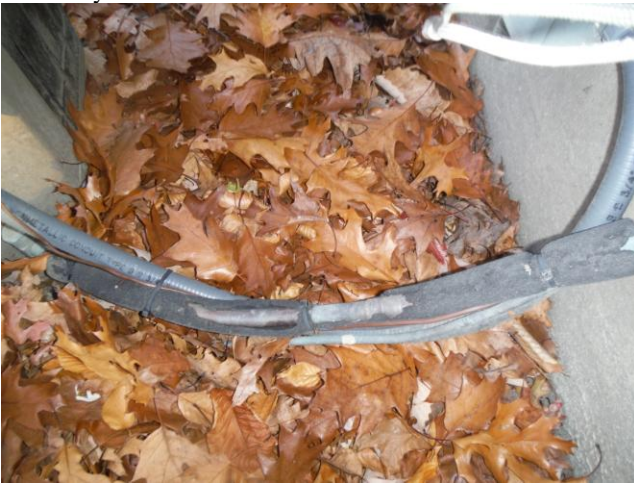
80) Replace-Recommend. Cost=Low.

The AC suction line insulation on the exterior (rear) is deteriorating and should be replaced in order to preserve cooling efficiency.

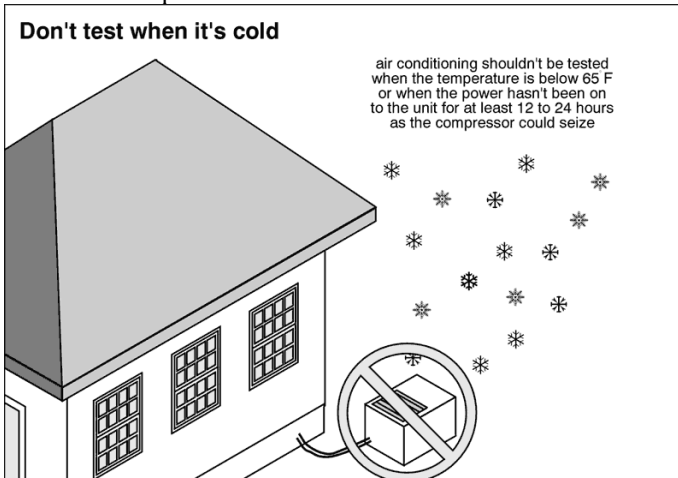
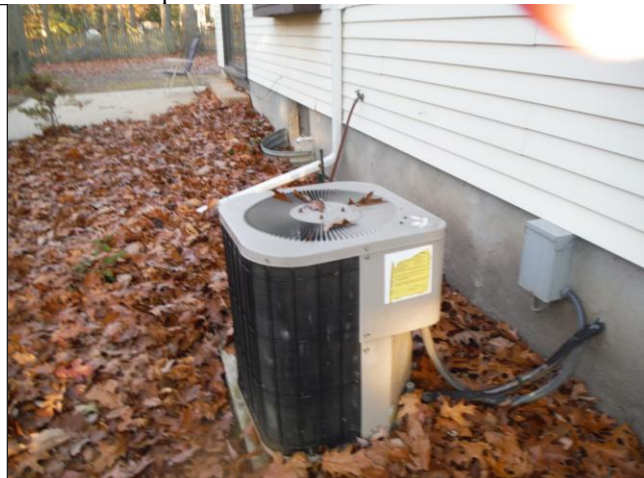
81) Further Investigation Required-Recommend.

The AC condenser unit could not be tested during the inspection due to temperature limitations. The unit is 16 years old. The recommendation is to have an AC technician service the AC system to ensure its operability when temperature allows. There are no records present on-site which indicate it has been serviced in the recent past.
