Building Inspection Report

Any Street

Saturday, November 29, 2014

South Jersey Home Inspection, LLC

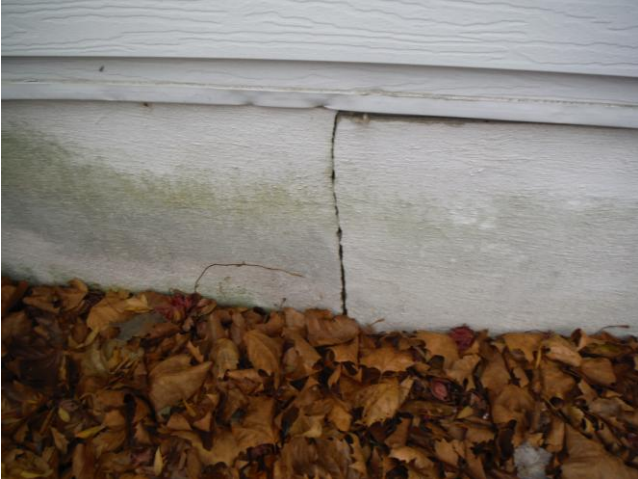
- 1) Repair-Recommend. Cost=Low.

At least one addition was added to the house. There is evidence of differential settlement between the original house and the front/right addition as evidenced by the vertical separation/crack on the right side. It does not appear to be structurally significant in terms of collapse/failure. However, the homeowner should be aware that the differential settlement may continue, which can cause additional cracks to appear as well as utility pipe damage and improperly opening doors/windows, etc. It is recommended to seal the crack to at least keep damaging moisture out of the crawl space areas. The crack will probably need to be periodically resealed as continued movement can be expected.

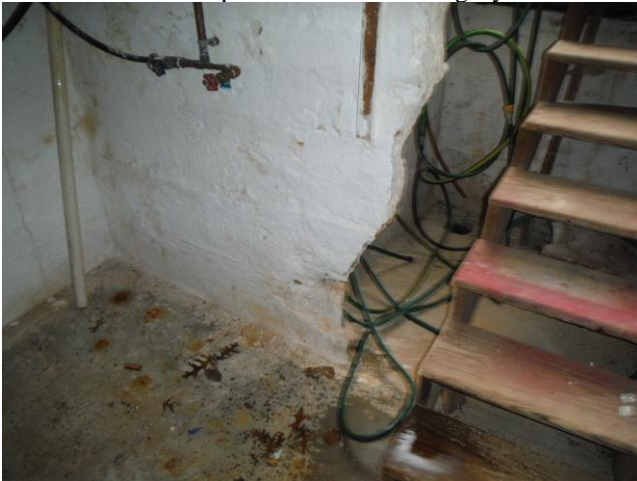
3) Repair-Recommend. Cost=Medium.

An opening was made in the rear/left of the basement for the installation of rear basement stairs. The opening is apparently not sound as the wall is not continuously supported as there are openings visible above the ground. A foundation specialist should be hired to repair the structural integrity of the wall.

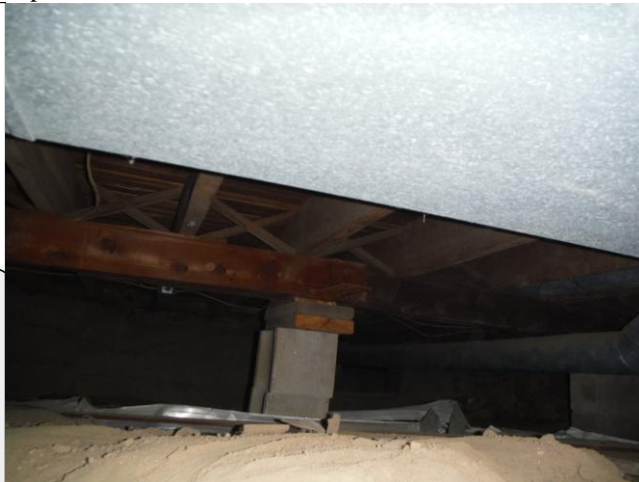
11) Further Investigation Required-Recommend.

The bearing beam in the main crawl space may have been moved/modified as it appears the piers, etc are not original construction. The construction permits should be acquired that confirm this was a design modification that is acceptable in order to prevent localized floor/wall collapse/sag. This may explain some of the floor unevenness above.

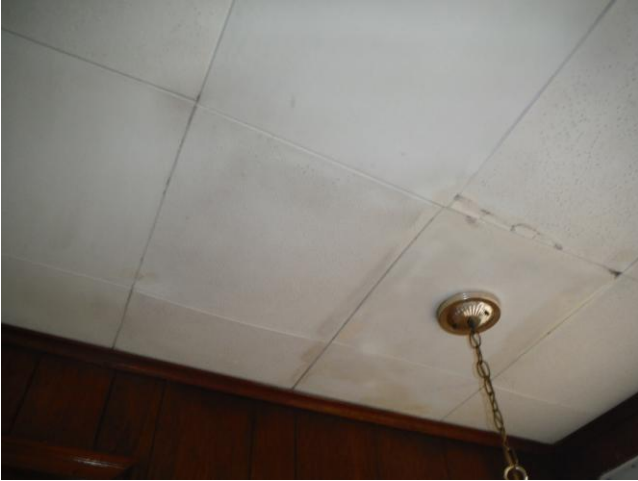
24) Monitor-Recommend.

There is evidence of a roof leak in the lower right porch. It appeared to be dry during the inspection. No evidence of current roof leaks was found in the attic. The area should be monitored for continued leakage and addressed if it does return. The home owner should consider removal of any fungi/mildew/mold on the sheathing. The leak may have been from kitchen/bathroom issues above.

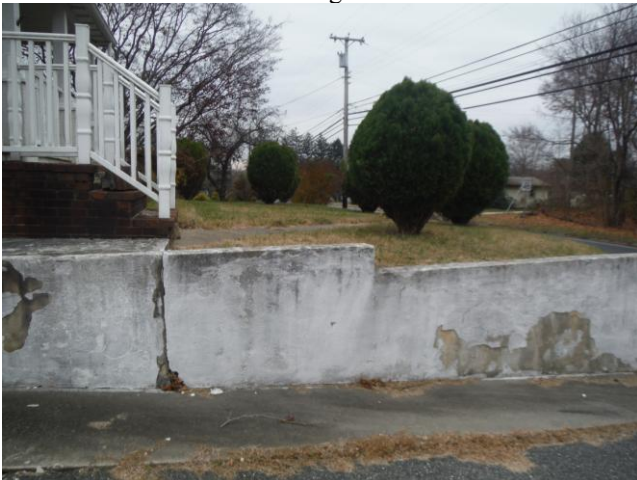
26) Provide-Recommend. Cost=Low/Medium.

A guard rail and infill should be provided around the front retaining wall top for safety (to prevent falls, etc.). It is recommended because the height of the wall exceeds 30" in height.

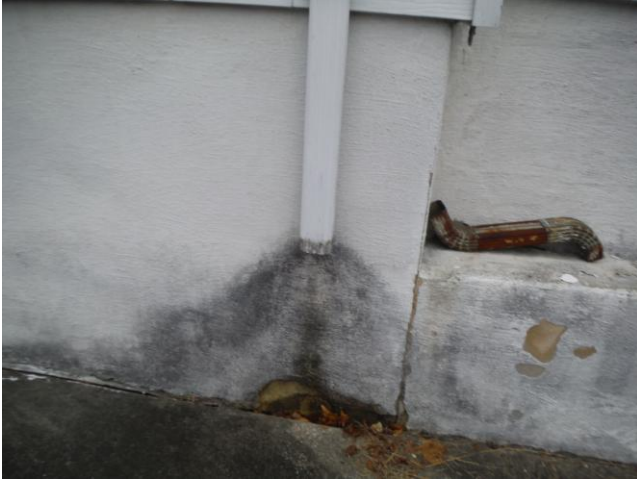
27) Repair-Recommend. Cost=Low.

Several downspouts and/or elbows are missing/disconnected. They should be replaced and installed so as to divert water away from the foundation to prevent foundation deterioration.

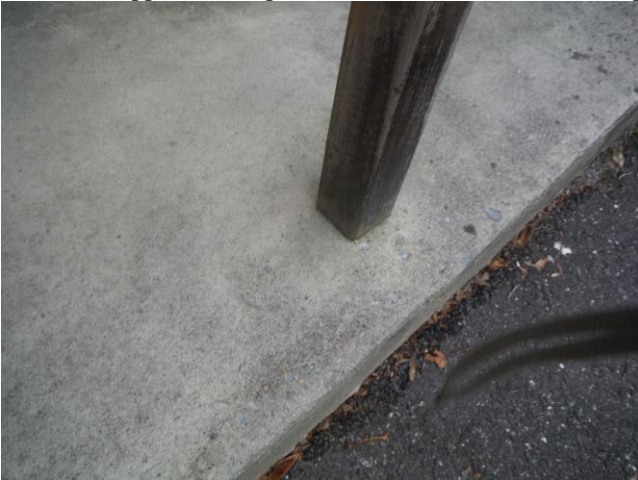
29) Provide-Recommend. Cost=Low.

It appears the columns that support the rear porch are suffering from moisture damage at their bases. This can lead to lost structural support. A rot-preventative treatment should be applied to halt further deterioration.

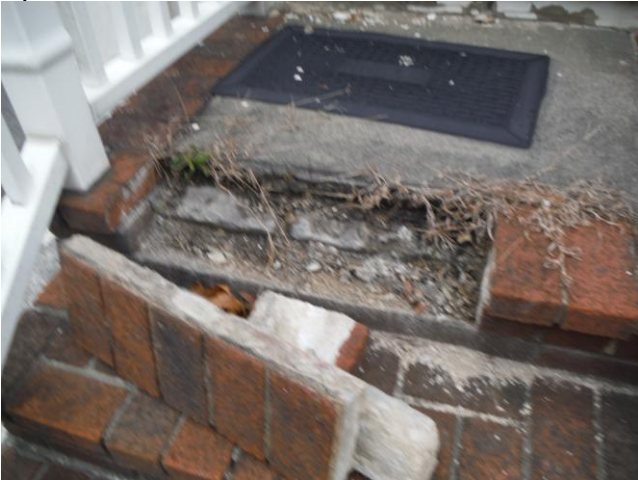
33) Repair-Recommend. Cost=Low.

The front entry steps/walk has several potential tripping hazards. To prevent tripping hazards the steps/walks should be repaired.

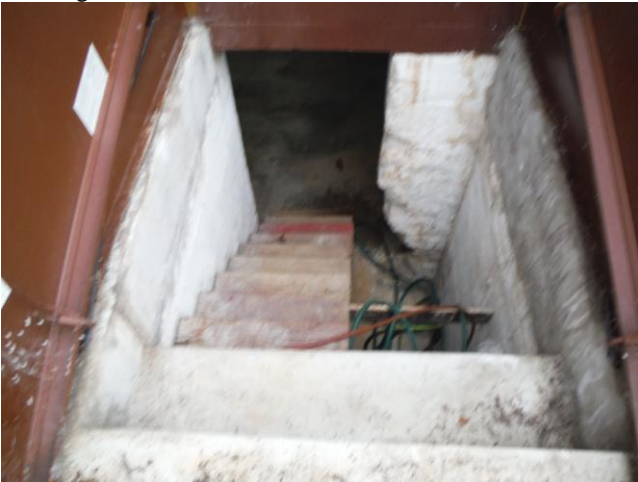
35) Provide-Recommend. Cost=Medium.

The basement stairs should be enclosed with a hand/guard rail so that a 4" ball cannot pass off/through the stairs at an elevation of 30" or more from the floor. This is a child safety issue (i.e. falling off/through) and is required in modern building science recommendations.

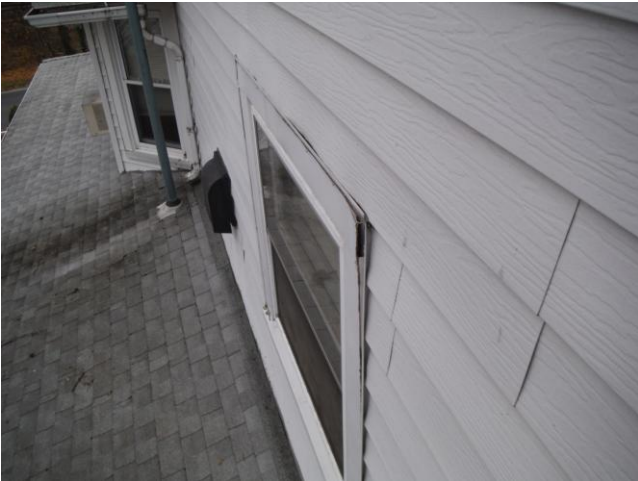
37) Repair-Recommend. Cost=Uncertain.

Several windows (upper right) are improperly flashed/capped or damaged and may be allowing damaging moisture intrusion into the wall envelopes. A flashing/window expert should be hired to ensure all windows are properly sealed from damaging weather and water intrusion.

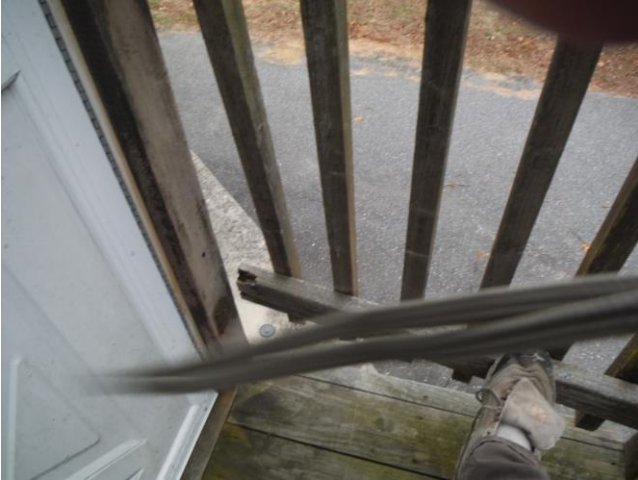
40) Repair-Recommend. Cost=Low.

The rear porch guardrails are loose/unsecure/unfastened. The guard rails should be properly fastened to prevent falling injuries. Rails should be able to properly support 200 lbs of horizontal force for safety.

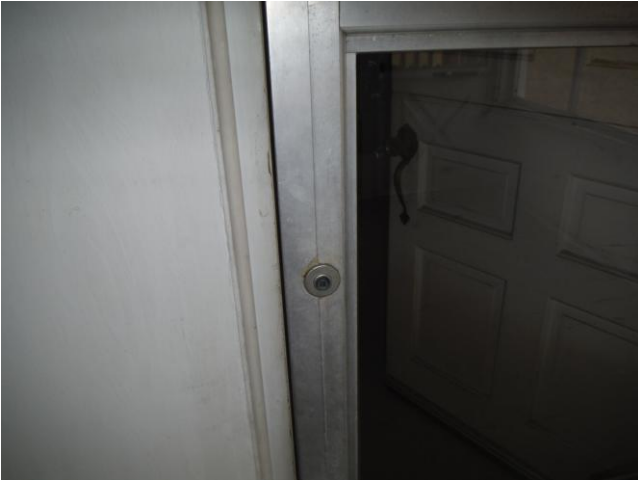
42) Repair-Recommend. Cost=Low.

The top rear door handle is missing/broken. It should be repaired/replaced in order to return for operability, security and convenience.

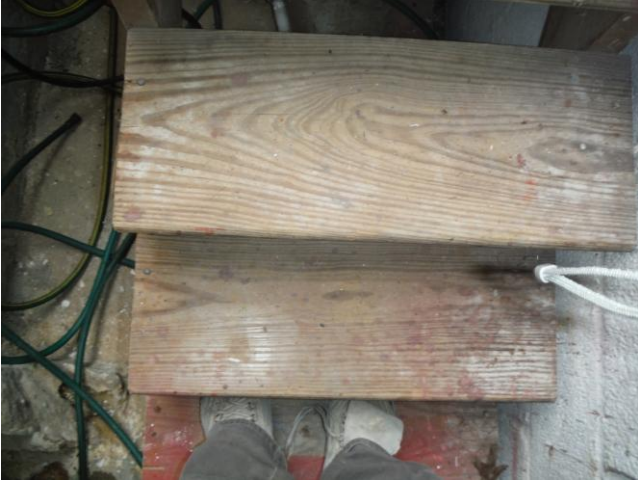
43) Repair-Recommend. Cost=Low.

The rear basement steps are loose and should be re-fastened for safety.

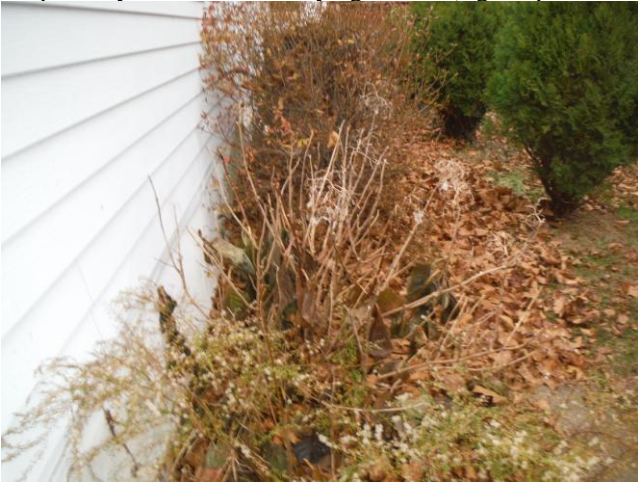
44) Remove-Recommend. Cost=Low.

The exterior vegetation (e.g. right) should be removed from the siding as they hold damaging moisture against the siding and are pathways for wood destroying insects (e.g. carpenter ants).

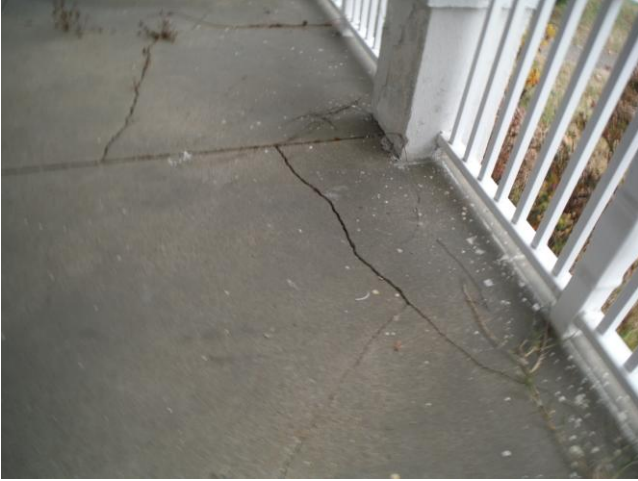
48) Repair-Discretionary. Cost=Medium.

The front porch floor is settling. The homeowner should consider repairing it as it may represent a tripping hazard in its current state. There is no access below this porch to determine a cause for the settlement.

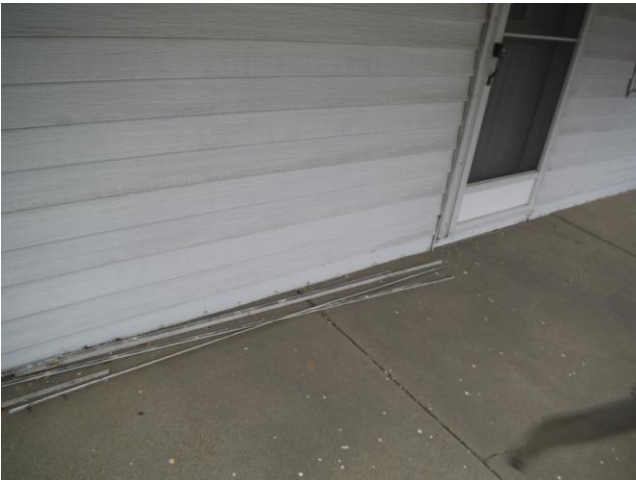
50) Provide-Recommend. Cost=Low/Medium.

An outlet should be added to the front exterior for convenience. Modern building science recommends exterior outlets on the front and rear exterior of the house. Otherwise extension cords are used which are fire/safety issues.

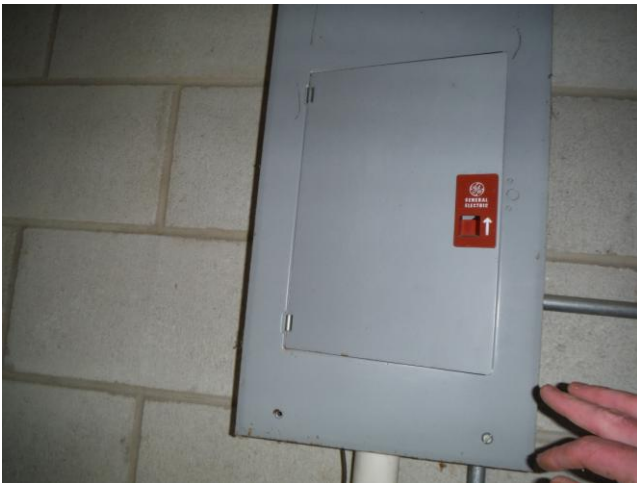
52) Provide-Recommend. Cost=Low.

The panel in the garage is not properly installed. The cover is not installed completely. For electrical and fire safety the panel cover needs to be properly installed by having screws fastened in ALL screw holes. There are insufficient screws currently installed.

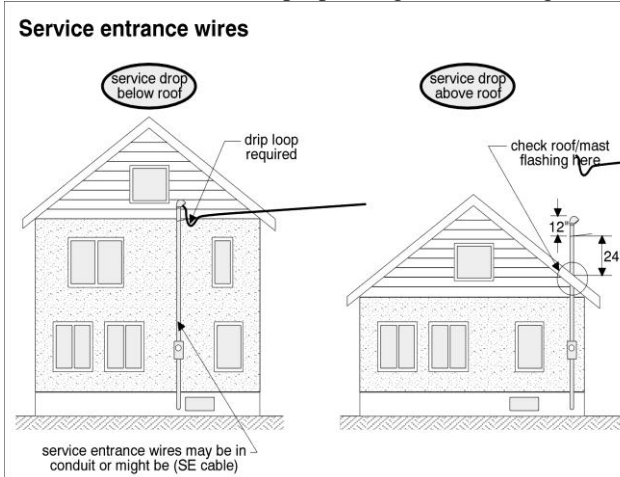
53) Repair-Recommend. Cost=Medium.

The wire from the garage to the shed does not have the required clearance above ground. A mast should be installed in order to elevate the wires to the proper height above the ground for electrical and fire safety.

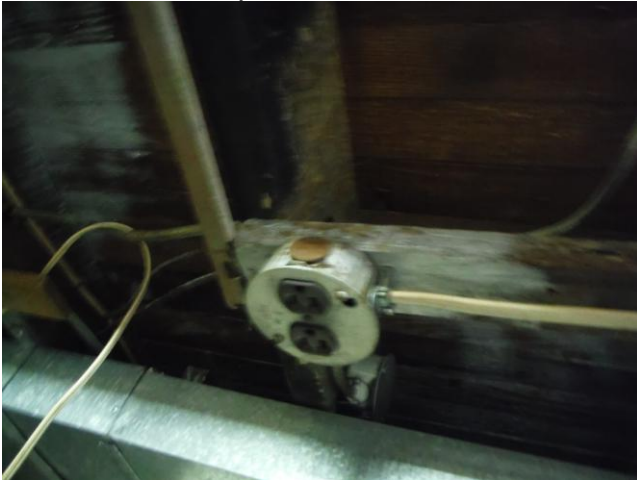
54) Repair-Recommend. Cost=Uncertain.

The junction box in the basement ceiling an opening that reveals the electrical wires. The opening should be sealed/covered for electrical/fire safety.

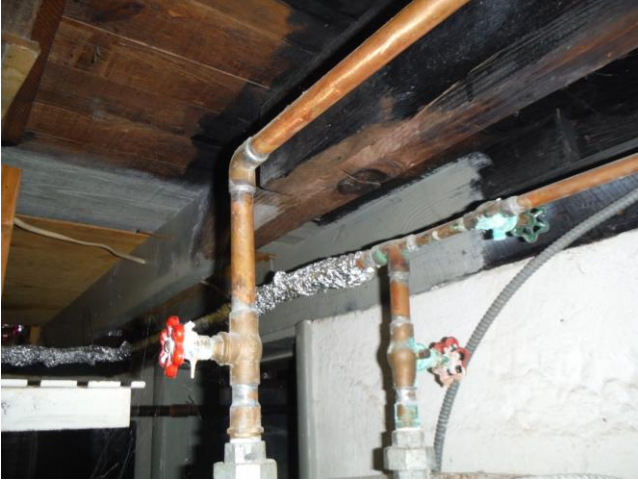
55) Provide-Recommend. Cost=Low.

A bonding jumper should be added to the water heater hot and cold water pipes in order to ensure a continuous path to ground in the event that the water pipes become energized. This is an electrical safety issue as the house does/may use water pipe grounding.

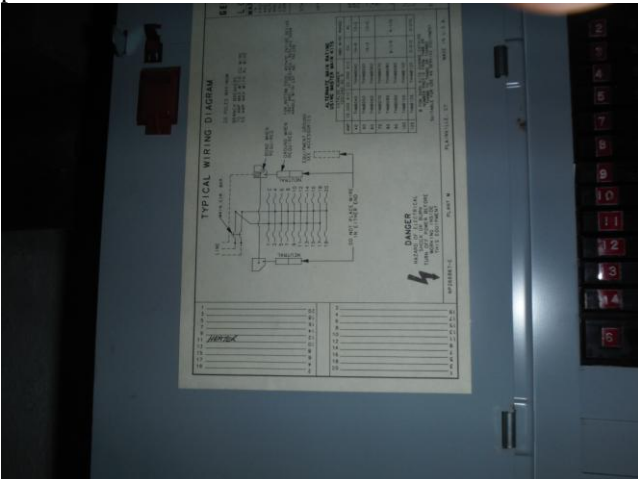
56) Provide-Recommend. Cost=Low.

The panel in the garage is not properly marked. For convenience and servicing EVERY breaker should be identified in the panel.

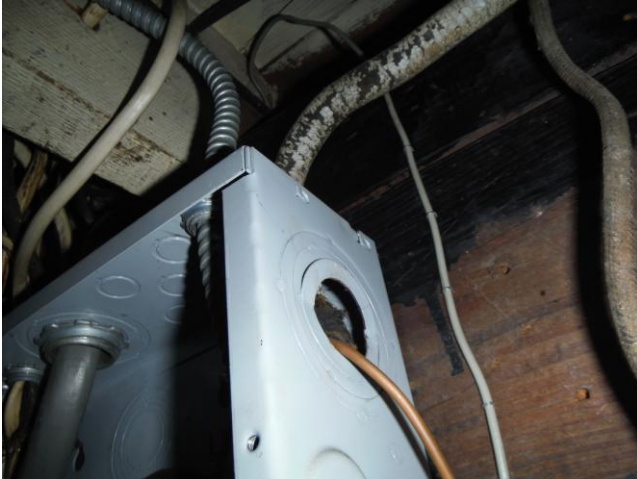
64) Repair-Recommend. Cost=Low.

The basement panel has an opening in its top that should be sealed for electrical safety.

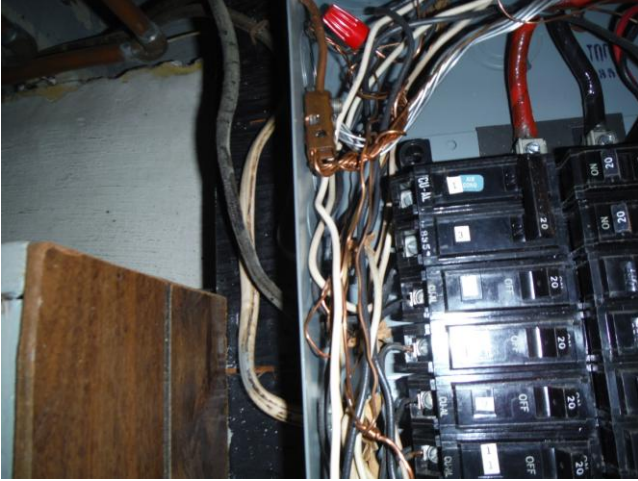
65) Repair-Recommend. Cost=Medium.

There are multiple wires installed in the panel in the basement that are poorly installed (jumbled) and may represent fire/safety issues. An electrician should be hired to ensure the panel is properly wired.

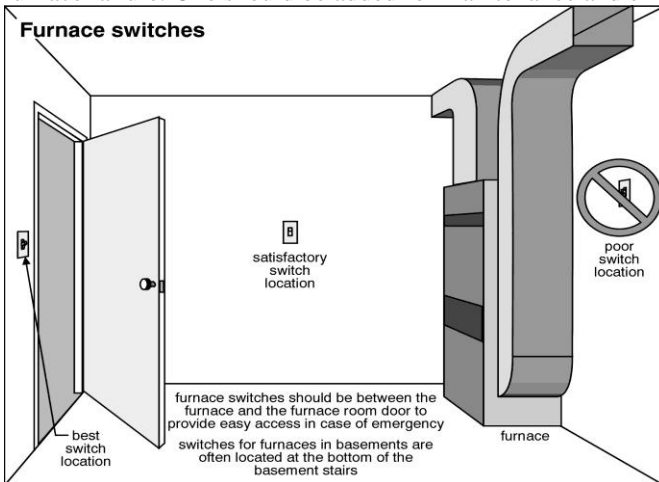
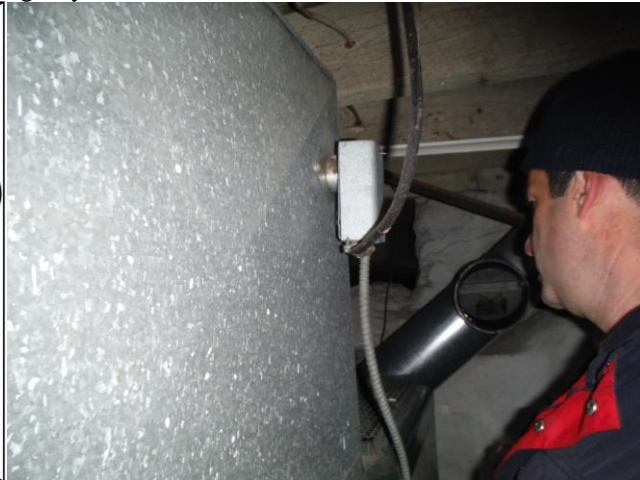
66) Provide-Recommend. Cost=Medium.

There is apparently no furnace emergency shut-off switch installed. It is required to shut off the furnace in the advent of a furnace failure. One should be added for maintenance and emergency situations.

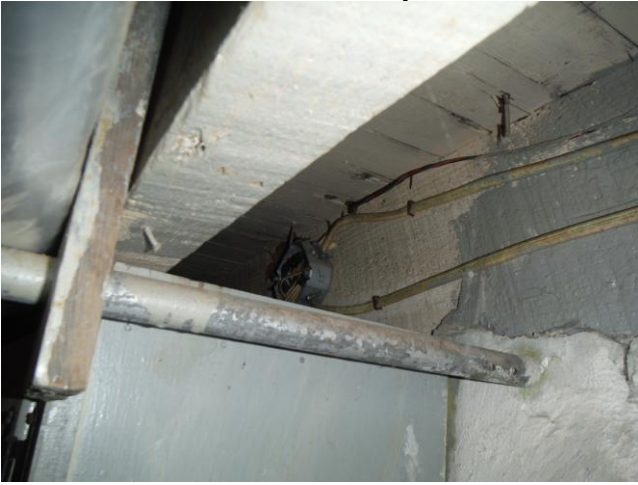
67) Repair-Recommend. Cost=Uncertain.

The junction box in the basement front wall an opening that reveals the electrical wires. The opening should be sealed/covered for electrical/fire safety.

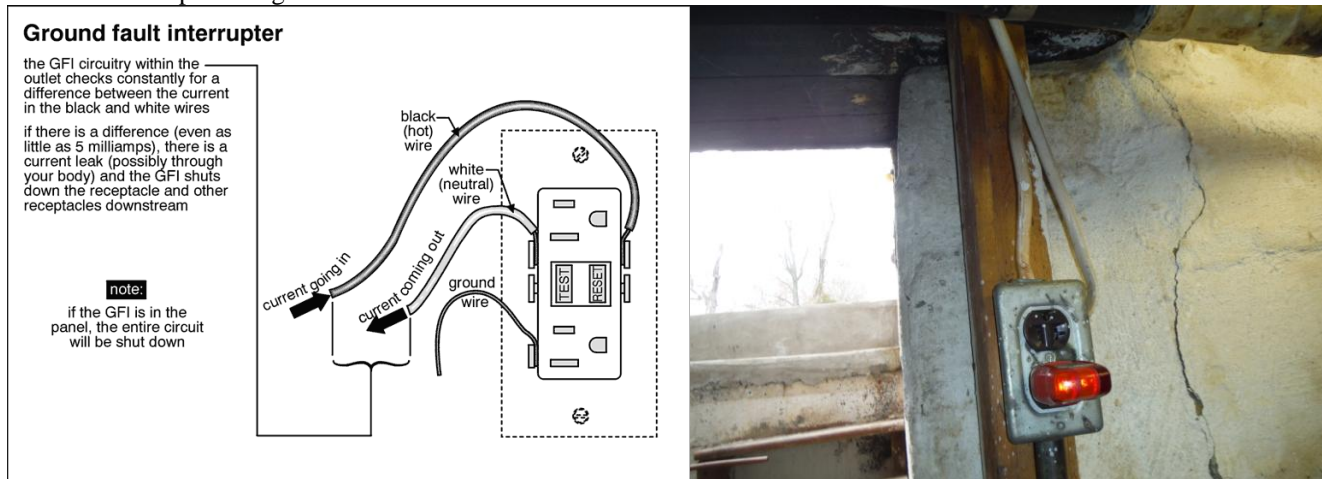
68) Replace-Recommend. Cost=Low.

The outlets in the unfinished basement should be replaced with GFCI outlets for electrical safety. All exterior, unfinished basement, crawl space outlets and outlets within 6' of a sink should be GFCI outlets or should be protected by upstream GFCI outlets to protect against electrocution/shocks.

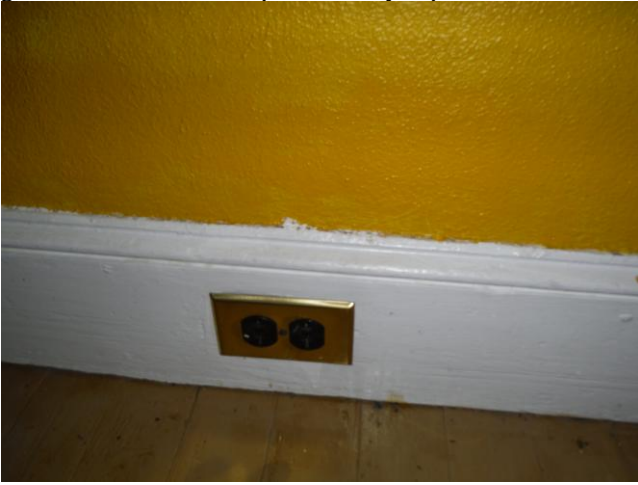
69) Monitor-Recommend.

The home was built with ungrounded outlets. Using “cheater plugs” that adapt these two prong outlets to modern 3 prong receptacles is not recommended for electrical/fire safety. The homeowners should be aware that properly converting these to grounded outlets can be prohibitively expensive.

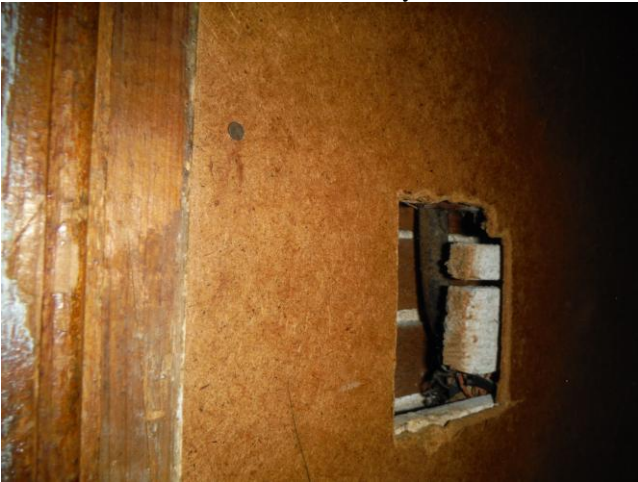
70) Repair-Recommend. Cost=Uncertain.

The junction box at the base of the attic stairs has an opening that reveals the electrical wires. The opening should be sealed/covered for electrical/fire safety.

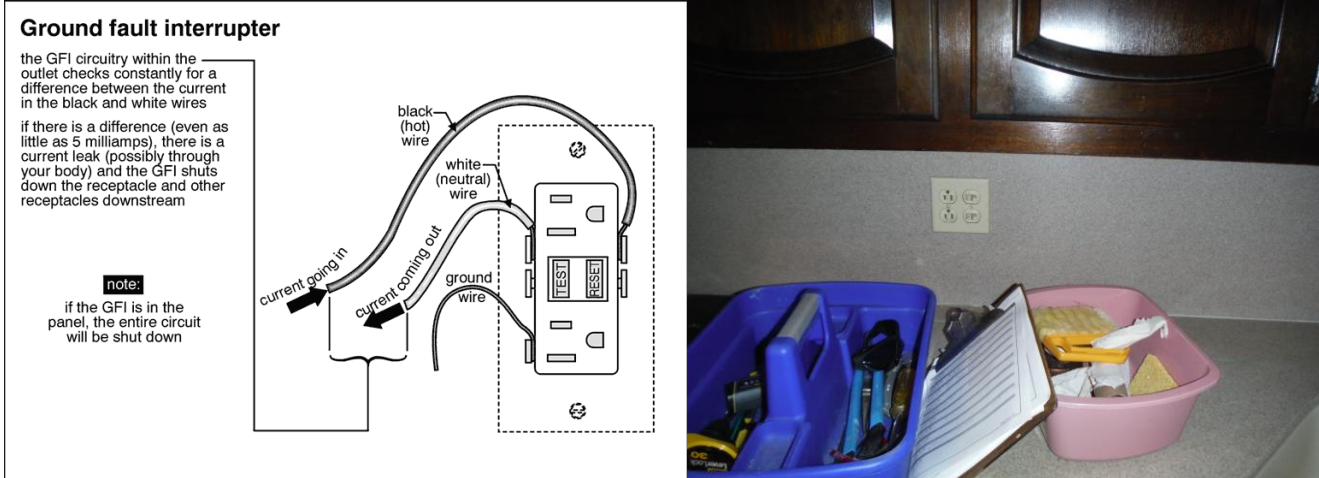
71) Replace-Recommend. Cost=Low.

The outlets next to the lower kitchen sink should be replaced with GFCI outlets for electrical safety. All exterior, unfinished basement, crawl space outlets and outlets within 6' of a sink should be GFCI outlets or should be protected by upstream GFCI outlets to protect against electrocution/shocks.

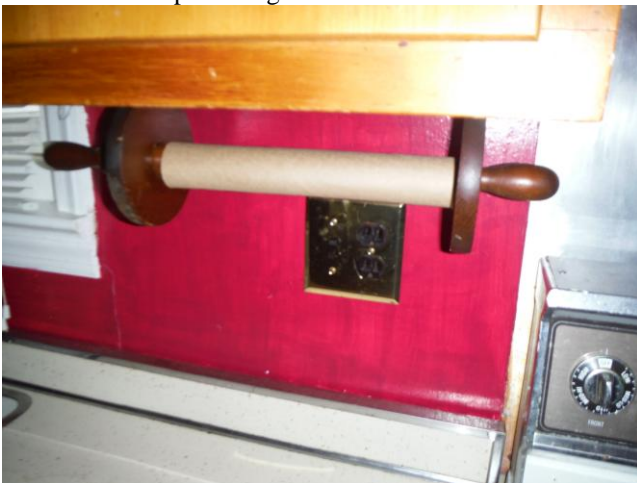
72) Replace-Recommend. Cost=Low.

The outlets next to the top kitchen sink should be replaced with GFCI outlets for electrical safety. All exterior, unfinished basement, crawl space outlets and outlets within 6' of a sink should be GFCI outlets or should be protected by upstream GFCI outlets to protect against electrocution/shocks.

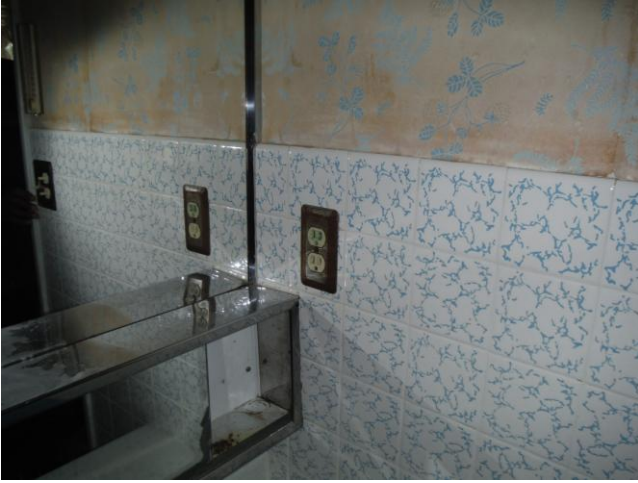
73) Replace-Recommend. Cost=Low.

The outlet in the bathroom should be replaced with a GFCI outlet for safety (protection from shock/electrocution). All exterior, garage, unfinished basement outlets or those next to a sink/water source should be GFCI outlets.

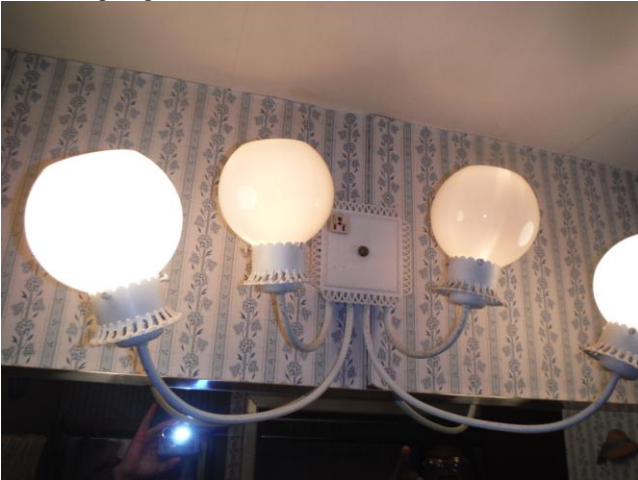
74) Replace-Recommend. Cost=Low.

The outlet in the hall bathroom should be replaced with a GFCI outlet for safety (protection from shock/electrocution). All exterior, garage, unfinished basement outlets or those next to a sink/water source should be GFCI protected.

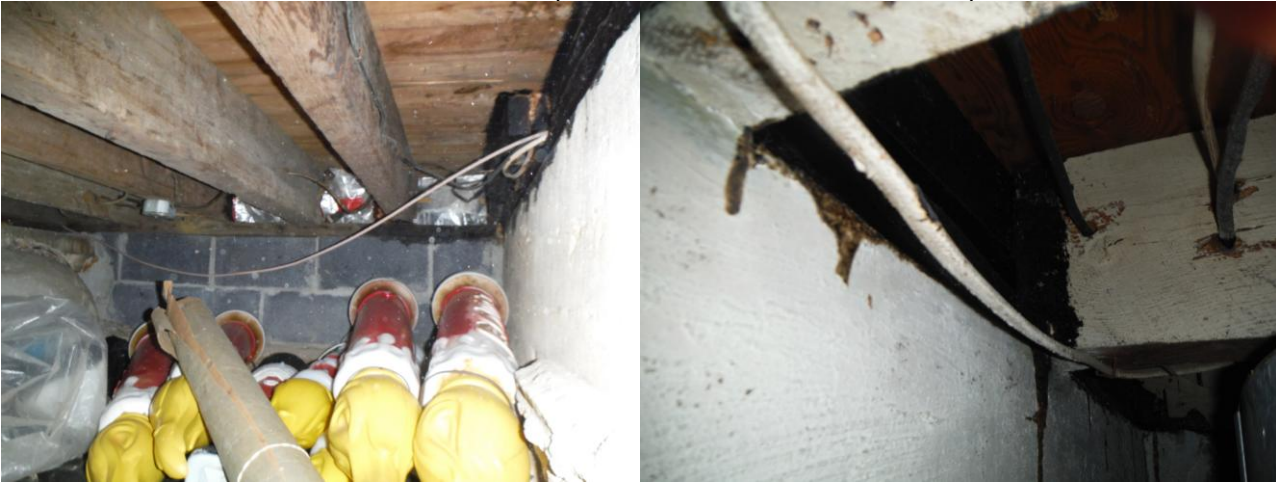
75) Repair-Recommend. Cost=Low/Medium.

There are multiple loose/unfastened wires in the crawl spaces (e.g. right/rear) and basement that need to be properly fastened and protected as they represent an electrical/fire hazard in its current state. All wires should be fastened with a minimum distance of 4.5'. An electrician should be hired to repair all such deficiencies in the crawl spaces and basement.

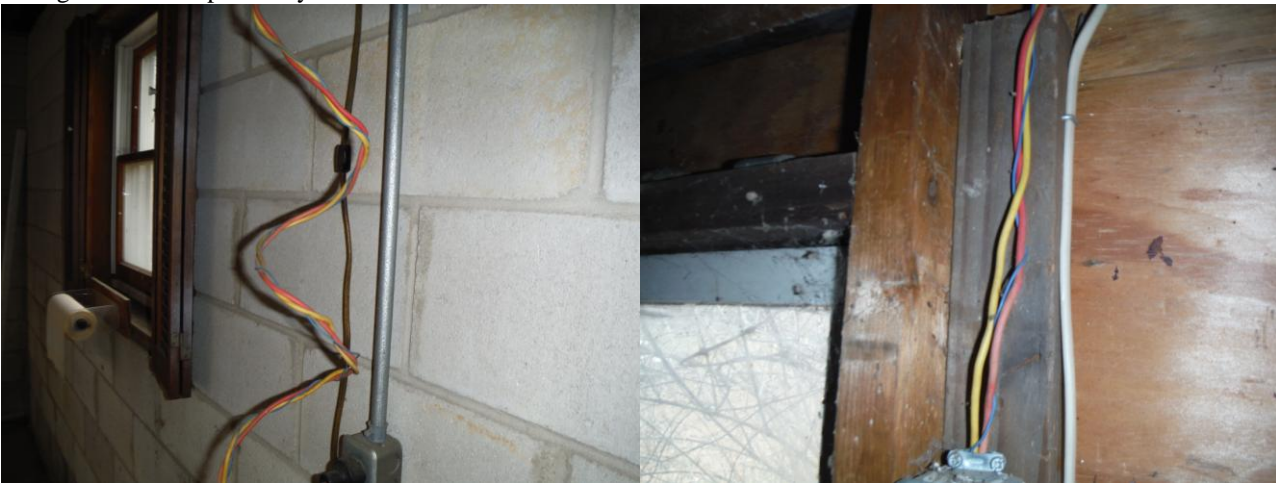
76) Replace-Recommend. Cost=Medium.

Unsheathed extension cord is used as permanent wiring from the garage to the rear shed. Extension cord is not suitable for use as permanent wiring as it can be damage from staples/fasteners and does not necessarily have the required ampacity of permanent NM wires. Therefore it is a fire/electrical safety issue. All such instances of extension cord installed as permanent wiring should be replaced by an electrician.

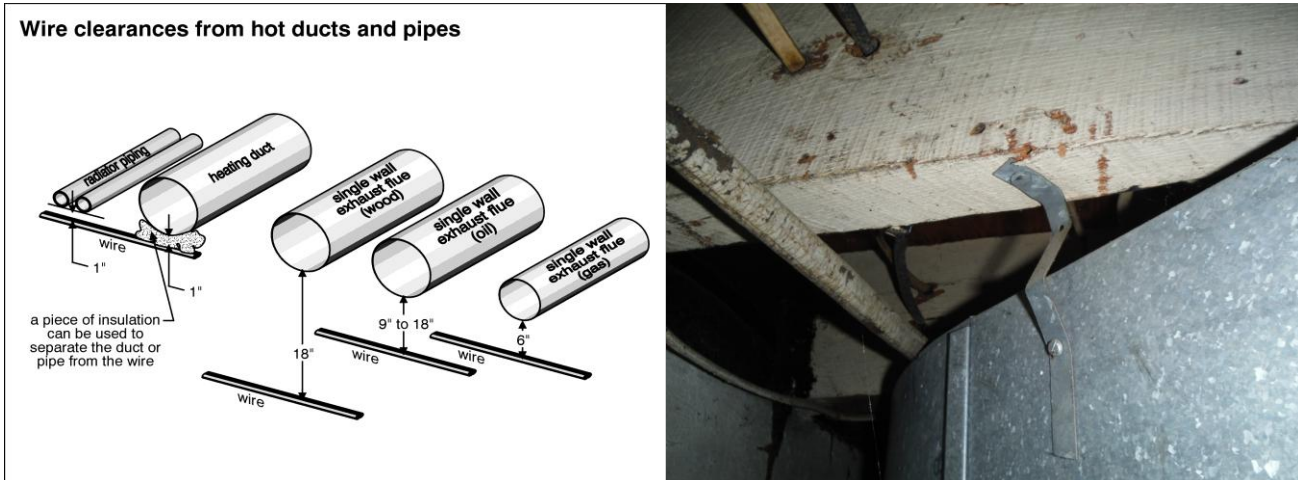
77) Repair-Recommend. Cost=Low.

The NM wires in the basement are in contact with the supply ducts. They should be separated in order to prevent fires and damage to the plastic sheathing which can results in electrical issues and fires.

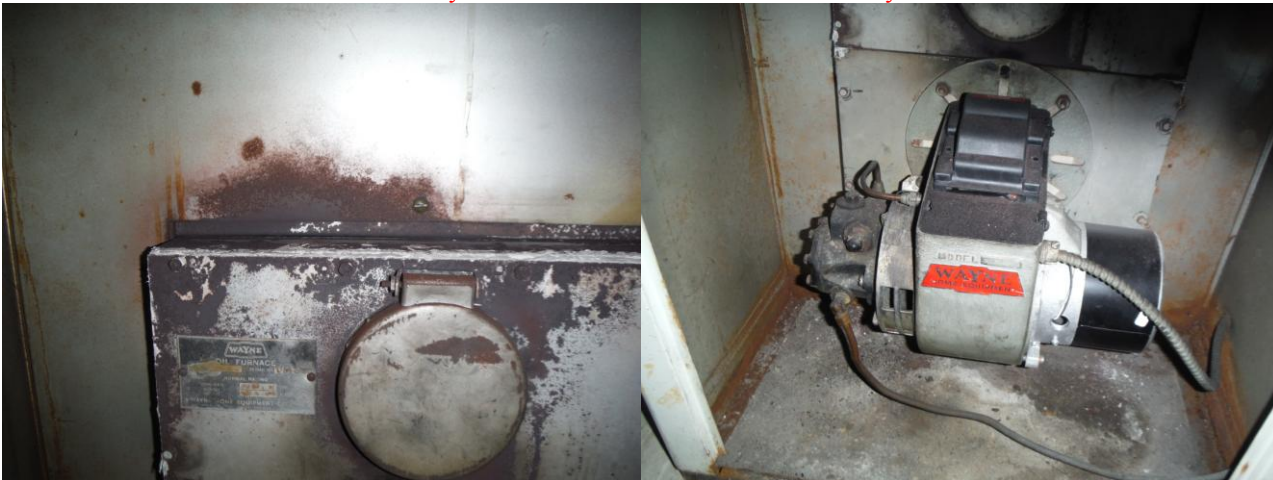
78) Further Investigation Required-Priority. Cost=Uncertain.

The oil furnace is the past its expected lifespan. It should be verified the heat exchanger is not cracked which can be a health/safety issue. There is evidence of rust/spillage which may indicate a flow/back-draft issue which should be further investigated by the HVAC technician. If the heat exchanger is rusted through then there will be carbon monoxide being emitted into the home which is a life safety issue. Also homeowner's insurance may be an obstacle with a furnace of this age.

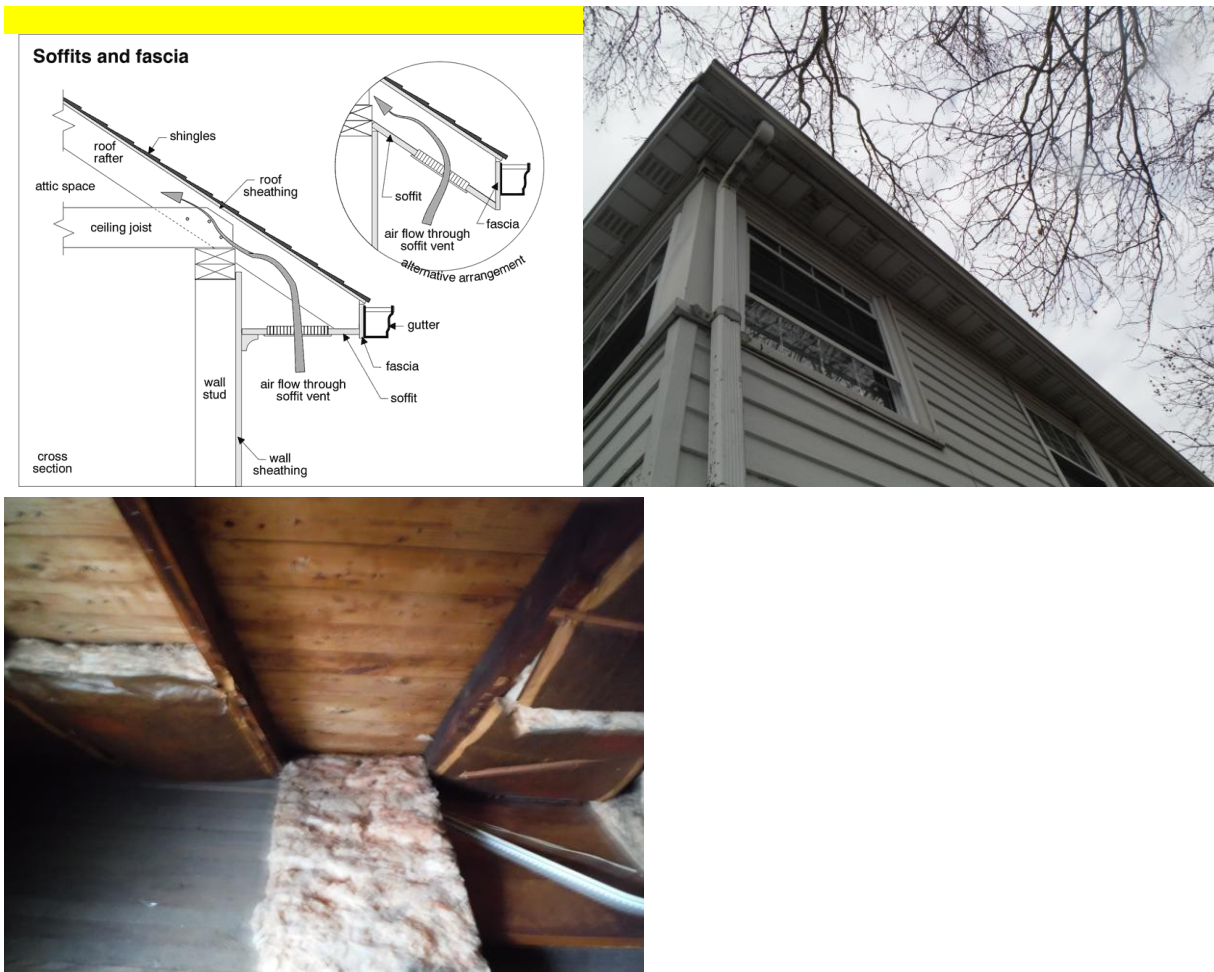
79) Repair-Recommend. Cost=Medium.

It appears that the soffit vents paths are blocked by insulation in the main attic. They should be cleared of insulation and/or have baffles added so that proper attic air flow is allowed for ventilation in order to prevent wood rot, mold and ice damming issues.

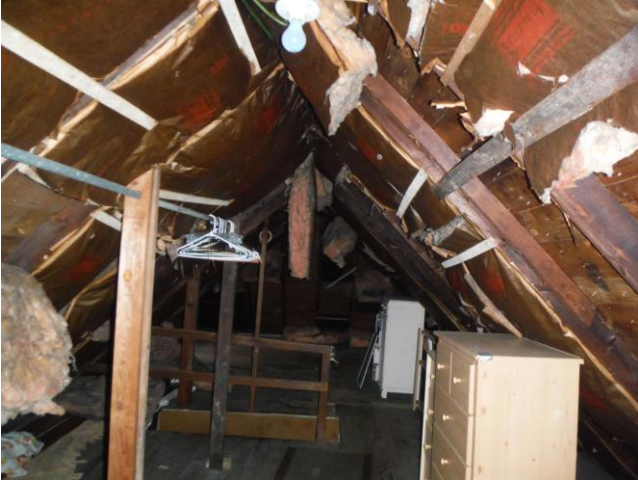
80) Provide-Recommend. Cost=Medium.

The attic does not have an adequate method of ventilation. Without proper attic ventilation wood rot and mold issues can become prevalent in the attic envelope. Minor mildew is visible on the roof rafters where accessible. It is recommended to add proper ventilation for the attic. A ventilation specialist should be consulted to ensure proper ventilation is provided. Otherwise mildew/mold/fungi will form and deterioration (wood, insulation, etc.) can be expected).

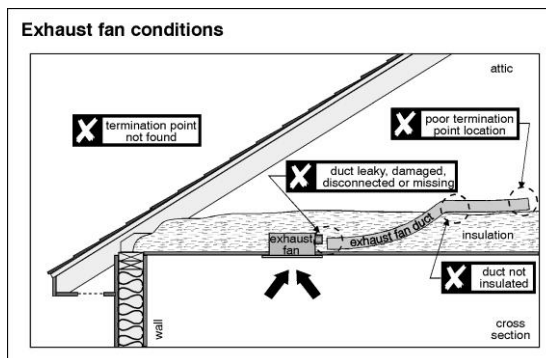
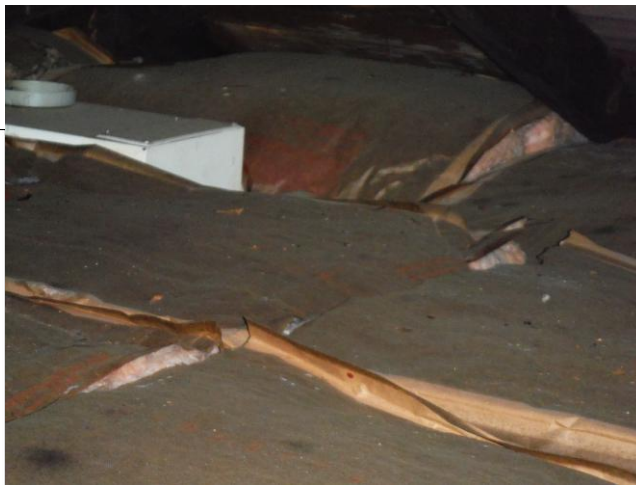
81) Repair-Recommend. Cost=Medium.

The top bathroom ventilation fan discharges to the attic. This causes excess moisture to be added to the attic space which can cause mold and wood rot issues. It should be ducted to the exterior.

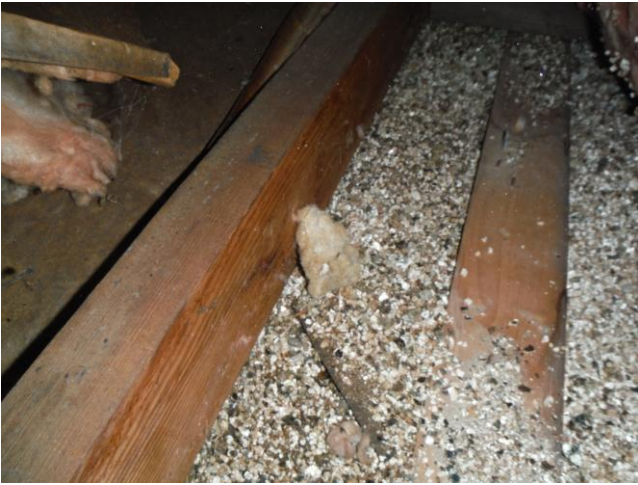
82) Further Investigation Required-Recommend.

It appears there is vermiculite insulation installed in the attic floor. Vermiculite was installed in some homes between 1920 – and 1990: It contained asbestos fibers in both attic insulation and gas fireplace materials. Most came from a mine in Libby Montana which was contaminated with asbestos. A particular product name was Zonolite. It should not be disturbed which can loosen the friable asbestos fibers. The EPA recommends to not disturb this material and do not remove yourself and to not store boxes in attics with vermiculite.

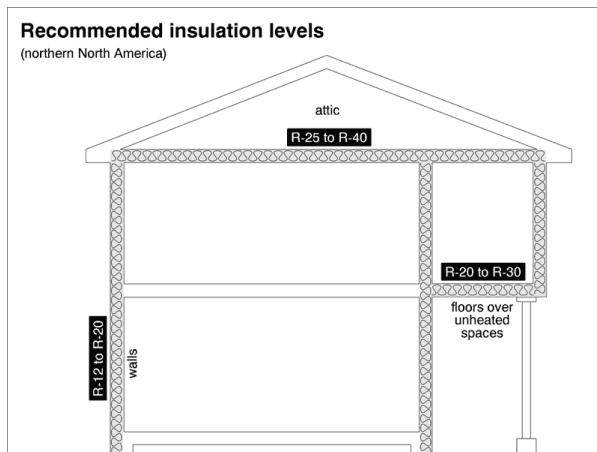
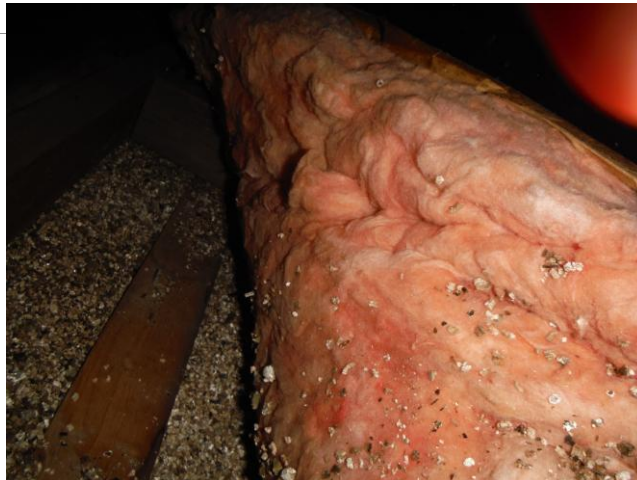
83) Improve-Recommend. Cost=Medium.

It appears the attic only has about 4" of fiberglass insulation. There is insufficient insulation depth on the floor in this area according to modern construction codes. Insulation that provides R-30+ capacity should be provided in order to prevent conditioned air loss and the formation of ice dams which can cause roof and interior damage. Also, poor insulation levels in the attic can cause mold issues and wood rot in the attic area.

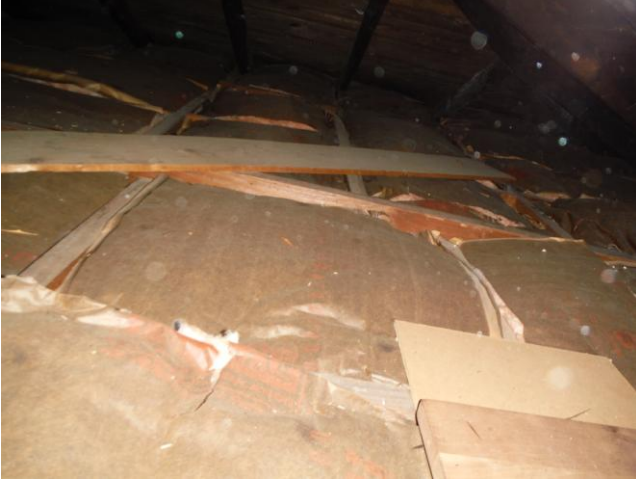
84) Repair-Recommend. Cost=Low/Medium.

The insulation in the attic is installed backwards. The Kraft paper (class 2 vapor retarder) should face down toward the heated rooms below to prevent the trapping of condensation between the Kraft paper and the wall sheathing. This can cause wood rot and mold issues. The insulation should be inverted to the proper orientation.

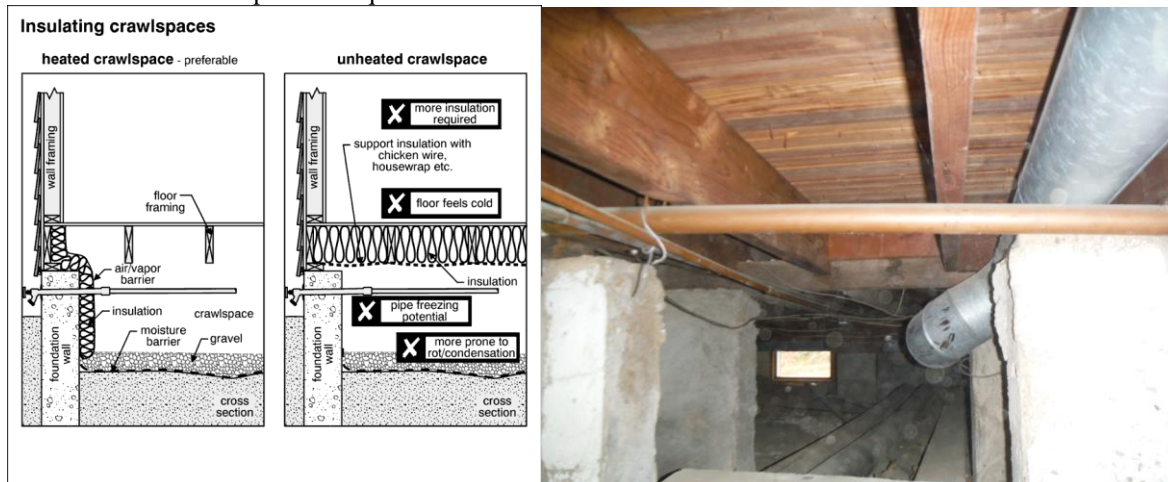
85) Repair-Recommend. Cost=Low.

The crawl space does not have an adequate number (or location) of wall vents. Therefore it is recommended to maintain (keep open) the opening between the basement and the crawl space in order to be able to ventilate the crawl space and to keep mold and fungi/rot from forming. If the opening is to be sealed (e.g. with an access door) then additional wall vent(s) should be installed in order to provide required cross-ventilation.

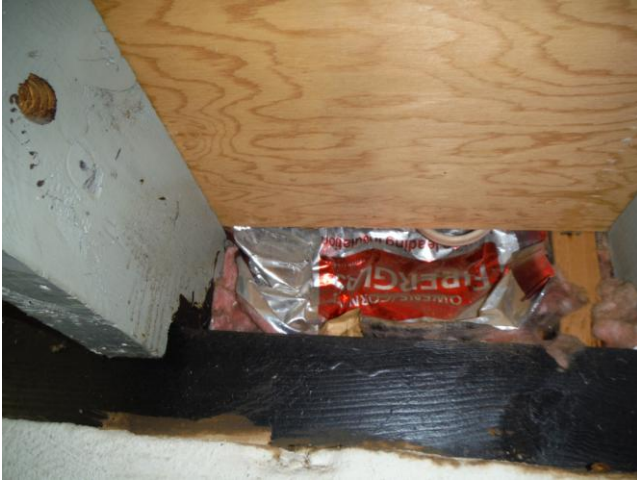
86) Provide-Recommend. Cost=Medium.

Atypical for a house of this age the house was built according to balloon framing methods and not of platform framing techniques present in modern construction. With balloon framing the walls were built first then the floors were added. In platform framing the floors are built first and walls added after. One drawback of balloon framing is that the areas between the wall studs can serve as a chase for the spread of fires. Therefore the open bays between the basement joists at the basement ceiling level should be fire-blocked to prevent the spread of fires to/from the upper floors to the basement.

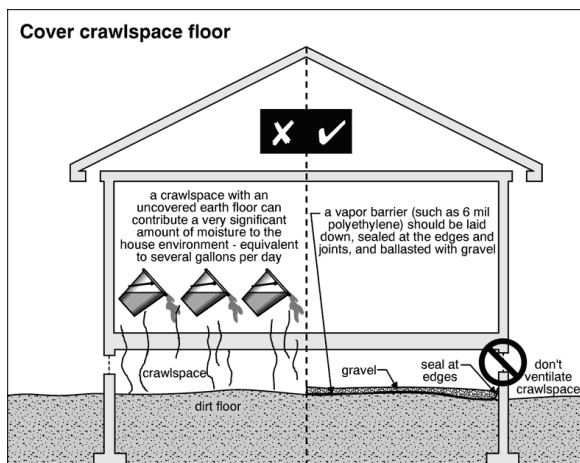
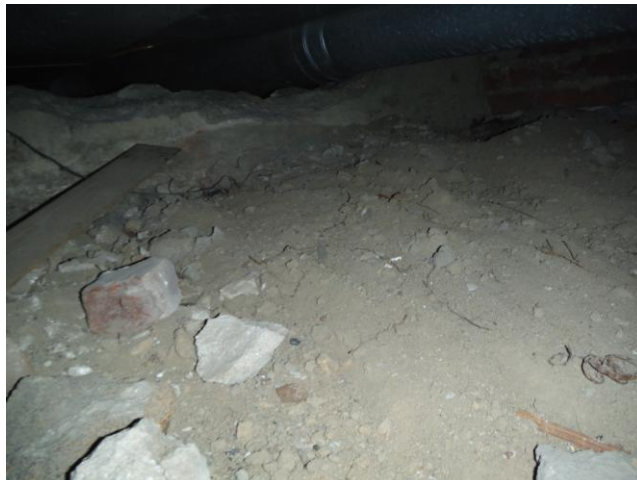
87) Repair-Recommend. Cost=Low/Medium.

The crawl space floors should be fully and continuously covered with a moisture barrier (e.g. 6 mil polyethylene or equivalent) to prevent the allowance of moisture to the crawl space. Otherwise wood rot, mold issues and potential structural issues can arise.

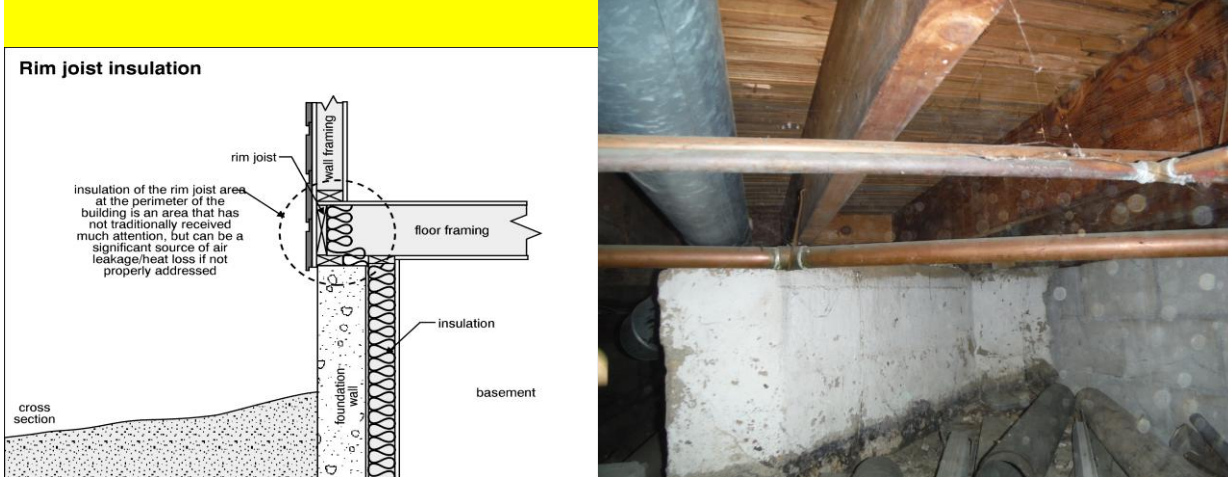
88) Provide-Recommend. Cost=Medium.

Insulation should be added to the basement and crawl space rim joists for heating efficiencies. It should be made continuous in order to provide an efficient insulation barrier to keep energy costs lower and to prevent the allowance of damaging condensation/mildew/mold into the home.

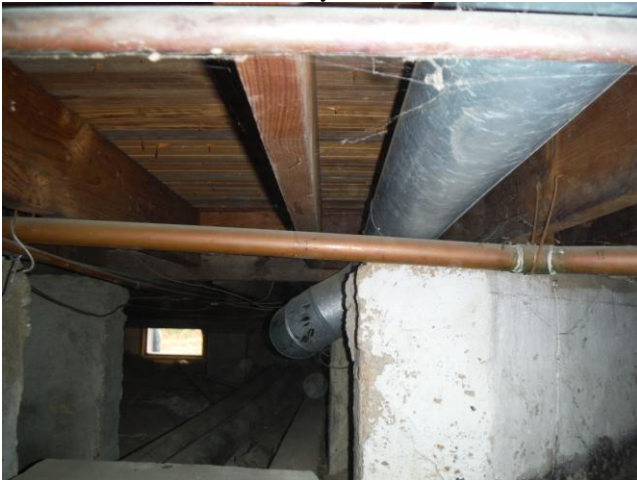
89) Further Investigation Required-Recommend.

The crawl spaces are not FULLY accessible due to height restrictions. There is a high potential for wood rot and/or mold issues in the crawl space. Also termite infestation is probable. It is recommended that proper ventilation be verified prior to closing. Evidence of mildew/mold/rot would indicate a lack of ventilation. There are insufficient wall vents present that would indicate it is sufficiently ventilated.
