Building Inspection Report

Any Street

Saturday, November 29, 2014

South Jersey Home Inspection, LLC

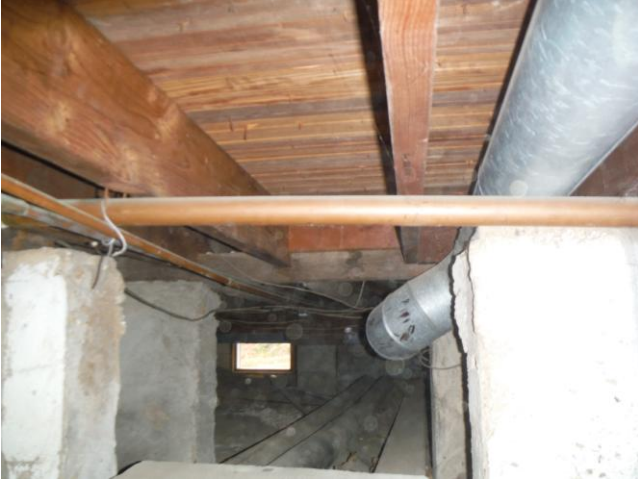
90) Provide-Recommend. Cost=Medium/High.

The crawl space is un-insulated. Insulation should be provided in order to prevent mildew/mold and even structural damage from condensation, etc.

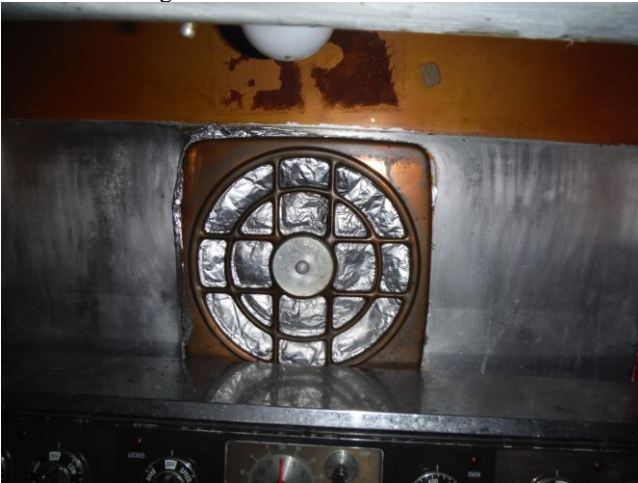
91) Repair-Recommend. Cost=Low/Medium.

The ventilation fan over the top kitchen stove does not function as it is blocked. It should be repaired in order to minimize or remove cooking fumes/smoke and odors.

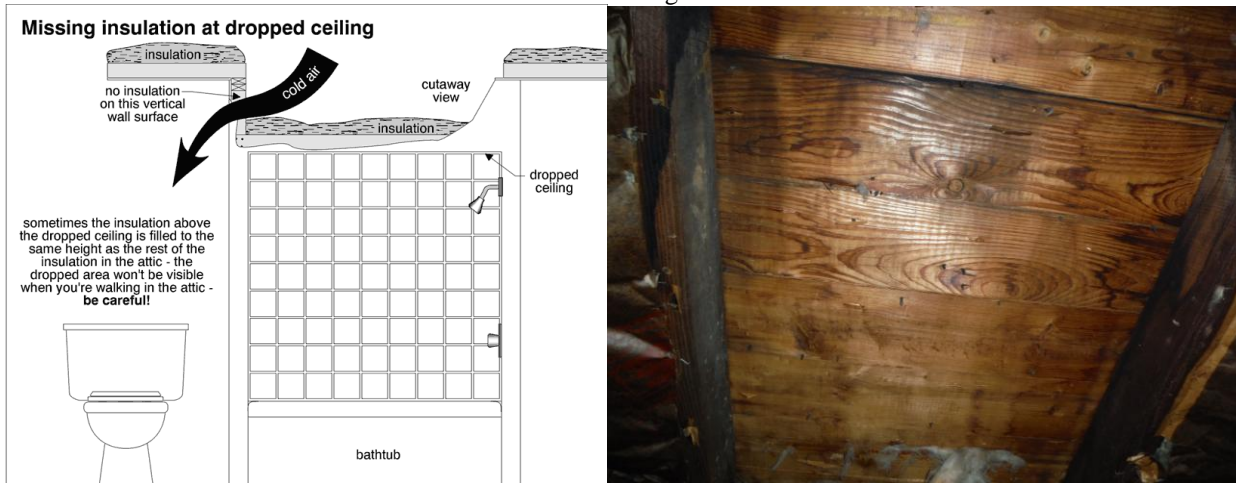
93) Repair-Recommend. Cost=Low.

There are several sections of roof sheathing walls in the attic/knee walls whereby the insulation has fallen off of the slopes. Continuous insulation should be provided in order to insulate/seal the surface in order to prevent conditioned air loss and the formation of ice dams which can cause roof and interior damage and mold issues.

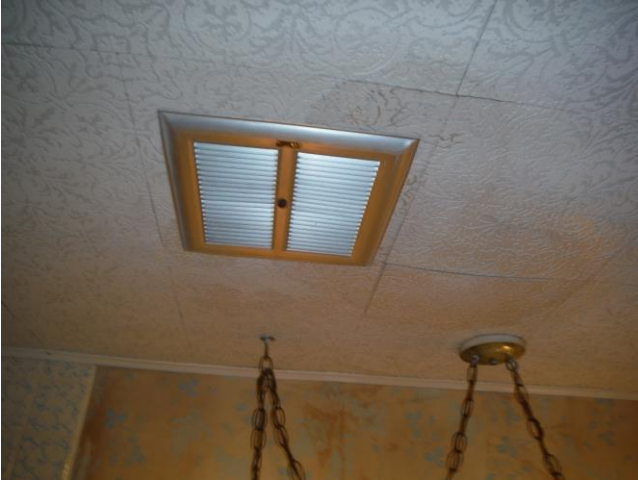
94) Further Investigation Required-Recommend.

It should be verified that the lower left/rear bathroom ventilation fans discharge to the exterior. Otherwise they will emit damaging moisture to the wall spaces which can cause structural damage and/or mildew/mold issues.

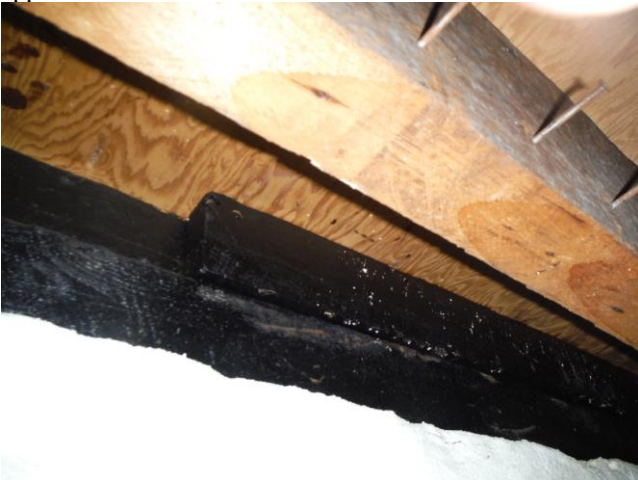
95) Further Investigation Required-Recommend.

It appears an anti-microbial treatment (or equivalent, black “goop”) may have been applied in an effort to contain mildew/mold in the basement (rim joists, joists, etc.). The seller should be asked as to the purpose/details regarding the application of this material. It is uncertain if this condition will return.

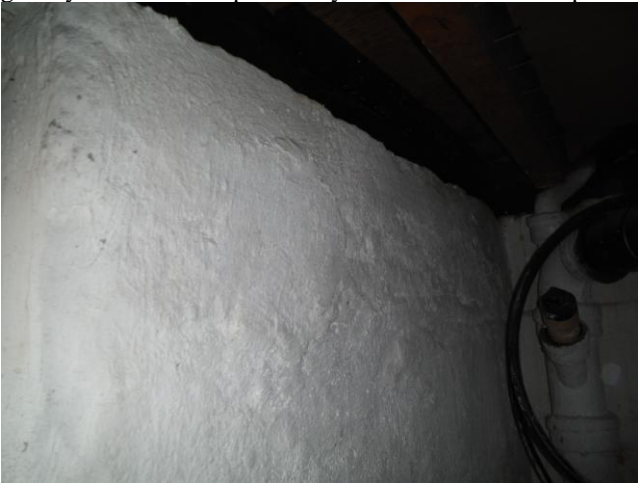
96) Provide-Recommend. Cost=Medium.

There is no visible dryer exhaust through the home's exterior. One should be provided so the residents can safely operate a gas dryer without the possibility of carbon monoxide poisoning.

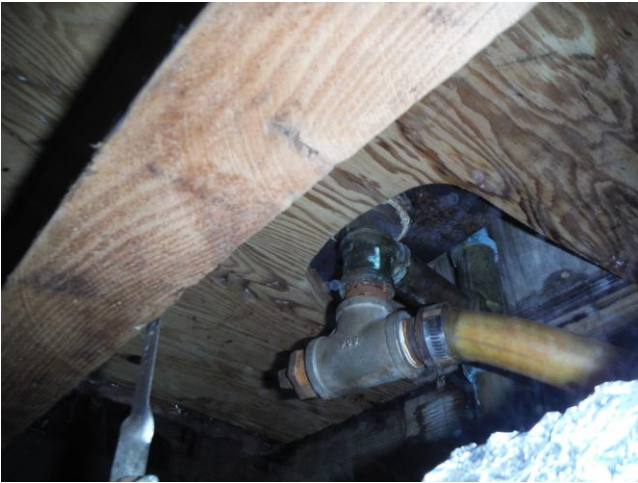
97) Repair-Priority. Cost=Low.

When the water was run to the lower rear bathroom a leak formed below this bathroom which was visible in the basement below. A licensed plumber should be hired to locate and repair the leak before the bathroom is used. Mildew/mold may be hidden on the non-visible wall surfaces, etc.

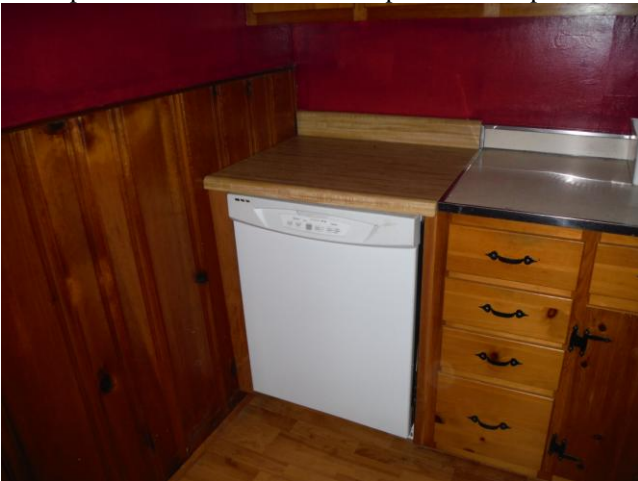
98) Further Investigation Required-Recommend.

The top dishwasher could not be inspected as the power was off to this floor..

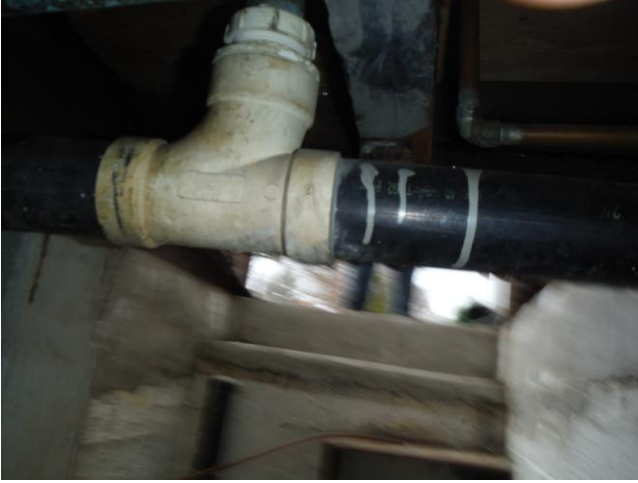
99) Monitor-Recommend.

In the basement the DWV piping is composed of interconnected PVC and ABS piping. These two materials are generally not compatible to be connected according to some building science experts and authorities. The joints are susceptible to leak between the two disparate fittings. The joints should be diligently monitored for leakage.

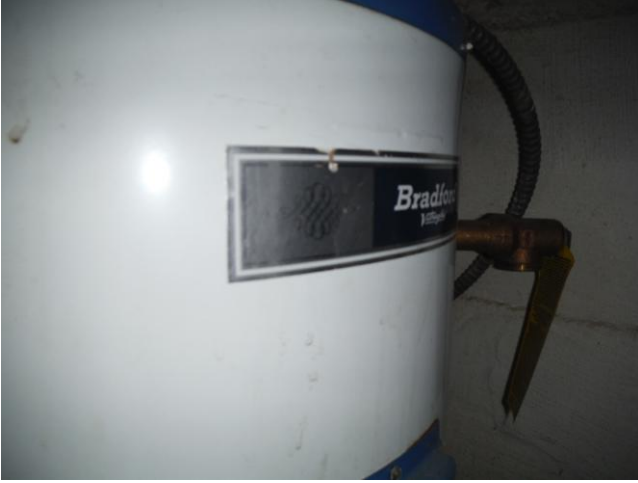
101) Monitor-Recommend:

The water heater may be at/near the end of its expected lifespan. There is evidence of minor rusting at the interior base which may indicate a minor leak. It should be diligently monitored for future/expanding leaks and replaced when they occur. It does not need to be replaced at this time but budgeting should begin for water heater replacement.

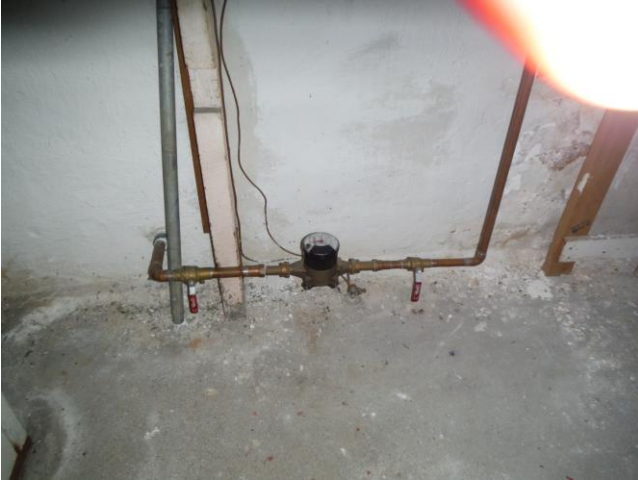
102) Further Investigation Required-Recommend.

It appears a public water source is installed in the basement but is not connected to the home's water supply. The home is currently being served by well water only.

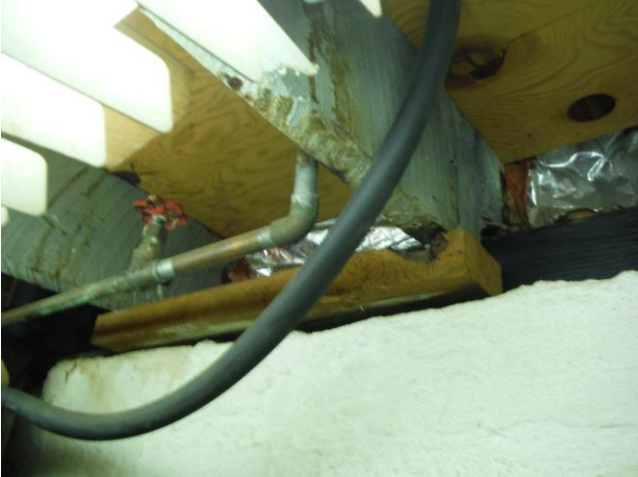
103) Replace-Recommend. Cost=Medium.

The dishwasher drain is composed of flexible pipe through the floor to the basement. The flex pipe should be replaced with hard-walled piping to prevent clogging. Also a trap needs to be installed to prevent dangerous sewer gases from entering the home. A licensed plumber should be hired to repair the dishwasher piping.

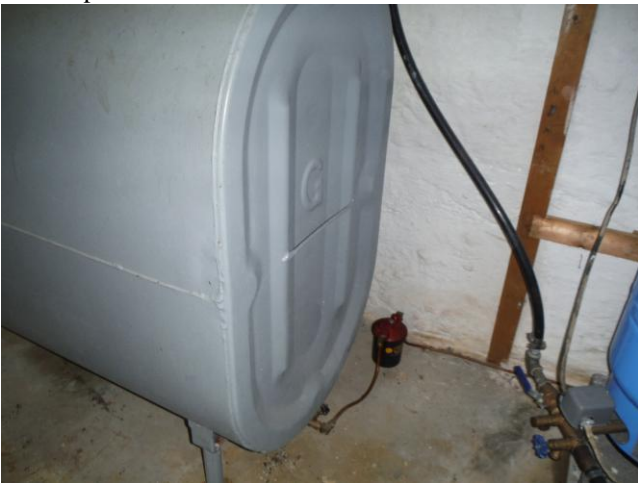
104) Further Investigation Required-Recommend.

Due to the age of the home it should be confirmed that there are no abandoned oil tanks on the property which can become a catastrophic cost to the homeowner if environmental contamination is an issue.

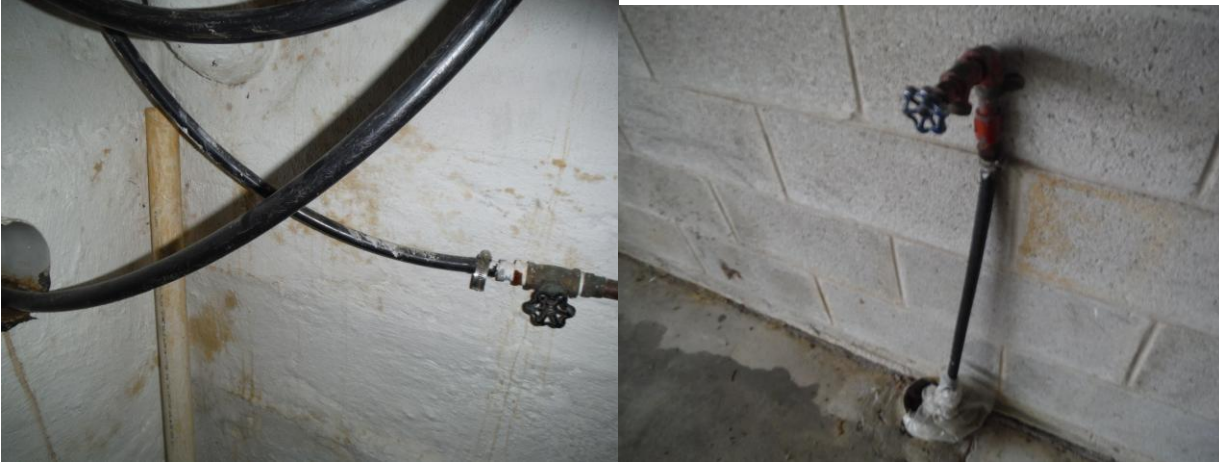
105) Monitor-Recommend.

The supply piping to the detached garage is susceptible to freezing as there are no heating appliances installed in these areas. This piping is also composed of non-recommended flexible plastic material which may be susceptible to leakage/breakage. It was off during the inspection.

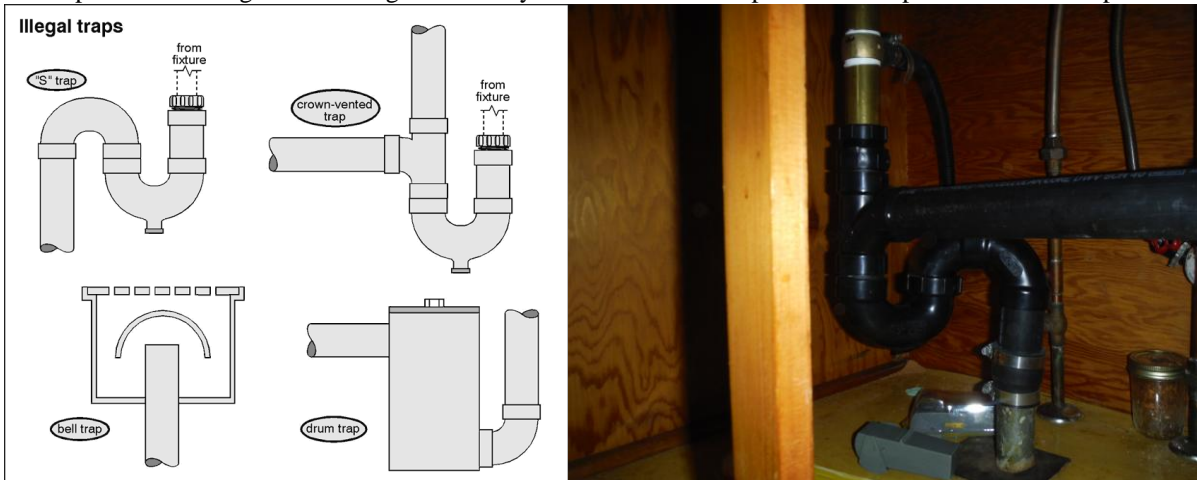
106) Replace-Recommend. Cost=Low.

The top unit kitchen sink drain trap should be replaced in order to allow proper drainage and to prevent dangerous sewer gases from entering the home. The S-trap which serves the sink can suffer from self-siphoning which leave the trap dry which permits the dangerous sewer gases to entry the home. The S-trap should be replaced with a P-trap.

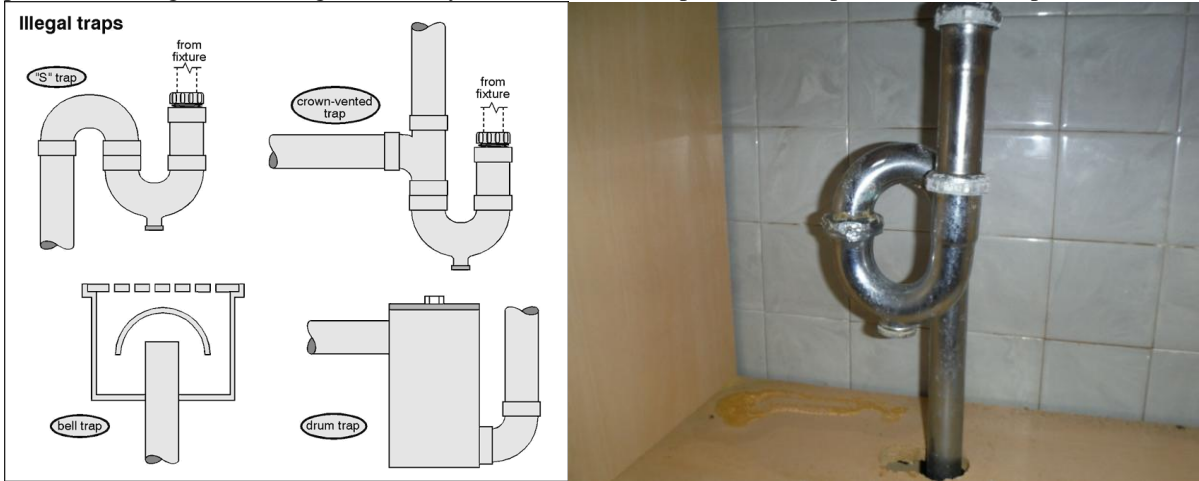
107) Replace-Recommend. Cost=Low.

The top bathroom sink drain trap should be replaced in order to allow proper drainage and to prevent dangerous sewer gases from entering the home. The S-trap which serves the sink can suffer from self-siphoning which leave the trap dry which permits the dangerous sewer gases to enter the home. The S-trap should be replaced with a P-trap.

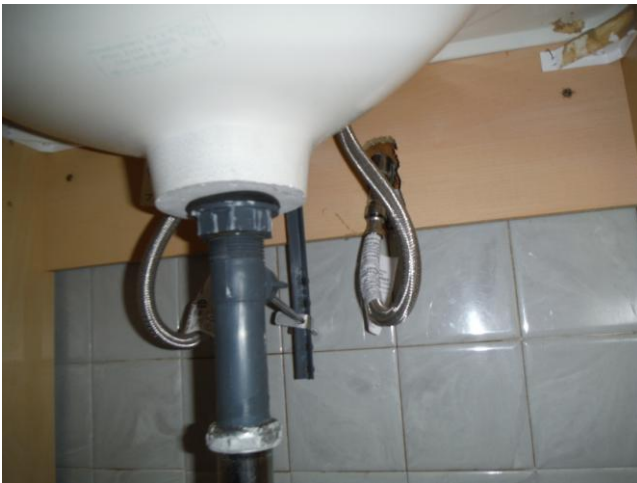
108) Provide-Recommend. Cost=Low.

The top bathroom sink shut-off valves are missing. They should be installed so that the water can be turned off for emergencies and maintenance.

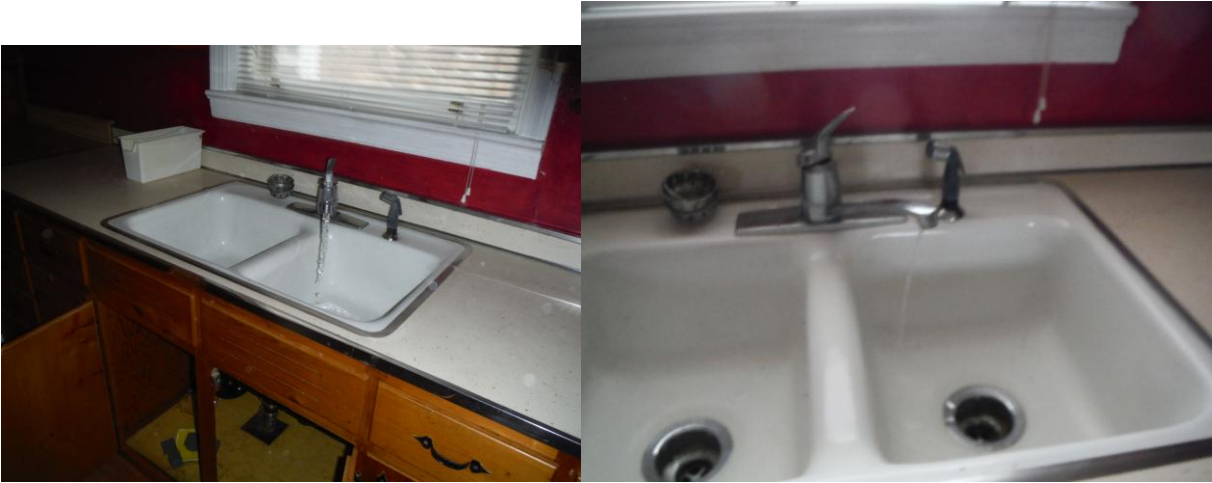
109) Further Investigation Required-Recommend.

Considerable water hammer was noticeable when the supply water was run through the fixtures on the top floor. A licensed plumber should determine the cause and mitigation for the water hammer so that supply piping does not form damaging leaks because of it.

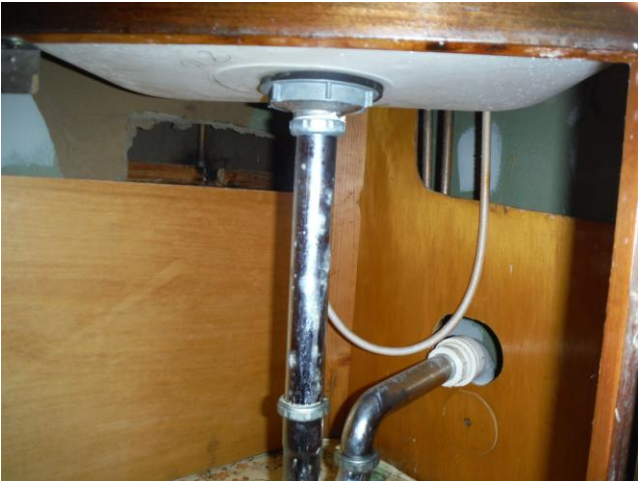
110) Provide-Recommend. Cost=Low.

The top kitchen sink shut-off valves are missing. They should be installed so that the water can be turned off for emergencies and maintenance.

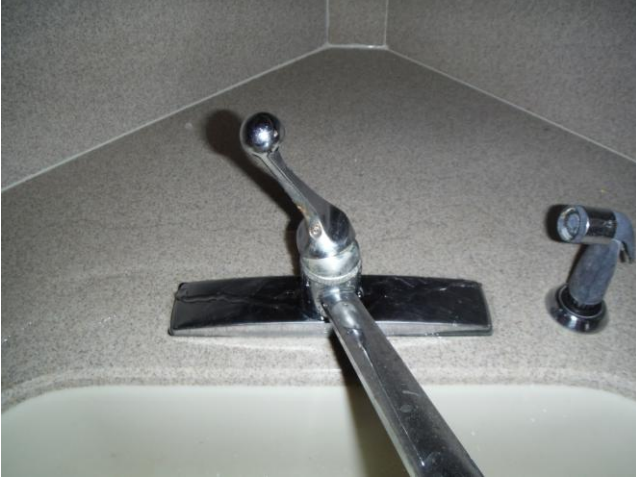
111) Repair-Recommend. Cost=Low.

The lower kitchen sink faucet has a leak/drip that should be repaired.

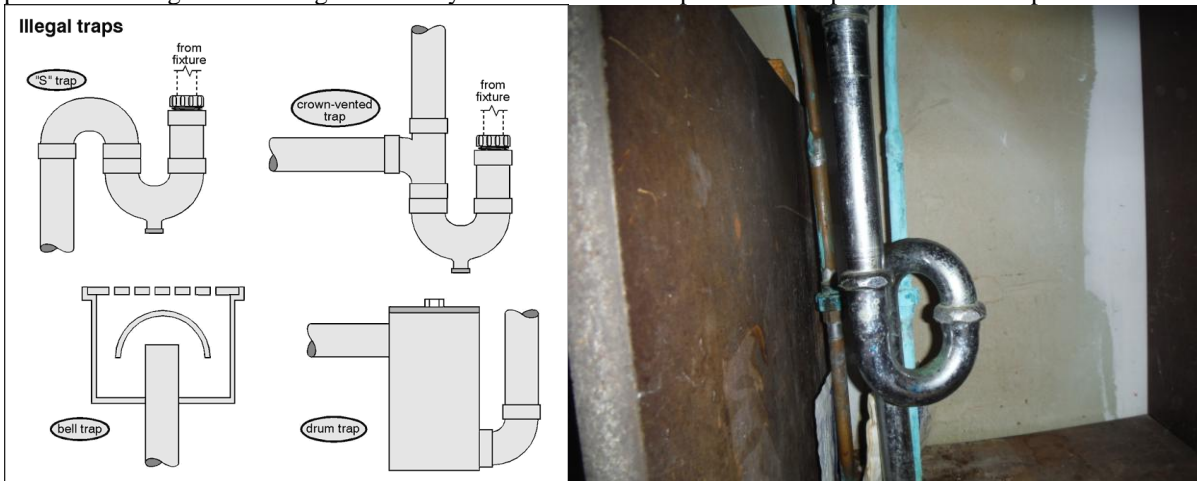
112) Replace-Recommend. Cost=Low.

The lower kitchen sink drain trap should be replaced in order to allow proper drainage and to prevent dangerous sewer gases from entering the home. The S-trap which serves the sink can suffer from self-siphoning which leave the trap dry which permits the dangerous sewer gases to entry the home. The S-trap should be replaced with a P-trap.

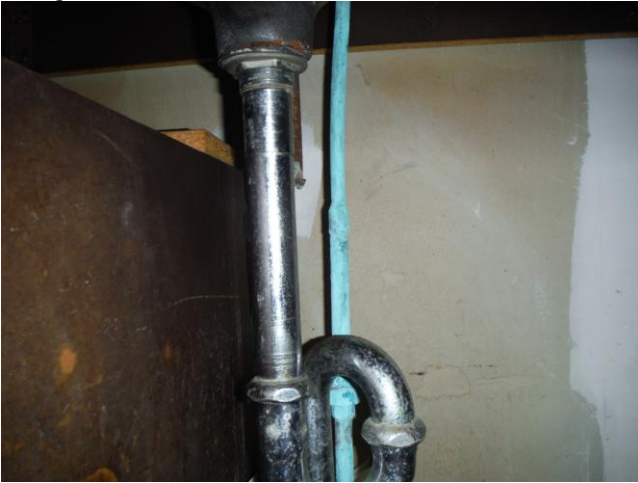
113) Provide-Recommend. Cost=Low.

The lower kitchen sink shut-off valves are missing. They should be installed so that the water can be turned off for emergencies and maintenance.

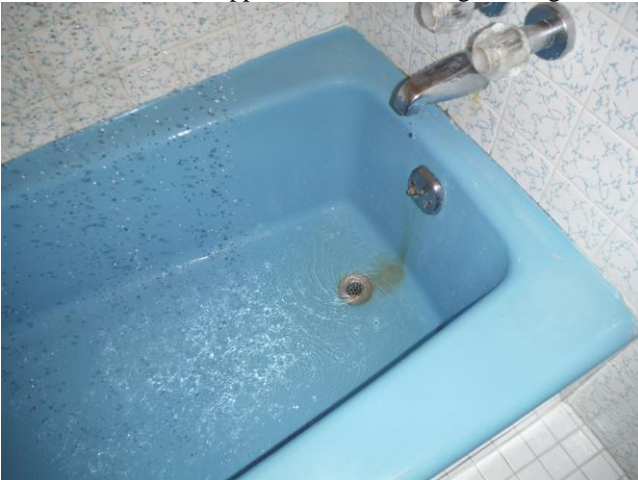
114) Repair-Discretionary. Cost=Low.

The bathroom tub stopper is not functioning/missing. It should be repaired/replaced if the homeowners wish to use it.

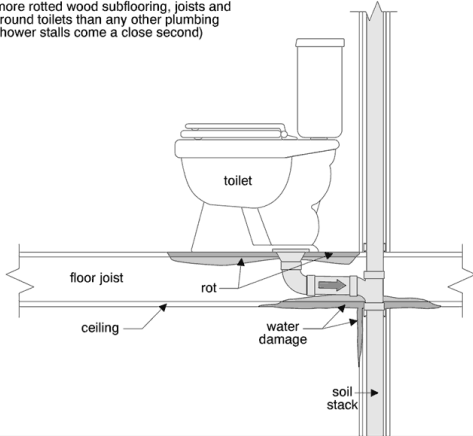
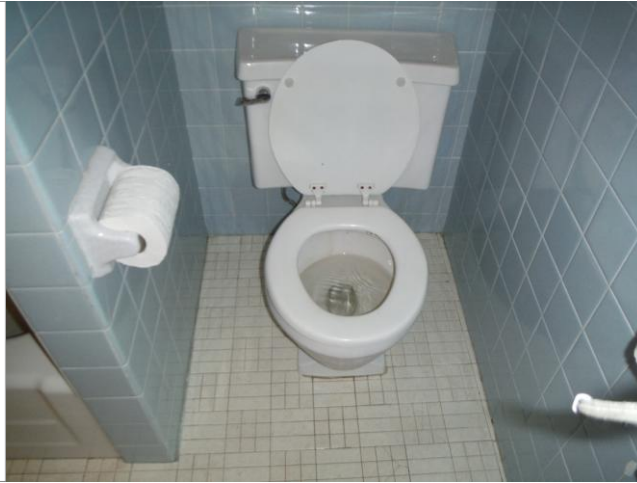
115) Repair-Recommend. Cost=Low.

The front hall bathroom toilet is loose and should be re-set with a new wax ring and/or floor flange to prevent further subfloor and floor damage from leaking water.

Rot around plumbing fixtures

we find more rotted wood subflooring, joists and beams around toilets than any other plumbing fixture (shower stalls come a close second)

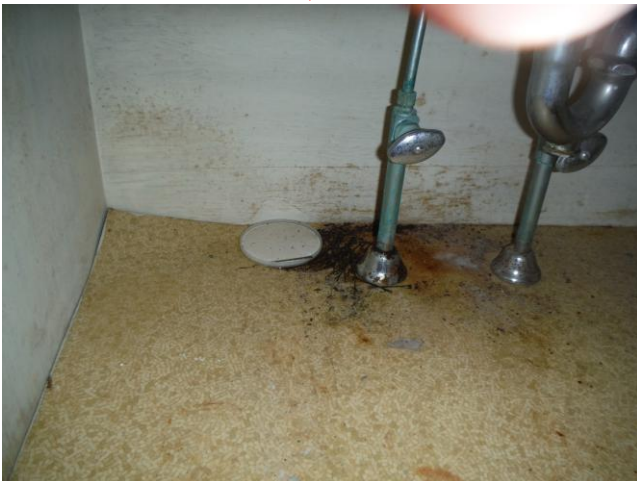
116) Repair-Priority. Cost=Low.

When the water was run to the front hall bathroom a leak formed below this bathroom which was visible on the shelf below. A licensed plumber should be hired to locate and repair the leak before the bathroom is used. Mildew/mold may be hidden on the non-visible wall surfaces, etc.

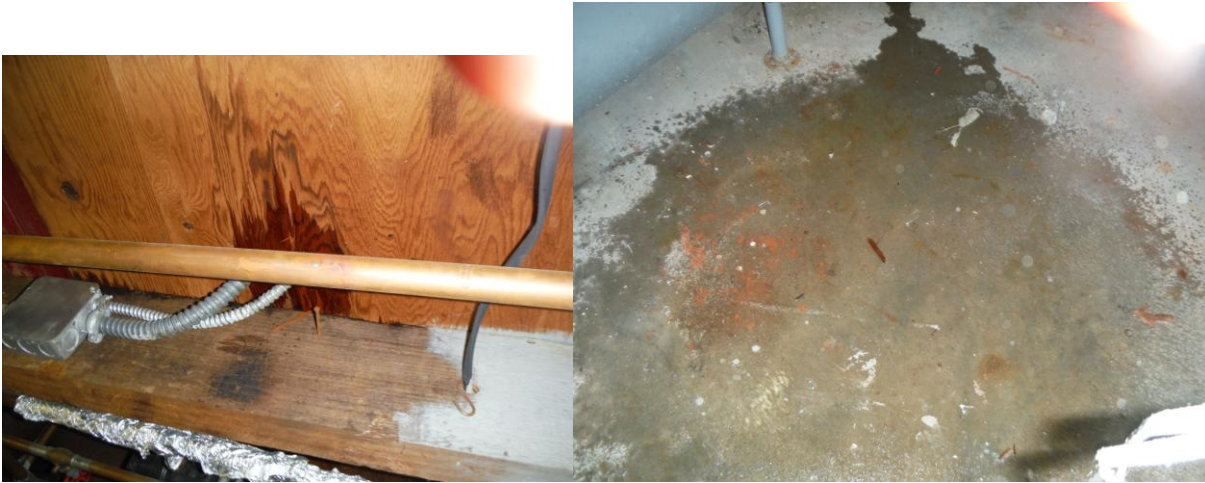
117) Repair-Priority. Cost=Uncertain.

When the water was run a second leak formed in the basement ceiling not related to the first leak. A licensed plumber should be hired to locate and repair the leak before the bathroom is used. Mildew/mold may be hidden on the non-visible wall surfaces, etc.

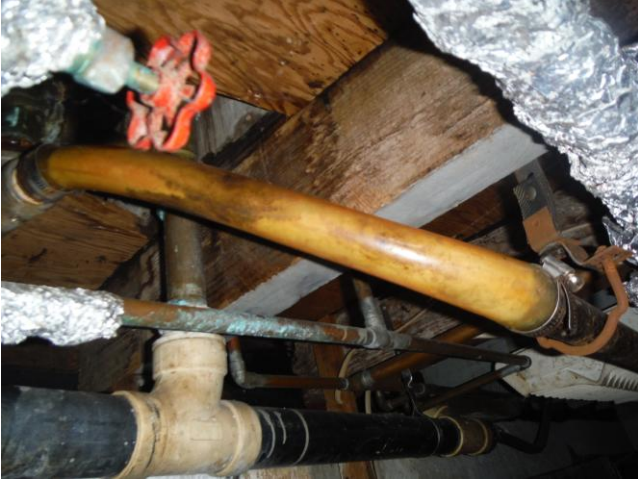
119) Replace-Recommend. Cost=Medium.

A flexible supply pipe/hose is used for plumbing as found in the basement ceiling (rear/center). Generally flexible connectors/hoses are not allowed for such applications due to maintenance, lifespan and inspection needs. A plumber should be hire to replace this hose with proper hard-walled piping.

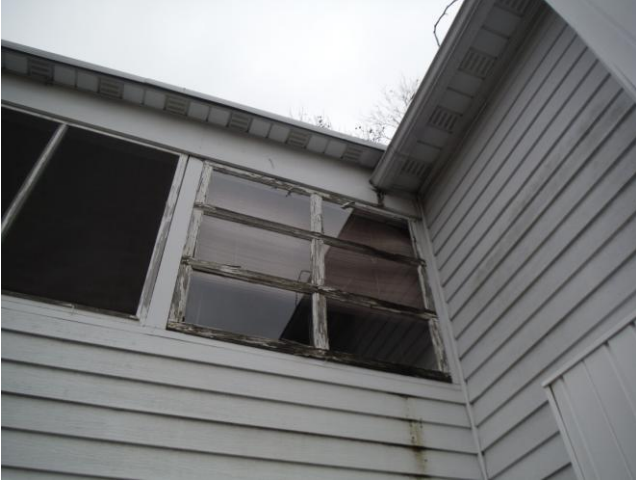
120) Repair-Recommend. Cost=Medium/High.

Several of the top rear porch windows are in disrepair (missing/deteriorated/etc.). They may need to be repaired/replaced for security/convenience and heating/cooling efficiencies.

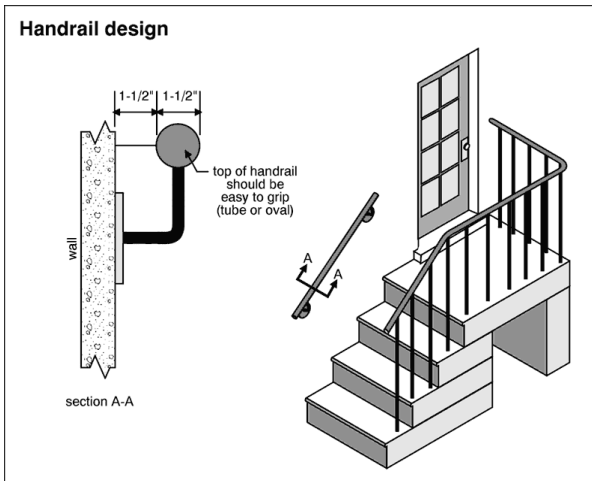
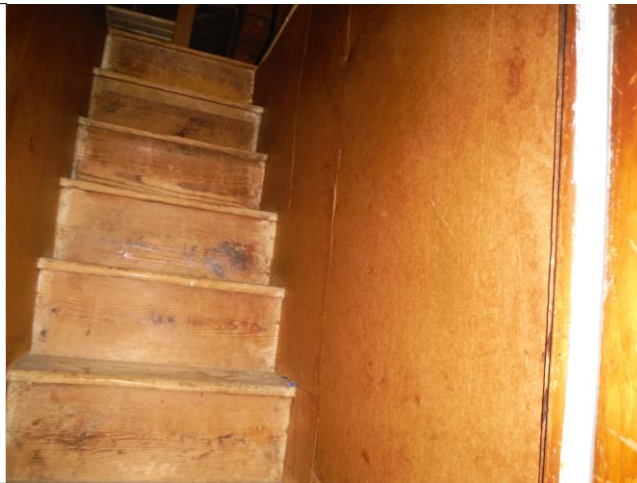
121) Provide-Recommend. Cost=Medium.

There is no handrail for the attic stairs. One should be provided that is graspable for safety (falling) hazards.

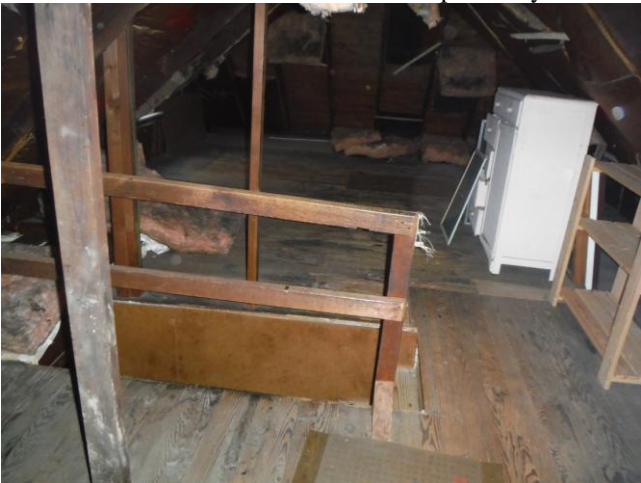
122) Provide-Recommend. Cost=Medium.

Since the attic stairs are fixed the opening should be enclosed so that a 4” ball (or equivalent) cannot pass off/through the attic floor to the stairwell. This is a child/pet safety issue.

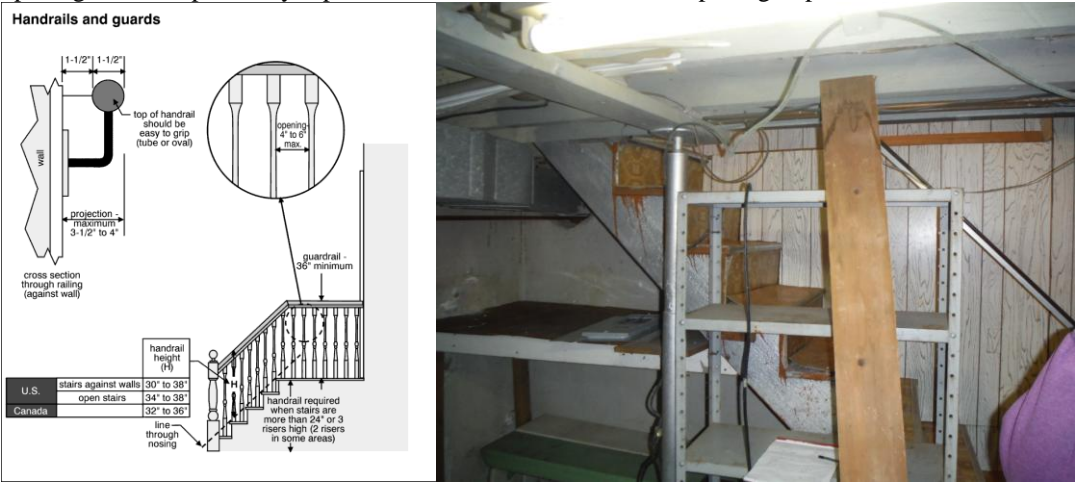
123) Replace-Recommend. Cost=Medium.

The basement stairway opening is a potential child/pet safety issue. A 4” ball should not be able to pass off/through the opening for child/pet safety. Spindles should be installed in this opening to prevent falls.

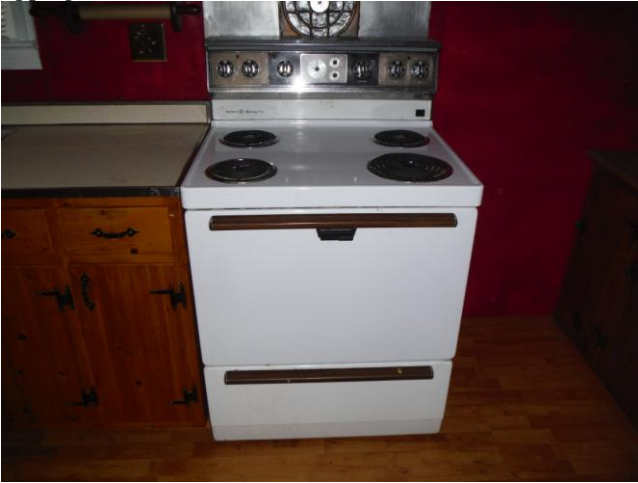
124) Provide-Recommend. Cost=Low.

An anti-tilt bracket should be added to the top kitchen stove for child safety. The bracket should prevent the stove from tipping over onto someone, etc.

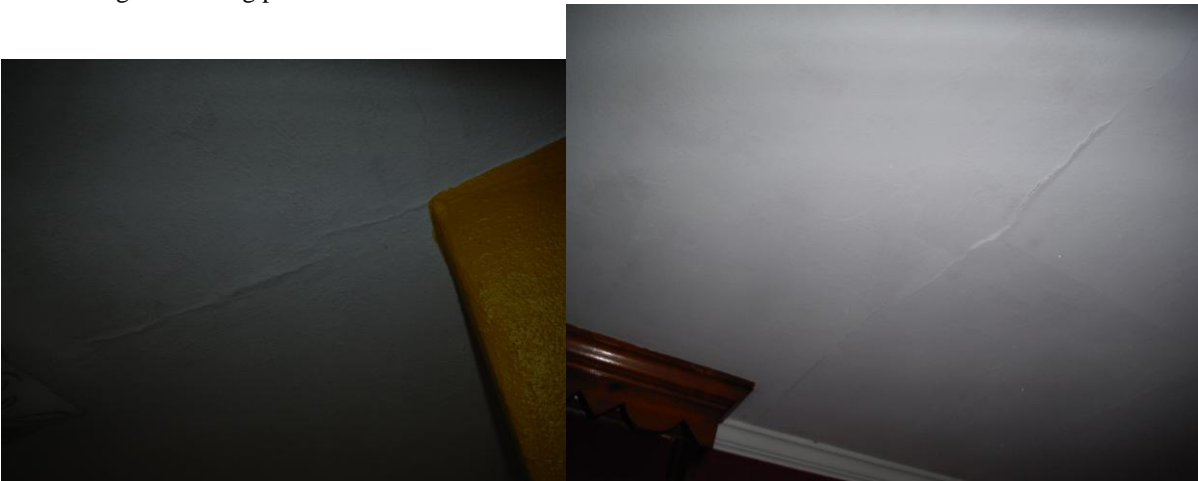
125) Monitor-Recommend.

The plaster on several top floor ceiling is loose in localized areas. Falling plaster can cause extensive damage and cause harm to residents/gusts/pets/furniture/etc. The homeowner should consider adding additional plaster fasteners to these weaker areas to ensure against falling plaster.

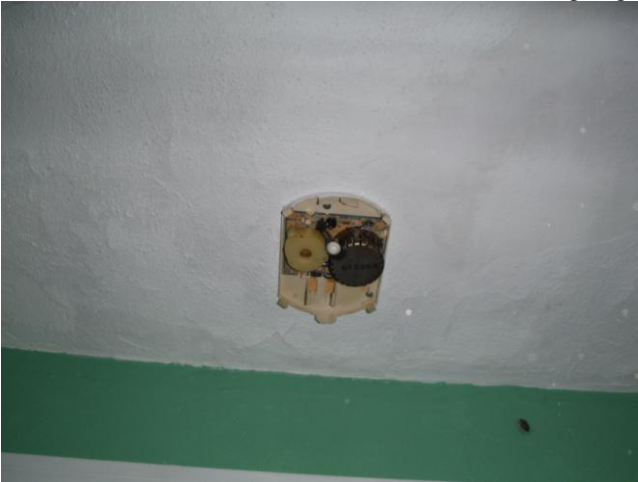
126) Repair-Recommend. Cost=Low.

Several smoke/carbon monoxide detectors are missing (e.g. top floor) and should be reinstalled for fire and health safety.

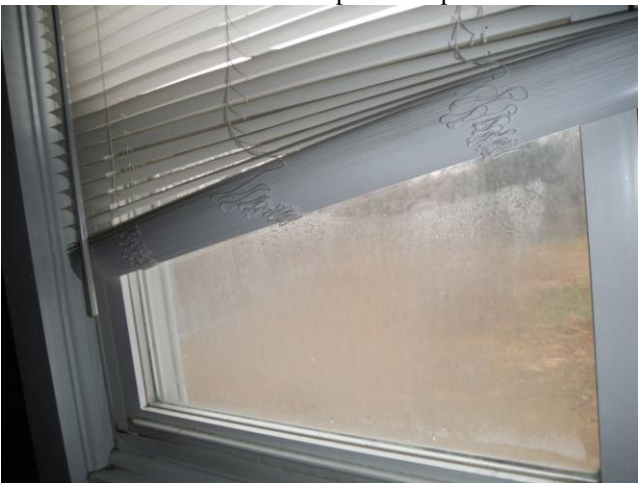
127) Repair-Recommend. Cost=Medium.

The top left kitchen window has a compromised seal and has lost some insulating capacity which has caused interior staining on the windows. It should be replaced/ repaired.

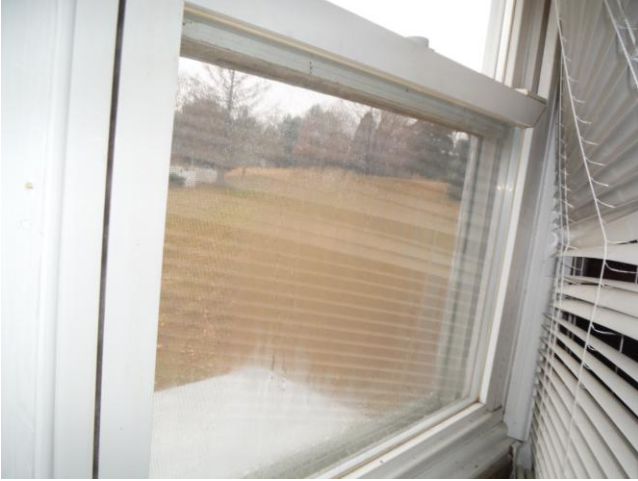
128) Repair-Recommend. Cost=Medium/High.

The top left hall window has a compromised seal and has lost some insulating capacity which has caused interior staining on the windows. It should be replaced/ repaired.

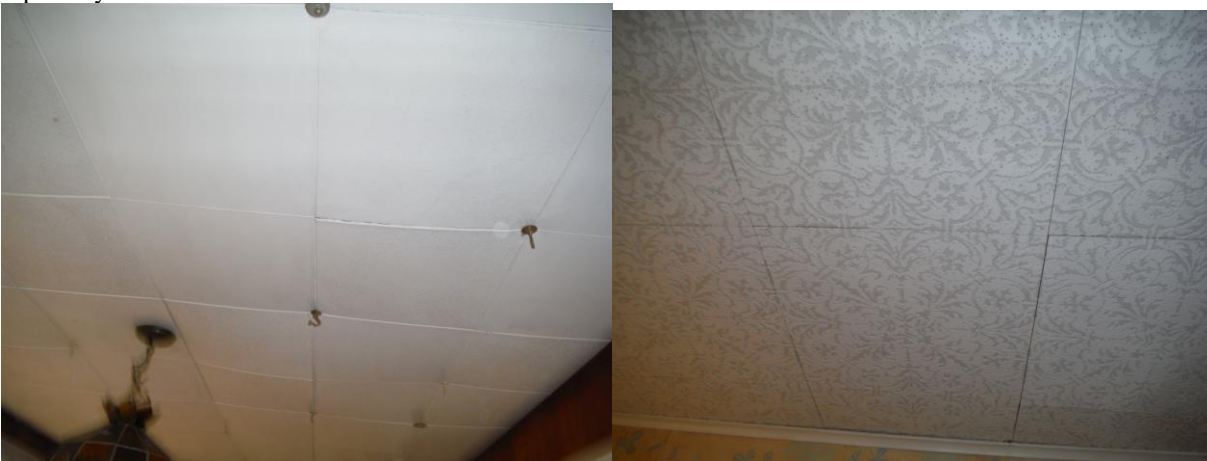
129) Further Investigation Required-Recommend. Cost=Uncertain.

The right porch and bathroom (lower) ceiling tiles may be asbestos based. This would not be uncommon due to the apparent age and size of them. An off-site laboratory test would be required to confirm if the tiles are asbestos-based. If it is confirmed that they are asbestos-based then they should be removed or encapsulated since asbestos is a known cancer-causing material, especially when it is friable.

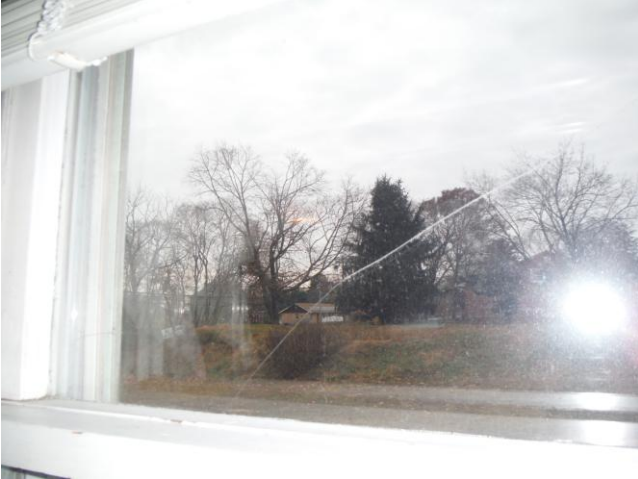
130) Replace-Recommend. Cost=Low.

The foyer left window has a broken pane which should be replaced for safety and security.

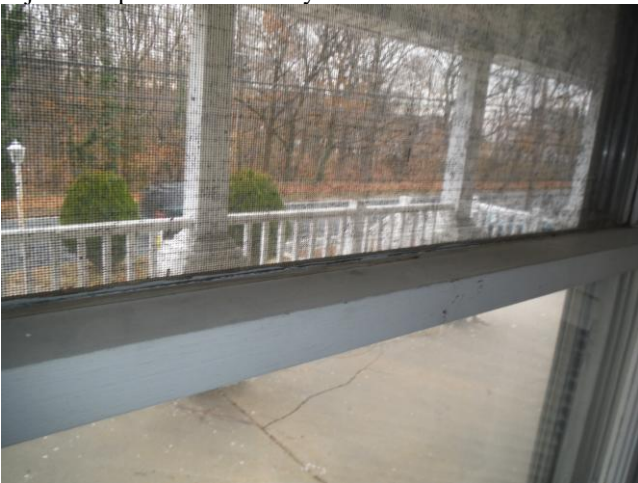
131) Repair-Recommend. Cost=Low.

There are several windows on the main floor which are missing lock latches The lock/catch mechanisms should be adjusted/replaced for security/convenience.

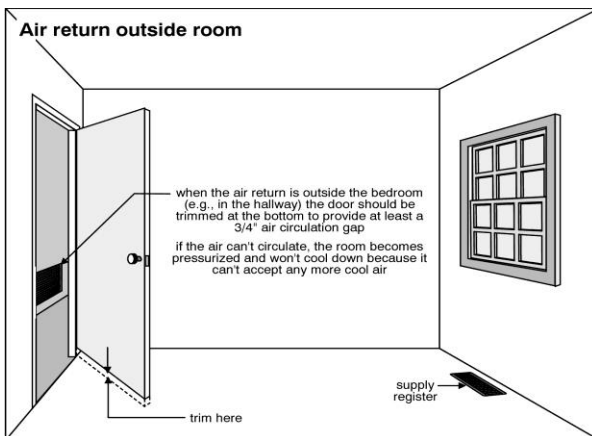
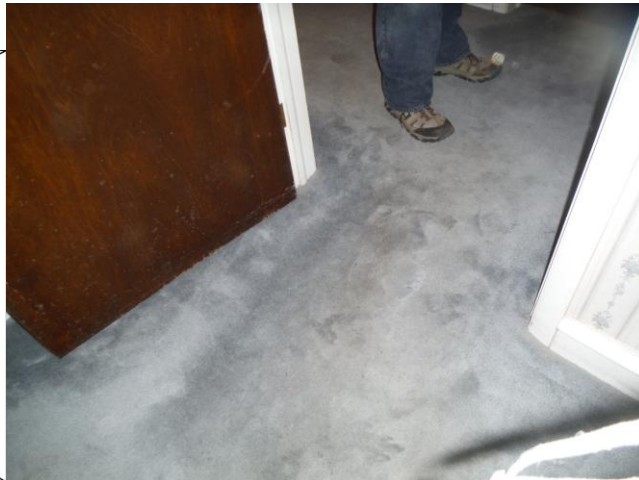
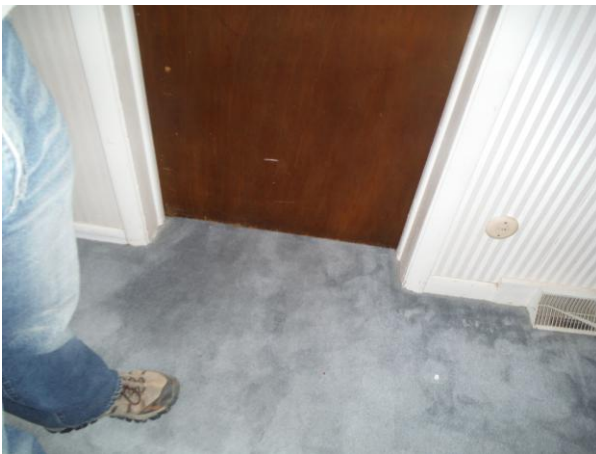
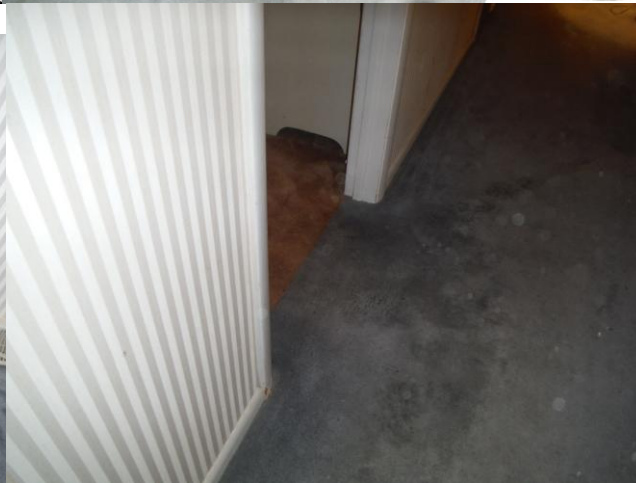
132) Improve-Recommend. Cost=Low.

The bottom of the carpeted bedroom doors should be trimmed in order to allow for proper return air pull to the forced air system. There is currently insufficient area to allow for proper return air. Otherwise stale, conditioned air will remain in these rooms which may prevent proper heating of these rooms due to over-pressurization. This will affect heating efficiency as well as comfort.

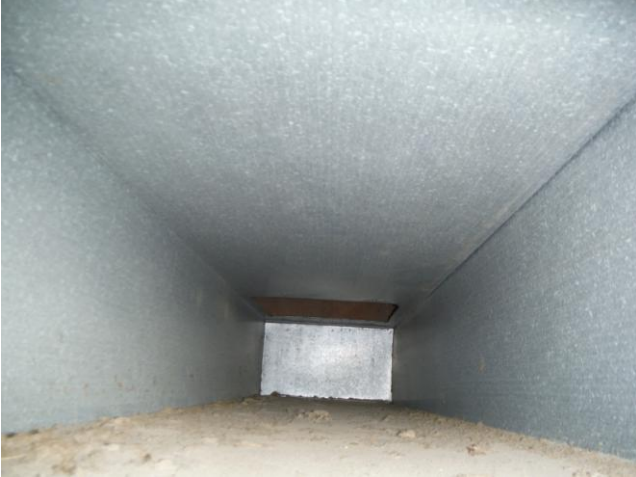
133) Repair-Recommend. Cost=Low.

A duct is disconnected in the basement. It appears this would supply the first floor bathroom with heat.

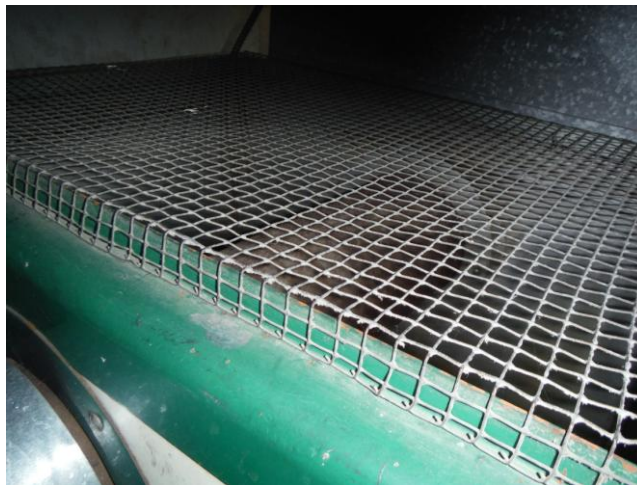
134) Repair-Recommend. Cost=Uncertain.

The return duct for the heating system is open to the unfinished basement. This is allowing the return air to be drawn from the unfinished basement instead of from the habitable interior rooms as expected. This will result in heating inefficiencies and potentially the allowance of un-clean air into the house air. The duct/plenum exposed in the air handler room should be extended to the finished sections of the home.
